<p>FLORIDA'S TURNPIKE ENTERPRISE (FTE) Construction Engineer: Pete Nissen, P.E. Assistant Construction Engineer: Bill Sears, P.E. FDOT Design Project Manager: William Sloup, P.E. GEC Design Project Manager: Terry Miller, P.E. Construction Project Manager: Ken Hudson</p> <p>CCEI NEW MILLENNIUM ENGINEERING, INC. (NME) Sr. Project Engineer: Gus Quesada, P.E. Project Administrator: Sergio Ambros</p> <p>CONTRACTOR COMMUNITY ASPHALT CORPORATION (CAC) Project Manager: Vernon Walker Project Manager: Aryail M. Gomez</p> <p>ENGINEER OF RECORD MOFFATT & NICHOL (M&N) EOR: Richard Rocktoff, P.E. Project Manager: Jeff Messenger, P.E.</p>	<p>PERFORMANCE MEASURES:</p> <p>Notice to Proceed Date: 06/06/13 Construction Start Date: 07/08/13 Completion Date: 05/19/14 Original Contract Time: 270 days <u>Approved Time Extensions:</u> Weather/Holidays: 46 days Supplemental Agreements: 0 days Final Contract Time: 316 days % Overrun Orig. Contract Time: 0%</p> <p>Original Contract Amount: \$6,589,153.50 Final Contract Amount: \$6,665,935.50 % Overrun Contract Amount 1.17%</p> <p>Final CPPR: 91</p>

<p>PROJECT DESCRIPTION: The Improvements under this Contract consist of milling and resurfacing with design cr

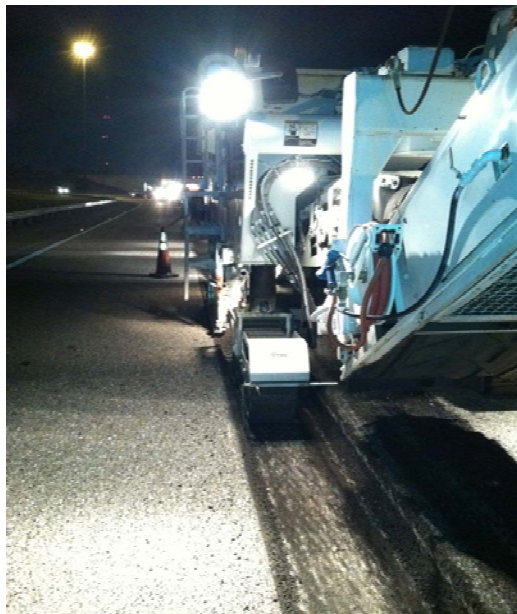
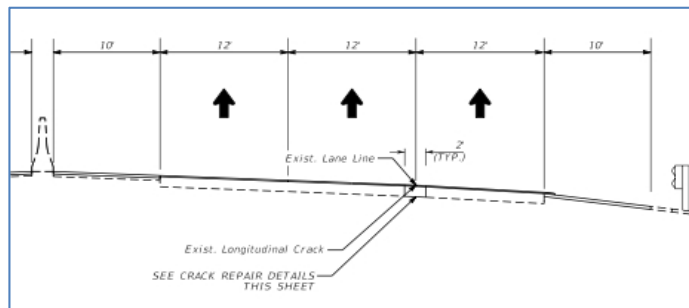
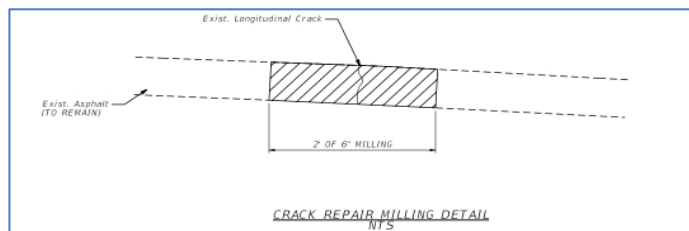
Pay Item: 334-1-4 SP Trench Repair – The trench repair detail called for a 2' wide trench; however, to achieve density requirements and based on the contractor's available equipment, the trench width was too small. It was determined to increase the trench width to 27+/-" to allow the contractor's equipment to access the trench and properly achieve density.

PAY ITEM NOTE:
 334-1-4 SUPERPAVE ASPHALTIC CONCRETE (TRAFFIC D) INCLUDES 1608.1 TN OF SP UTILIZED AS SACRIFICIAL PAVEMENT IN TRENCH REPAIR. THE TOP 3" OF TRENCH REPAIR WILL BE REMOVED IN THE NORMAL MILLING & RESURFACING OPERATION.

Summary and Recommendation: Although CAC performed this work at no additional cost to FTE, we feel this may have been a potential claim because another contractor may have tried to achieve density with a smaller piece of equipment which would not have yielded the favorable results CAC achieved. The industry has compactors that are exactly 24" in width, but they are not readily available and need to be ordered, the typical ones are 26". Density could have also been achieved by using smaller lift thickness, but the operation would have taken longer, which is a greater impact to the motorist. This repair procedure proved successful and we highly recommend its use in other areas; to avoid potential claims, we recommend increasing the trench width to 27".

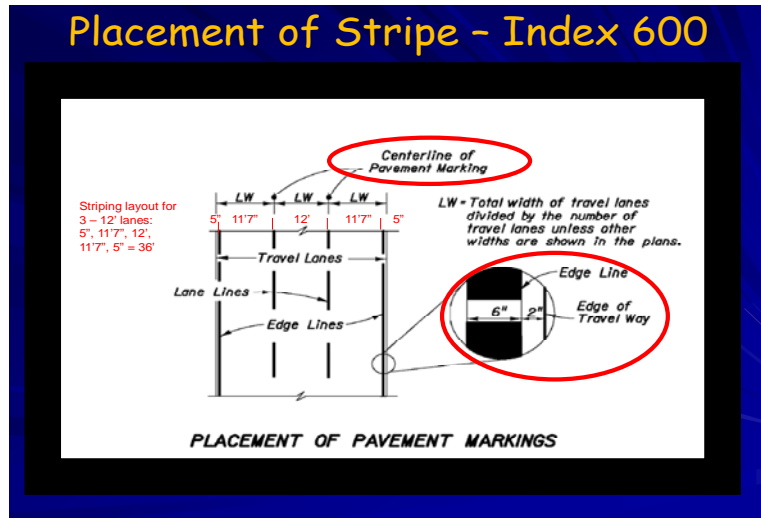
211 Painted Pavement Markings –

The shoulder width throughout the project varied from 10' standard (+/-) 0"-8", which made it difficult to maintain the standard detail. This was even more of a challenge when we approached the bridges as you can see from the illustrations below as well as the beginning and ending of the project limits.

Summary and Recommendation: for the bridge approaches we recommend to create a typical detail that tapers the FC to meet the existing bridge edge line configuration. This way we keep the edge line completely on the FC and maintain compliance with the index requirements. This issue was not as prevalent on the main line; however, there are cases where the edge line does not have the prescribed 2" clearances from the EOP.

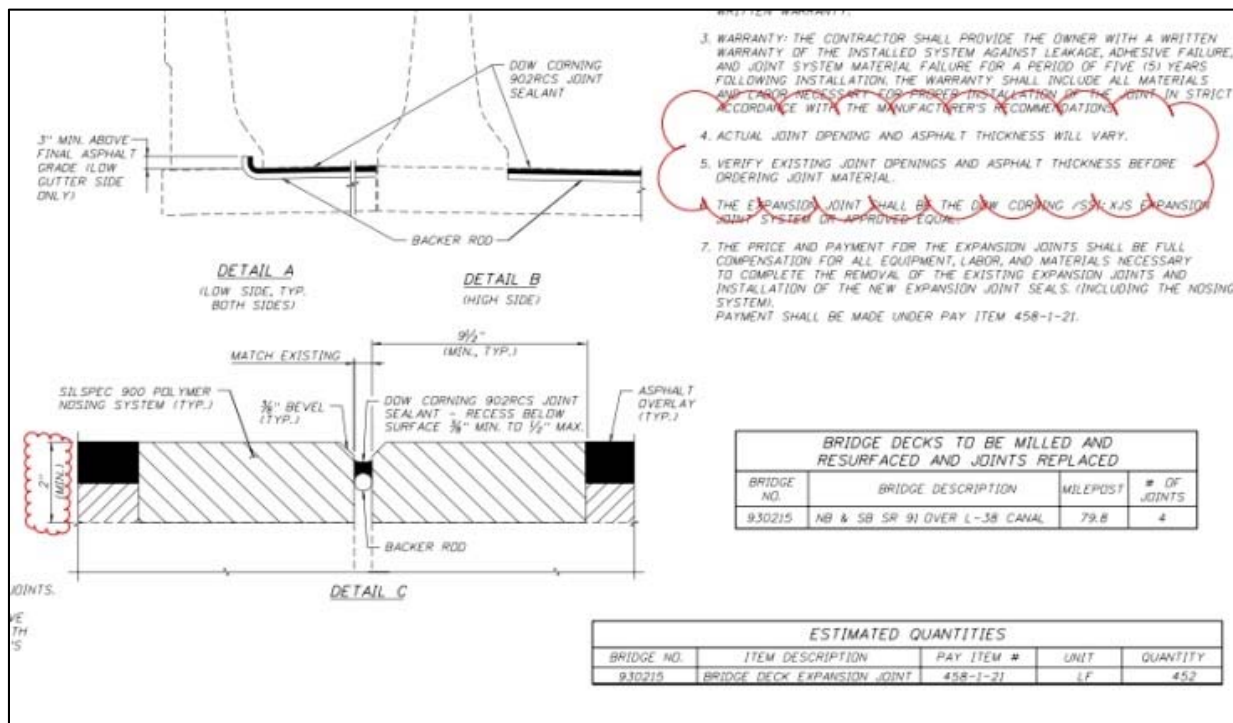
Pay Item: 458-1-21 Bridge Deck Expansion Joint (Plan Quantity) – The joint installer is claiming unforeseen conditions based on the significant difference between the theoretical joint thicknesses to that of the actual field condition. Although the plan sheet requires that the contractor verify the thickness prior to initiating the operation, it does not provide for compensation if there is an overrun based on thickness. The contractor assumed a theoretical thickness of 2" and applied 1.5" overbuild after milling, 3/4" FC, and deduced that the final thickness would be 2.75"; however, the actual thickness for the joint was between 3.5" – 4".

Summary and Recommendation: NME has discussed this issue with several bridge design engineers and it's a common occurrence on rehabilitation projects; that the bridge design engineers place the 2" (min) on the detail simply to address the design criteria, not to be used as a threshold for estimating labor/materials needed. The notes on the plan do not address estimating for costing the item, they are more to the operation's logistics so that the contractor doesn't start the work without having the proper materials on hand. We recommend that several cores be taken during the design phase and the results provided on the plans for estimating purposes.

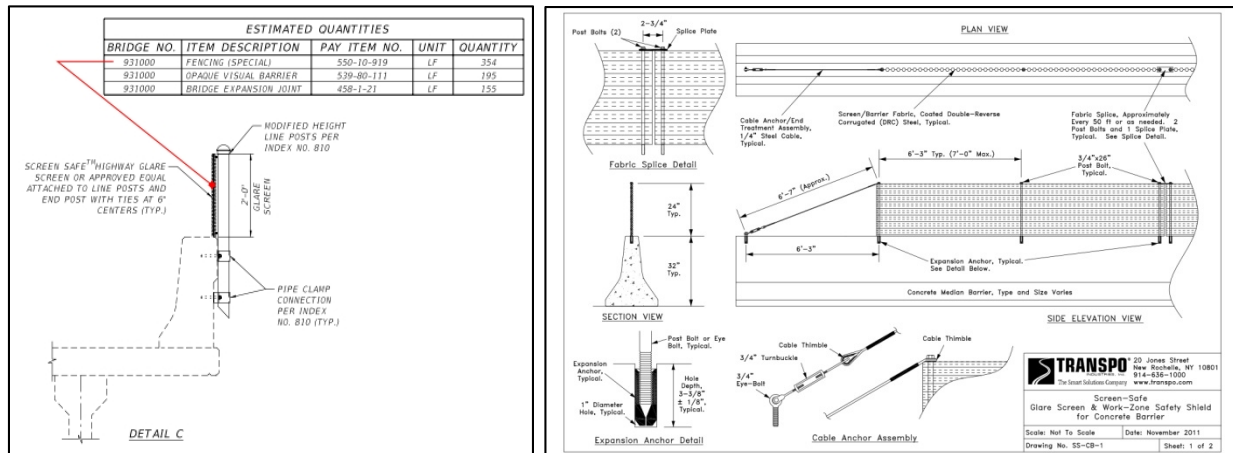
Pay Item: 550-10-919 Fencing (Special) – We encountered an issue where the glare screen installer did not properly interpret the intent of the plan detail (Detail C, left) and assumed that the manufacturer’s recommended anchoring detail (right) would supersede the Plan detail. This was cause for delays and it is currently a pending claim where the subcontractor feels that the anchoring should be the manufacturer recommended rather than the one prescribed by the plan detail.

Summary and Recommendation: Although we feel that the Detail “C” is clear in relating the intent of the EOR, the fact that we are veering from a manufacturer’s recommended installation detail is not good practice. We recommend that if sole sourcing a product, the EOR should investigate all aspects of the product’s working criteria and include them as part of either a pay item note or TSP. The final product required some creative thinking on the part of the subcontractor, which yielded an acceptable product.
