EXTINGUISH THE TORCH MEETING SESSION ONE

Project: Turnpike Mainline Shoulder Evacuation NB (MP 210-249)

LESSONS LEARNED

SUMMARY REPORT

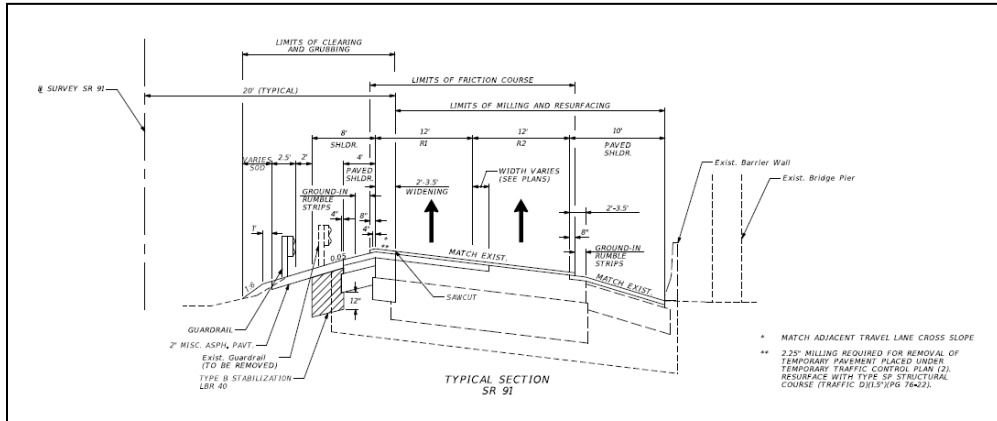
Typical section shows different optional bases and structural course for the 2 to 3.5 foot widening and the 4 foot inside shoulder. It is very difficult to construct and compact the 2 to 3.5 foot widening with the small equipment (plate tamper) required to work in this narrow strip.

During construction, to expedite the construction and to achieve better quality, the widening and shoulders were constructed with same typical section (same as widening) at MP 241.94, MP 243.56 and MP 244.87. This required 104.8 tons of additional TLD Poly, 334.2 tons of additional TLB and 202.0 tons of additional TLD (over-runs).

The EOR should consider same typical section for widening & shoulder, when total width of construction is less than 8'.

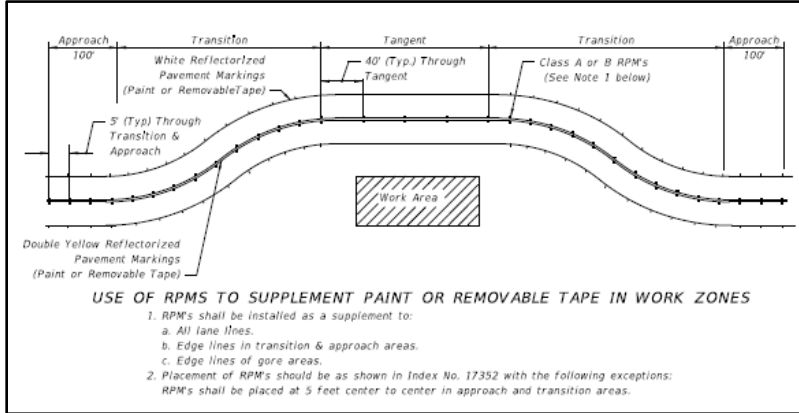
MOT plans did not account for transition approach distance of 100' to be included with milling and resurfacing.

Extended the milling limits 100' at MP 229.37, MP 241.94, MP 243.56 and MP 244.87 to remove the strips outside MOT plan limits. This required additional 756 SY of 3/4" mill and 31.2 tons of additional FC-5 (over-runs).

Milling and resurfacing limits should include transition approach distance as per Standard Plans.

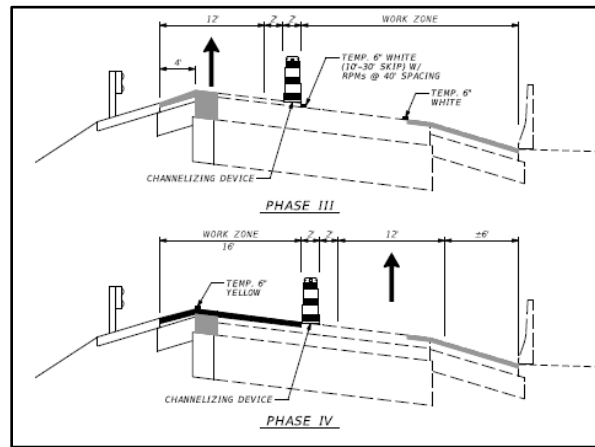
The traffic control plan called for milling the existing friction course on the outside travel lane in phase III. Then mill and resurface the inside travel lane (structure course) in Phase IV. Phase V called for placement of friction course on both travel lanes. Milling the friction course in the outside lane would have left a milled surface until Phase V. Even though Special Provision Section 327 allowed traffic on the milled surface for up to 3 calendar days, FTE and the CEI were concerned that weather would likely impact the work on the inside lane (which had to be milled and resurfaced with structure course and friction course), resulting in traffic being kept on the milled surface for more than 3 days.

During construction, the contractor did not mill the friction course in the outside lane (Phase III) until after the inside travel lanes were resurfaced with structure and friction. This allowed the traffic to shift to final configuration as the FC-5 was placed and traffic was never placed onto a milled surface.

The EOR should avoid leaving milled surface and should call out placement of friction course same night of milling.

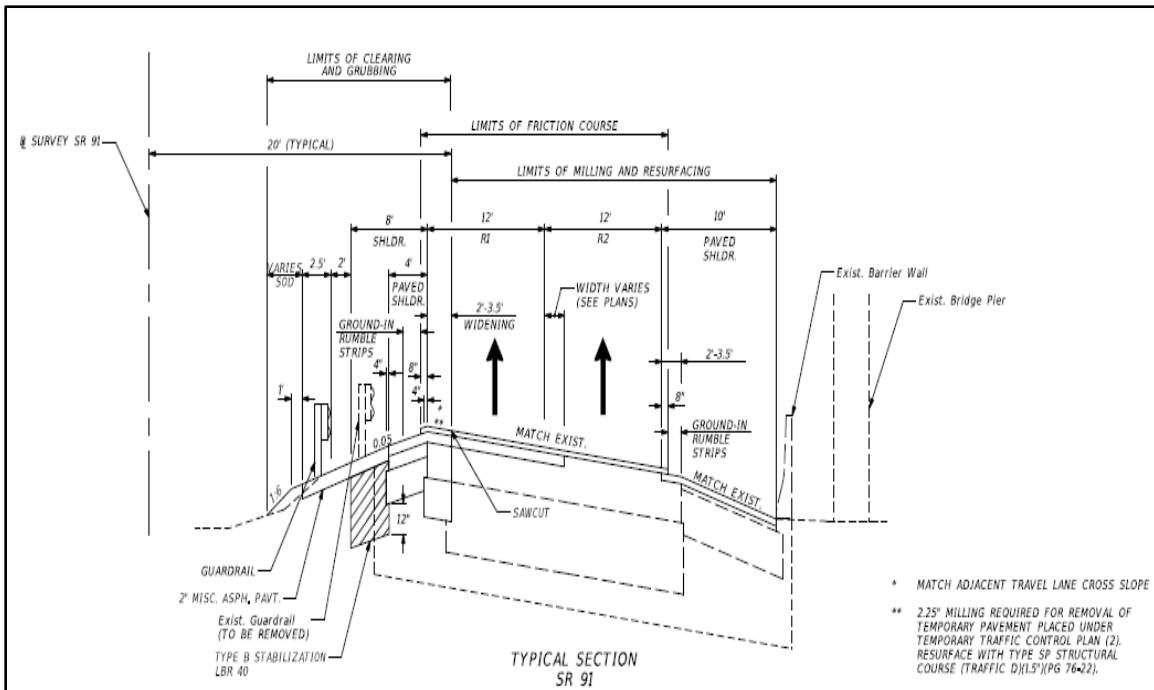
Per plan, the cross-slope break between the original travel lane and original shoulder (2% to 6% break) was to remain at the original location with permanent traffic shifted to the left, away from that break. This would have required the rumble strips to cross the shoulder break. The rumble strip would not have met design criteria if it had been placed in the shoulder break.

During construction, the Contractor did not provide the break in the outside shoulder as depicted on the typical section. The resulting shoulder cross slope was 5.7% instead of the original 6% but no longer included the break.

Typical section should show the shoulder break (2 % to 6%) at 10' between the mainline and the outside shoulder to avoid rumble strips to cross into the shoulder break.
