Summary Report

Polk Parkway (SR 570) Resurfacing from MP 8.1 to MP 21.7
FPN's 423199-1-52-01 and 423199-3-52-01
Contract E8L90

Project Scope of Work

Polk Parkway (SR 570) Resurfacing and Improvements from MP 8.1 to MP 21.7

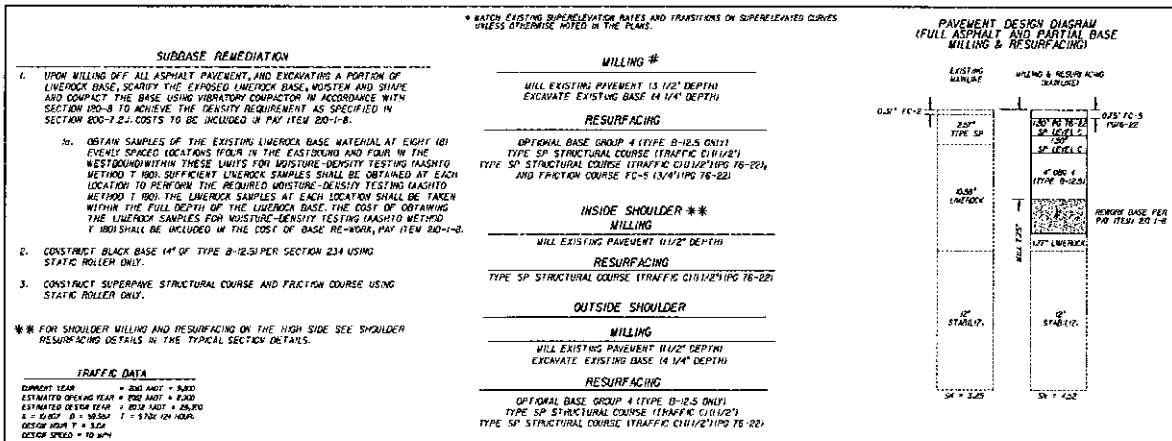
In several of these areas, it was discovered that the existing base was yielding at a depth of 7.75". The OBG-4 could not be placed in the areas where this condition was encountered. Once an area of failing base was identified, the project personnel would evaluate the situation on a case-by-case basis to determine the most effective method of repair.

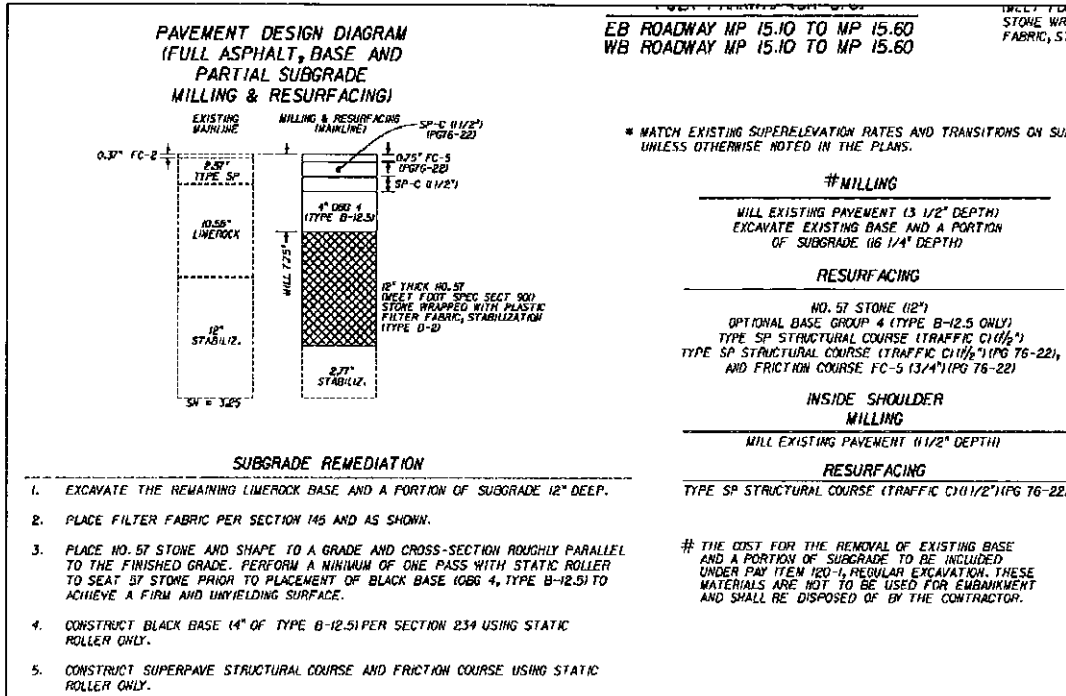
- Excavate 19.75" and place 12" of gravel fill to replace the failing base material. Then 4" of OBG-4 asphalt, 3" of SP, and 0.75" of FC-5 are placed on top of the gravel fill. This method is described in the typical section notes on Plan Sheet 8 (shown below):

The advantage to this method is it has worked every time it has been used. The disadvantage was the amount of time it took to perform the operations. When we encountered the first base failure, the contractor's methods to repair the area took 24 hours to repair 350 feet of the roadway. They excavated the failing base with a small capacity loader and placed the gravel fill with a dozer.

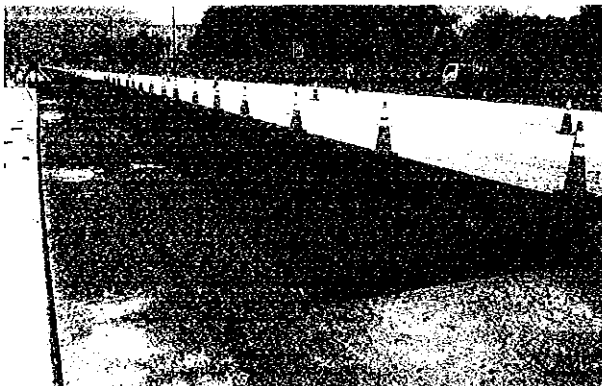
Preparing subgrade for placement of gravel fill

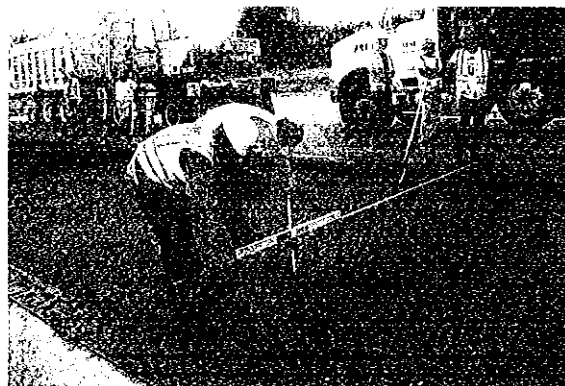
Checking final grade of gravel fill

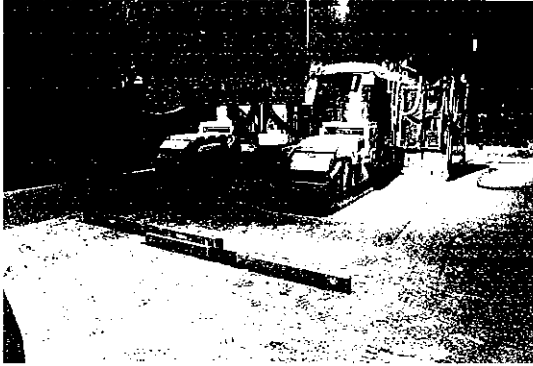
Checking cross slope of subgrade following milling of existing limerock base

A lesson learned from this operation has been to use different methods of excavating the failing material and placing the asphalt. After the first repair, the Contractor excavated the failing base material with a milling machine. The milling machine was able to remove the failing base and cut to grade in 2 passes.

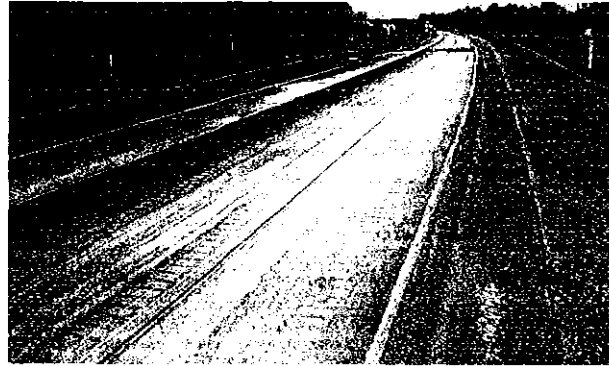
Milled limerock base

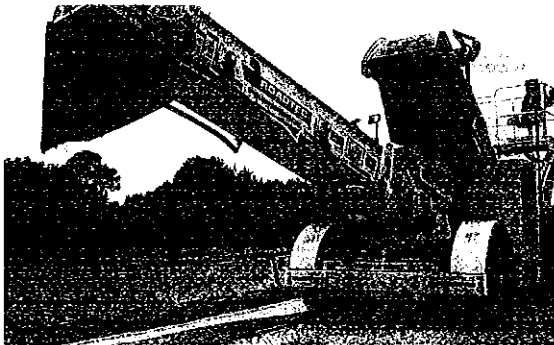
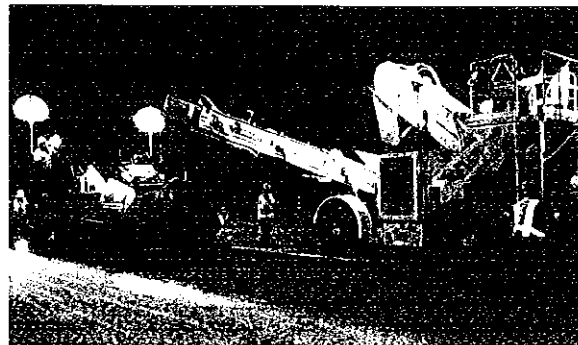
Another measure implemented to reduce the repair time was use of a Motorized Transport Vehicle (MTV) and a track paving machine to place the asphalt. This allowed the asphalt truck to back up to the MTV and dump asphalt while the MTV transferred the asphalt to the paving machine without disturbing the grade of the gravel fill. When the contractor used this method to place the asphalt over top of the gravel fill, they were able to place 2,640 feet in 3 hours compared to 350 feet in 3 hours.

When the base remediation method shown in item (2) above is specified, it is recommended that the EOR require the Contractor to use a milling machine to excavate down to the 19.75" depth, and that the Contractor be required to use the MTV to transport the hot mix asphalt to a track paver when paving over the layer of gravel fill.

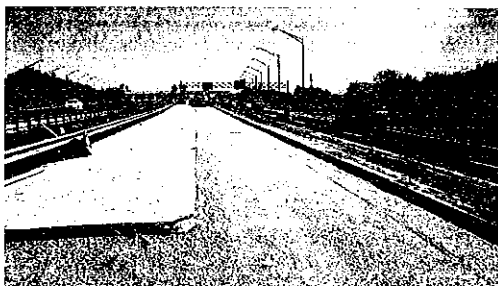
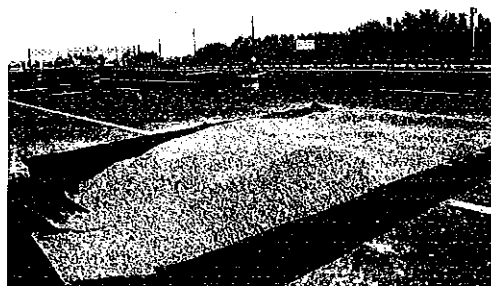
Construction of Weep Trenches

In the case of the base repair done at MP 12.4 described above, because the existing base beneath lanes L-2 and L-3 became saturated with the water that had been trapped under lane L-1, it was necessary to remove all of the base material from those lanes and employ the full-depth gravel fill repair described above. Two weep trenches along with select A-3 material were constructed on the shoulder to ensure that the water would not get trapped there again.

It is recommended that when the reconstruction of a roadway involves the placement of a layer of gravel fill beneath the pavement, the EOR specify in the plans the construction of weep trenches to allow a pathway for water to flow from under the roadway and into the grassed shoulder or grassed median.

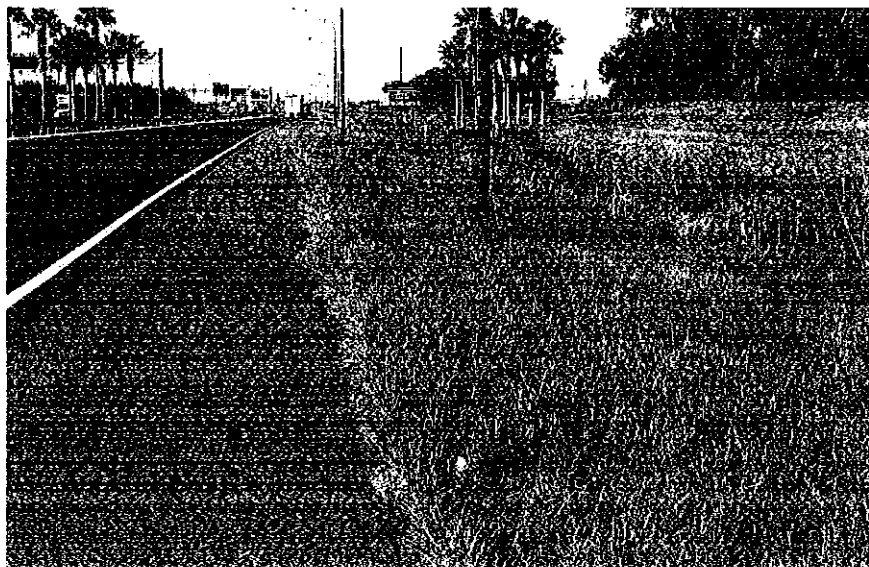
I recently visited one of the areas where a weep trench had been constructed 10 months ago. I noticed that the grass is growing extremely well in the area immediately adjacent to the location of the weep trench; the grass is green and is about 6 – 8 inches high. Whereas the grass on other areas of the shoulder is brownish and about 1 inch high.

This demonstrates that the weep trench is continuing to effectively drain the water from under the highway, even in the middle of the dry season

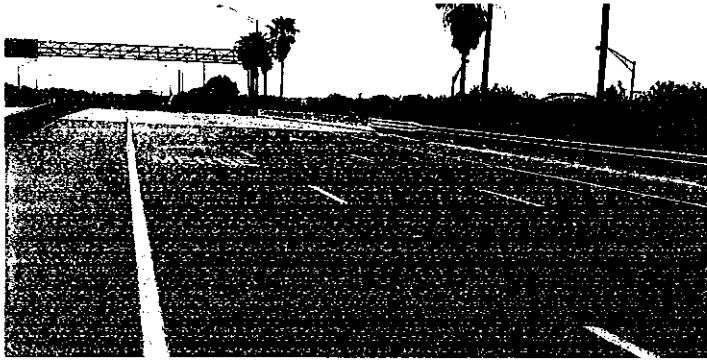
After this work had been completed, FTE implemented a plan revision to reconfigure the striping of the Parkway between the Western Toll Plaza and the intersection with Lakeland Highlands Road. The existing configuration was such that the on-ramp from Lakeland Highlands Road became one of the two through-lanes, while the inside lane of the Parkway was forced to merge to the right. Thus, traffic on the two westbound lanes of the Parkway was being forced to merge just before entering the Western Toll Plaza.

A Work Order was processed to have the Contractor hydro-blast the striping form the final lift of structural course and have it re-striped according to the new configuration. This prevented the striping conflicts following the placement of the FC-5.

It is recommended that the EOR specify in the plans that any reconfigurations of the existing striping patterns should be implemented immediately following the initial milling and resurfacing of the structural course. Since the contractor must re-stripe the road at that point, they can implement the new configuration without having to hydro-blast the stripe first.

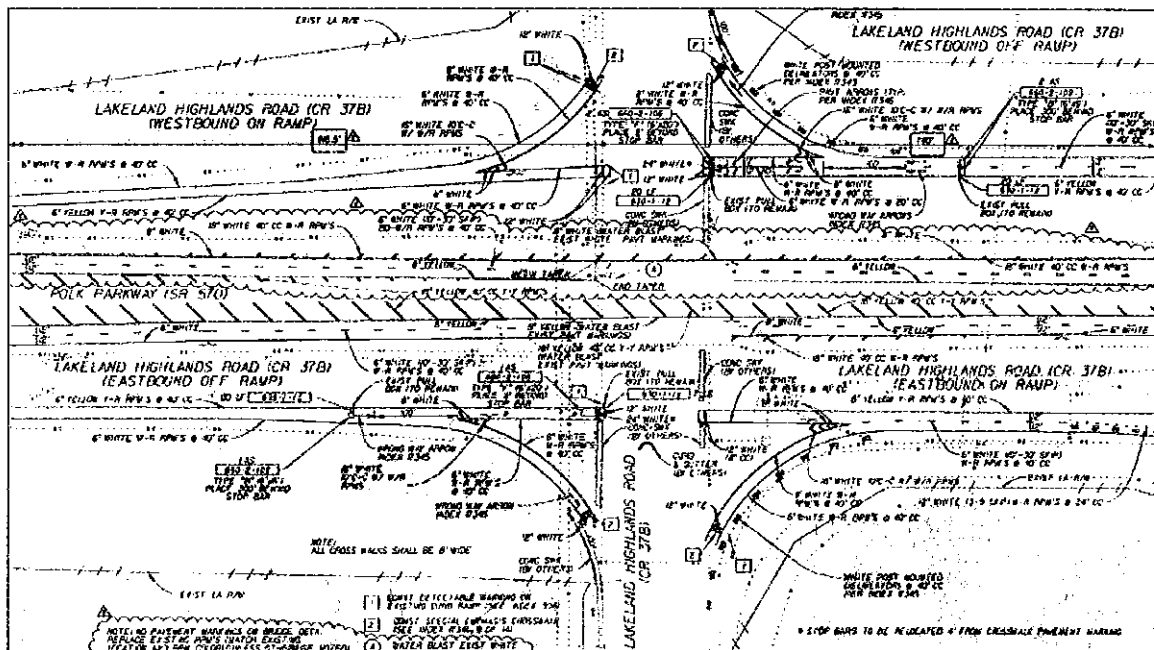
The plan revision reconfigured the striping so that the two WB through-lanes did NOT merge, but remained as through-lanes all the way to the Western Toll Plaza, while the WB on-ramp from Lakeland Highlands Road was forced to merge into the outside WB through-lane.

Since the revision was implemented prior to the placement of FC-5, the plan revision called for the Friction Course to be striped in accordance with the plan revision. However, since the Contractor only placed FC-5 on one lane at a time, it would mean that after the first night's operation one lane would be striped according to the new configuration and the other would still be striped according to the old configuration. This would have created conflicting striping in several areas.

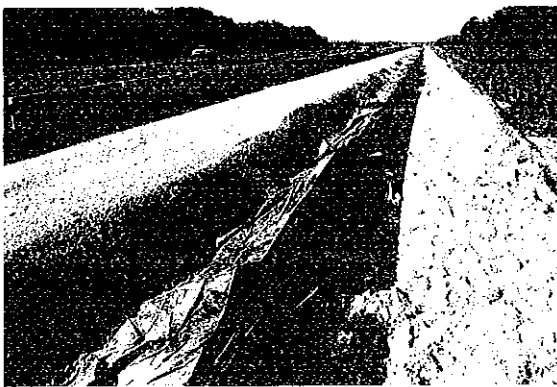
During the subgrade remediation operations, after placing the 12" layer of gravel fill, the rock was "seated" by having a steel-wheeled roller make several passes over the surface of the stone layer. In the areas where the stone layer was boxed in by select fill (sand), it settled between 1/2" and 1" upon seating with the roller. This was due to the movement of the adjacent sand when subjected to the lateral pressure of the gravel fill during the rolling. In areas where the stone was boxed in by either compacted limerock or compacted clayey subgrade, there was no measurable settlement in the stone layer after rolling.

Unconfined Edge

In the areas where there was a slight settlement of the stone layer, the thickness of the overlying asphalt was increased to bring the final grade of the asphalt up to the required height.

The settlement of the stone layer was observed during the initial placement of the gravel fill; thereafter, if the stone was to be placed adjacent select fill (or other sandy soils), the Contractor was instructed to increase the thickness of stone by 0.75" in order to achieve an average thickness of 12" after rolling.

When the placement of a 12" thick layer of gravel fill is specified, the CEI and the EOR should review the plans to see if the gravel is to be placed adjacent to select fill or other sandy soils. If so, it is recommended that the loose thickness of the gravel fill layer be increased by ½" to 1" in order to achieve a compacted thickness of 12".

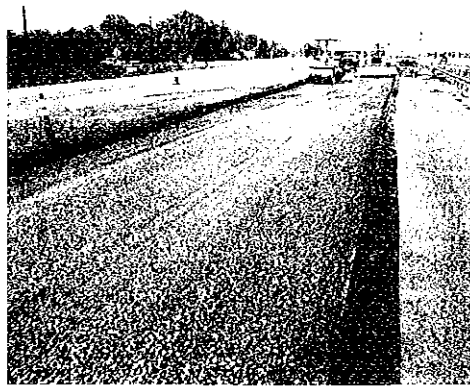
Confined Edges

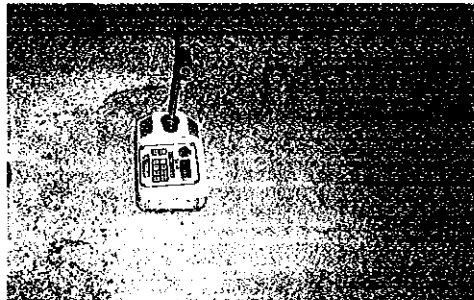
In several sections of the project, the plans called for the existing roadway to be excavated to a depth of 7.75" and repaved with 4" of asphalt base, 3" of SP asphalt, and 0.75" of FC-5. In the area between MP 12.0 and 12.6 where this method of construction was called for, after the initial excavation it was discovered that the remaining existing limerock base had an in-situ moisture content several percent above optimum. At first, this was not considered to be a problem, because the limerock was very hard and unyielding, and density tests indicated that the material had achieved the required compaction. Furthermore, all limerock used on FDOT projects must pass the LBR (Limerock Bearing Ratio) test which demonstrates the material's ability to sustain the required load while completely saturated.

Testing density and in-situ moisture content of existing limerock base

In the areas where a partial removal of the limerock was attempted and the base subsequently failed, the Contractor was directed to remove all asphalt and remaining limerock to a depth of 19.75". The highway section was then rebuilt with 12" of gravel fill, 4" of asphalt base, 3" of SP Asphalt, and 0.75" of FC-5.

In areas where the existing moisture content of the limerock base is over the optimum by more than 4%, it is recommended that the CEI direct the Contractor to remove all of the base down to subgrade, rather than attempting a partial removal of the limerock followed by resurfacing with HMA.

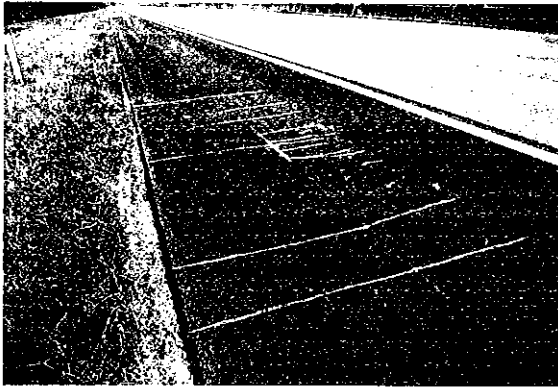
However, this particular limerock turned out to be extremely sensitive to moisture, and would begin "pumping" when its moisture content was a few percent above optimum. This became evident after attempting to place the first lift of hot mix asphalt (HMA) over the layer of remaining limerock. Even if the existing limerock was very hard and unyielding prior to the placement of the asphalt, the heat from the 300-degree HMA would cause the moisture in the limerock to rise to its surface and the limerock would subsequently fail.

"Weeping" Asphalt

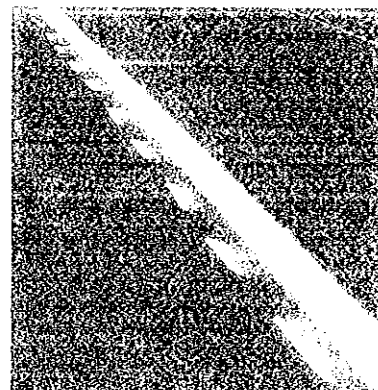
Following the initial placement of Friction Course, multiple instances of incorrect striping were noted by the inspection staff. Striping deficiencies included placing the outside solid stripe too close to the edge of the FC-5 mat, and the failure to install all RPM's, skip lines, and chevron striping as indicated in the Plans. In some areas, the stripe had been laid out correctly, but the striping crew had failed to follow the lay-out.

A CPPR Deficiency Warning Letter was issued based upon LANE's failure to perform proper QC over the striping operation. In the letter, LANE was directed to stop all milling and resurfacing operations until they could demonstrate their ability to maintain proper control over the striping operation. LANE responded by stating that every striping crew would have a member of their QC staff assigned specifically to that crew who would stay with the crew for the duration of the striping operations.

Additionally, Metric assigned an inspector to each striping crew to ensure that proper QC was being performed. Either the Sr. Project Engineer or the P.A. reviewed the striping layout prior to the placement of the paint to ensure conformance with the Plans.

In is recommended that the CEI ensure that the Prime Contractor has a person experienced in the proper layout and placement of pavement markings assigned to oversee the operations of their striping subcontractor. During the initial striping operations, the CEI should closely monitor the layout and placement of pavement markings to verify that the Contractor is exhibiting proper Quality Control over the operations. - WATERBLASTING CORRECTIONS

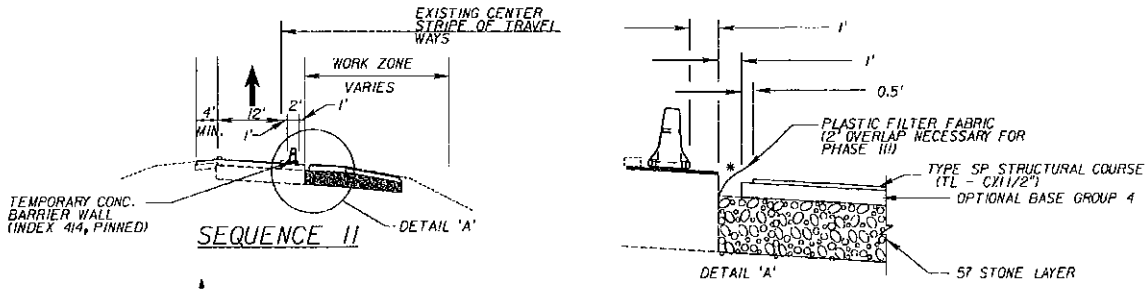
Detail from Traffic Control Plan

The TCP requires that the temporary K-wall be pinned per index 414 before the demolition of the existing outside lane and shoulder. The MOT phasing shown in the TCP would require that the pinning be performed in a live traffic lane, thus creating a safety issue. Also, the pinning would result in large pin holes being created in the newly placed asphalt in the outside lane.

The CEI worked with the EOR to develop an alternate TCP for this phase whereby the need to pin the wall was eliminated. The solution involved moving the work zone one foot towards the outside shoulder. Doing so provided a two-foot wide buffer zone between the temporary K-wall to the pavement repair drop off. Per Standard Index 414, pinning of the barrier wall is not required where there is offset of at least two feet, and the drop off is less than four feet.
