## LESSONS LEARNED - EXECUTIVE SUMMARY

Florida's Turnpike Enterprise  
Hillsborough County

FM 429025-1-52-01 SR 589 Suncoast Parkway  
Milling & Resurfacing & Safety

EXTINGUISH THE TORCH – MEETING 3  
Summary Report  
January 2015

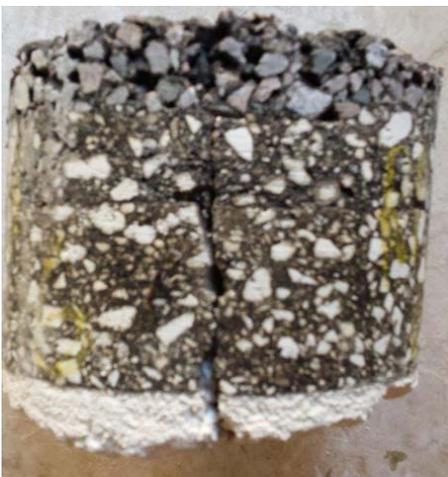
Prior to the start date of construction, the CEI observed areas with severe alligator cracking through the pavement to the limerock base. The Turnpike's Bituminous Engineer was contacted regarding these areas, to determine a repair procedure or if additional depth of milling and resurfacing would suffice. A more in-depth visual inspection was performed project wide and the Bituminous Engineer determined additional coring was needed throughout the project, due the amount of cracking observed. From the cores, it was determined the depth of resurfacing needed to be increased, especially for the outside lanes where most of the heavy truck traffic traveled. Also, during the first day of milling the inside lane, there were areas that were delaminating to the next asphalt course.

During Session 2, Maintenance indicated that the importance of accelerating this resurfacing project due to extensive pavement deterioration was conveyed to Production. Maintenance had requested that this project be advanced ahead of the Hernando resurfacing project. The pavement failure conditions of raveling, patching, potholes and rippling requiring "increased frequency of maintenance repairs" were noted in the Design Concept Report, December 2011, and the Existing Pavement Conditions Assessment Report, February 2013.

Various options were presented and reviewed by FTE personnel to determine the depth of resurfacing which would provide the best value (life of the pavement) for the additional cost. Both outside lanes were milled down into the limerock, providing 4" of structural course, versus the ultimate depth of 6".

For the inside lanes, the milling depth was increased to assure complete removal of the full lift of asphalt structural course.

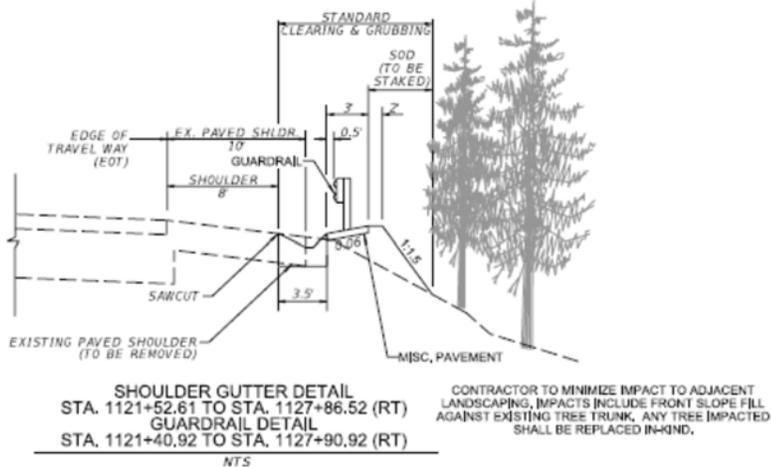
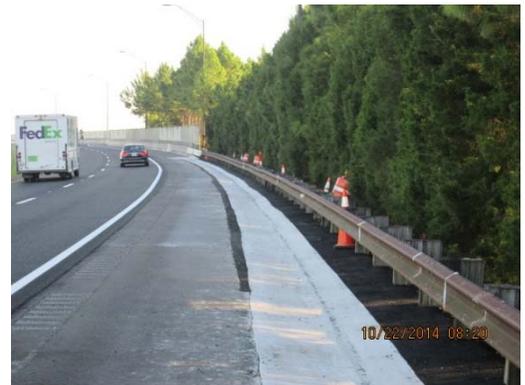
7. Aggregate cost of construction modification at shoulder gutter - In the area as shown where there is shoulder gutter and associated drainage, it was determined that the construction would not impact just one (1) tree as anticipated, but would impact twenty (20) trees. This landscaping was originally planted due to complaints by the community of Cheval. These trees took approximately two (2) years to get established and through discussions, it was decided the best solution was to not remove the trees, but meet the standards as close as possible by leaving the guardrail in place and building the drainage

structures/shoulder gutter in front of the guardrail. The electrical conduit was not replaced, except where it was conflict with the drainage structure. The miscellaneous asphalt was constructed as a wedge to meet the 6% slope to the back side of the guardrail. (Savings of \$23,124.01).
