# Extinguish the Torch Meeting

## Final Summary Report

### **Project: NB Turnpike and Glades Intersection Improvements**

**Financial Project Number: 435615-1/4-52-01**

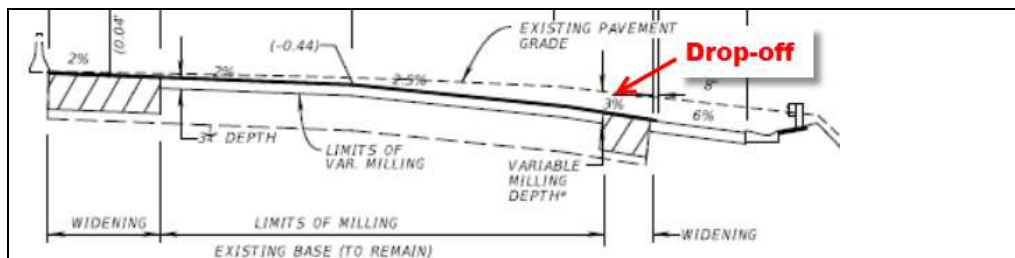
The plans did not indicate which phase to complete the Milling & Resurfacing, and called for outside widening first, and then the inside widening, and there was a concern with drop-offs created and the potential for holding water during the M & R operations.

Additional pre-pave meetings (workshops) were held early, and supplemental information was provided by the EOR (stations, offsets, elevations). From this information, it was clear that there would be a significant drop-off at the outside widening that would need to be addressed to allow the Phase 2 traffic shift. A sacrificial asphalt wedge was placed on the outside widening to address the drop off.

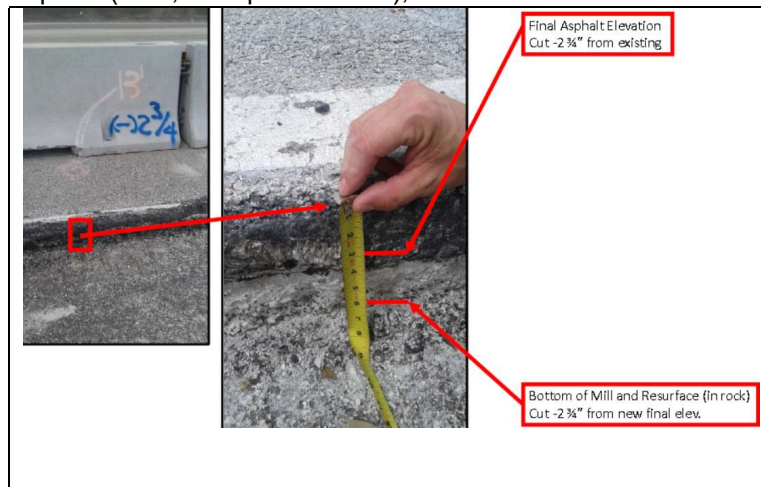
In addition, due to the deep mill (3 1/4", 2 3/4" plus 3/4" FC5), there was a concern about hitting existing base.

Additionally, due to the concern with hitting base, that became evident after the pavement was sawcut and removed, the Turnpike Materials office performed pavement coring to verify existing asphalt thickness. Due to the thin asphalt, the EOR modified the cross-slope of R-3 from 2.5% to 2% to address the issue. This adjusted cross-slope resulted in re-paving required on the outside auxiliary lane and the outside shoulder along the mainline between Stations 472+88 to 491+00, that had already been widened and paved during Phase 1B.

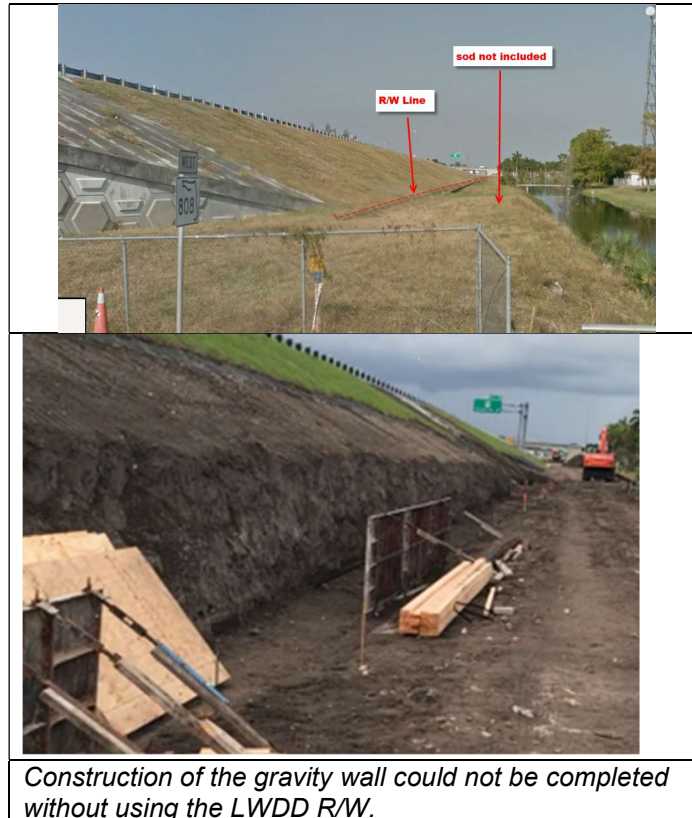
The designer did not include performance turf for areas within the project that should have been included, and the performance turf in these areas and had to be negotiated to close out the project. For example, the LWDD Permit area required 4010 SY of sod for restoration.

*Construction of the gravity wall could not be completed without using the LWDD R/W.*

For the LWDD right of way area, the CEI negotiated with the contractor to pay only for materials (\$1.98 per SY or \$7,940.00), since LWDD allowed excess material to remain within the LWDD R/W, a benefit to the contractor. Other areas requiring restoration were negotiated, in a similar manner. **Total additional costs related to performance turf totaled \$15,000.**

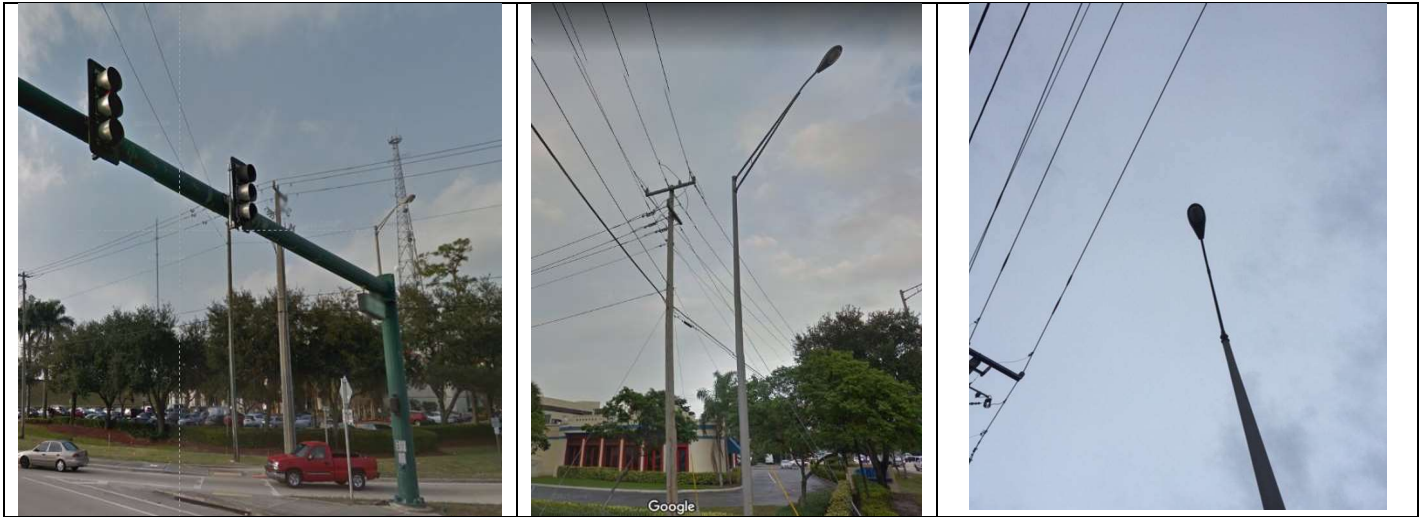
There were conflicts with overhead electric that had to be addressed during construction. The installation of the Mast Arm B on the NW corner of Turnpike entrance and Glades and the removal of the existing signal arm, and the removal

of 2 existing light poles on the NE and NW corners. The UWS did not include de-energizing (per the EOR, the 10' OSHA clearance was met). However, the contractor indicated the OSHA clearance could not be met, and this was confirmed in the field.

The proposed location of the mast arm was modified to minimize the OE conflict with the line running along Glades. In addition, an arrangement was made with FPL to de-energize the overhead electric running across the intersection, as this OE was only for the signal. One de-energizing was accomplished by FPL concurrently with a pole hold that was part of the UWS. In addition, FPL agreed to provide a 2-hour outage of the single-phase OE running parallel to Glades to allow for the removal of the 2 light poles approximately 5' from the OE.

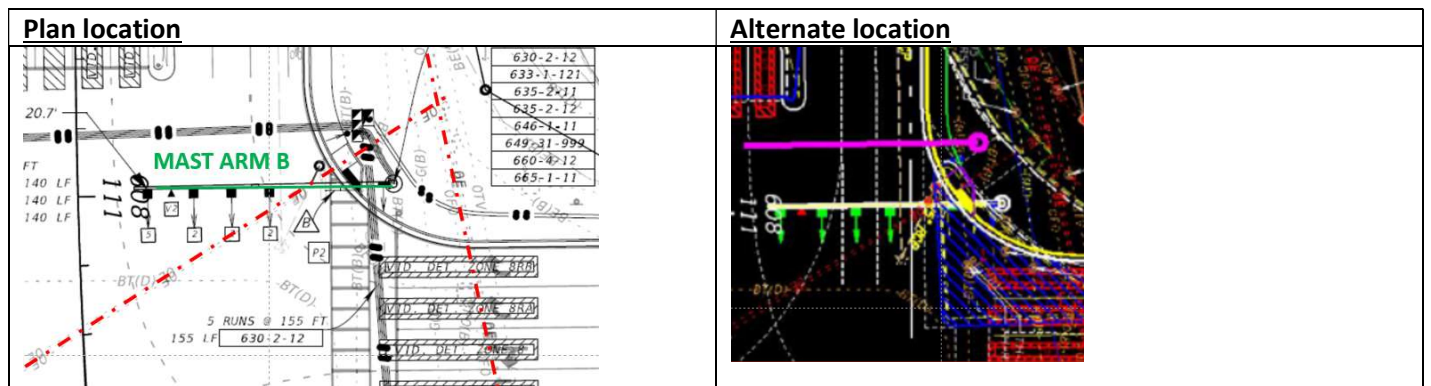
This was accomplished through direct coordination with FPL during construction, and was provided by FPL as a courtesy and partnering effort, at **no additional cost to the Department**.

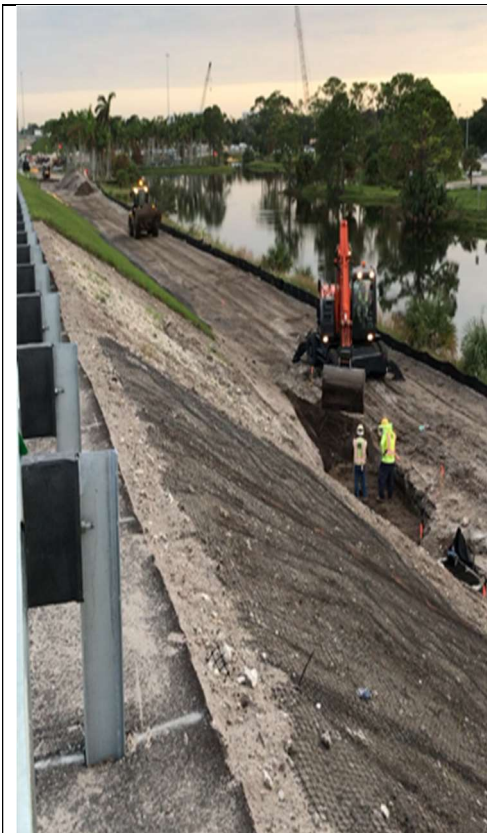
The maintenance office had placed "iguana mesh" on the slope north of Glades Road. The existence of the geogrid in this location was not indicated in the plans and it was encountered during clearing & grubbing efforts.

The Geogrid was removed, and per the request of Maintenance was replaced on the slope.

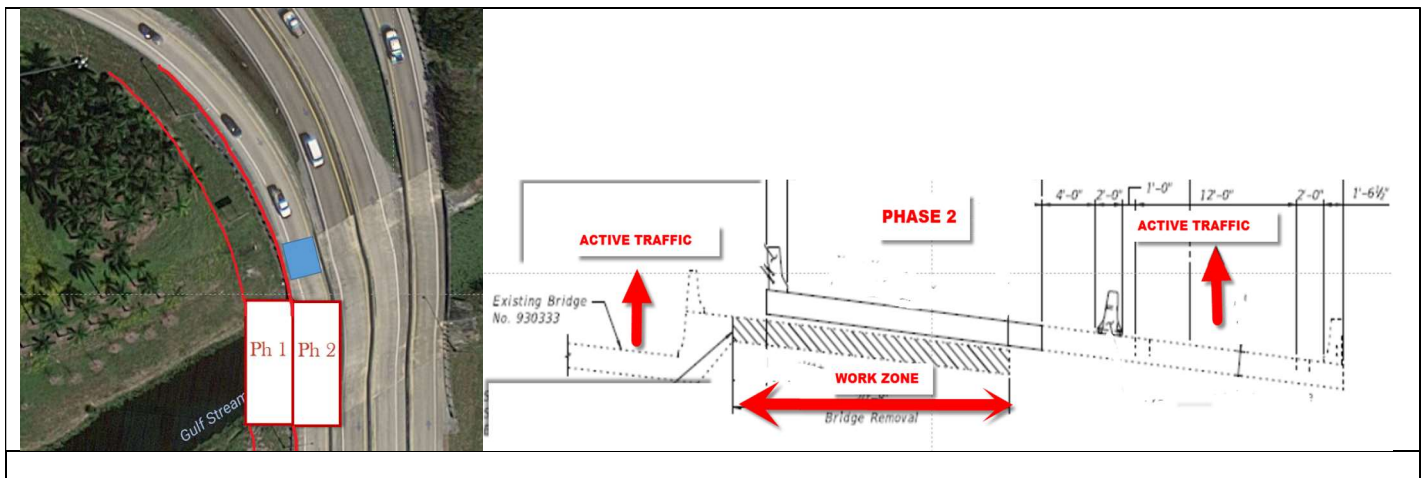
12. THE NUMBER OF LANES CLOSED AND THE HOURS LANE CLOSURES ARE PERMITTED ARE AS FOLLOWS:

SR 91 (FLORIDA'S TURNPIKE):  
SINGLE LANE CLOSURES 10:00 PM TO 5:00 AM  
DUAL LANE CLOSURES 11:00 PM TO 5:00 AM

SR 808 (GLADES ROAD) EXIT RAMP:  
SINGLE LANE CLOSURES 9:00 PM TO 6:00 AM

ONLY ONE Lane on Ramp - FULL RAMP CLOSURE

For the Ramp D-1 bridge construction work, the Turnpike allowed a continuous Ramp Full Weekend Closure (10 pm Friday to 5 am Monday) and extended closures on the other weekends to allow the contractor to complete the most time-consuming operations, such as canal excavation and riprap placement with fewer ramp closures and inconvenience to the travelling public.

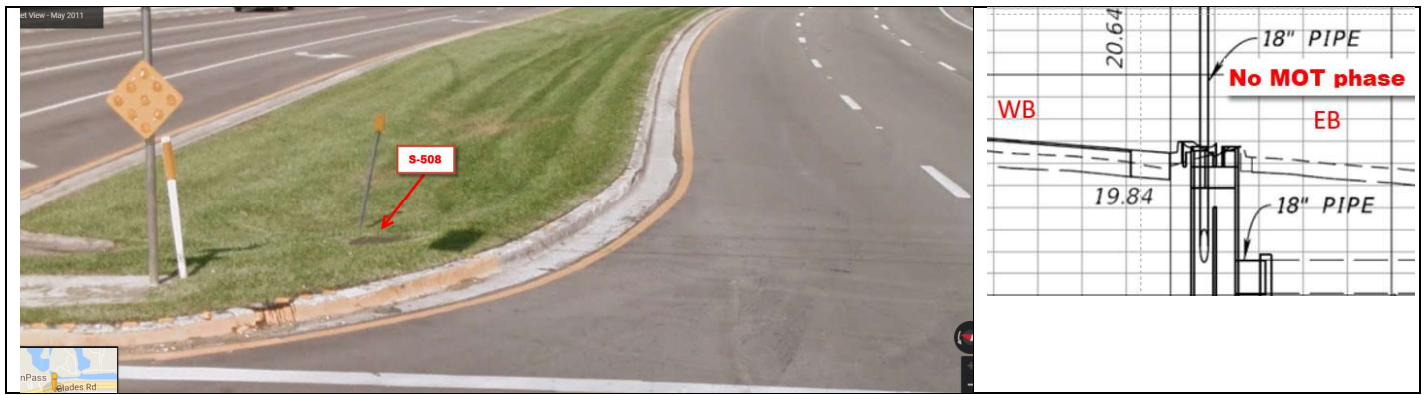
The proposed location of S-508 was not included as an MOT phase. All roadway work involved the WB side of Glades only, and the original location of the structure would have impacted EB traffic and would have involved extra costs to the contract for MOT. The contractor initiated a change in the location, and the EOR assisted with this change; however, the change was more complicated than it appeared, and due to the delay with getting the final design location (34 days after NOI submitted), the Department was exposed for a delay claim.

Structure location was moved, but an NOI was issued due to the delay in the EOR response, and the Department settled a delay claim with the contractor for \$100,000 (for project wide delays).

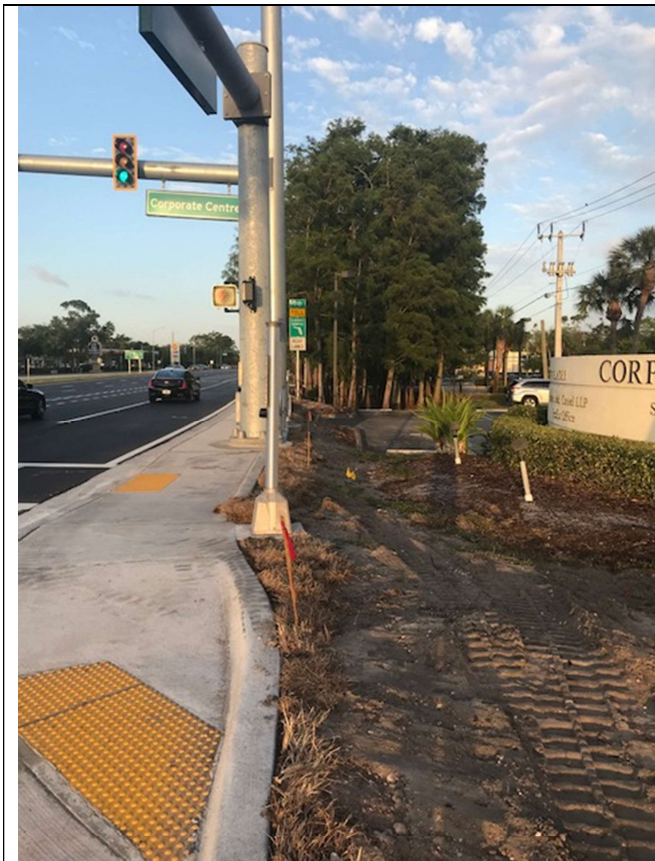
**West side of the driveway**

Limited R/W was available for construction on the northside of Glades Road, with the completed construction right at the property line at the eastern driveway of the Starbucks Plaza. The property owner contacted the Department at the start of construction with questions regarding the property line. In addition, towards the end of the project, the property owner conducted a property survey and claiming that portions of the completed handrail and traffic signal features were encroaching within the adjacent property right-of-way. In addition, with the limited space construction operations were very tight, and no temporary easement information was provided to the construction staff to facilitate this work

A response to the property owner regarding the R/W concern was provided by the Turnpike Right-of-Way office at the beginning of construction. During construction, the CEI staff met with the property manager on-site multiple times to discuss upcoming work and existing irrigation, since the irrigation was within the FDOT R/W and would be impacted during construction. Meetings were also held by the CEI with the property manager to discuss the concern with completed work and R/W encroachment. Additional survey completed by the CEI surveyor confirmed all construction was completed within the R/W per the plans. The Turnpike R/W Office also completed a review and additional survey, and found no encroachment or error in the survey. The property owner ultimately submitted a demand letter after project final acceptance, and the Turnpike Right-of-Way Office is handling responses, as required.
