LESSONS LEARNED

SUMMARY REPORT

Florida Turnpike Enterprise

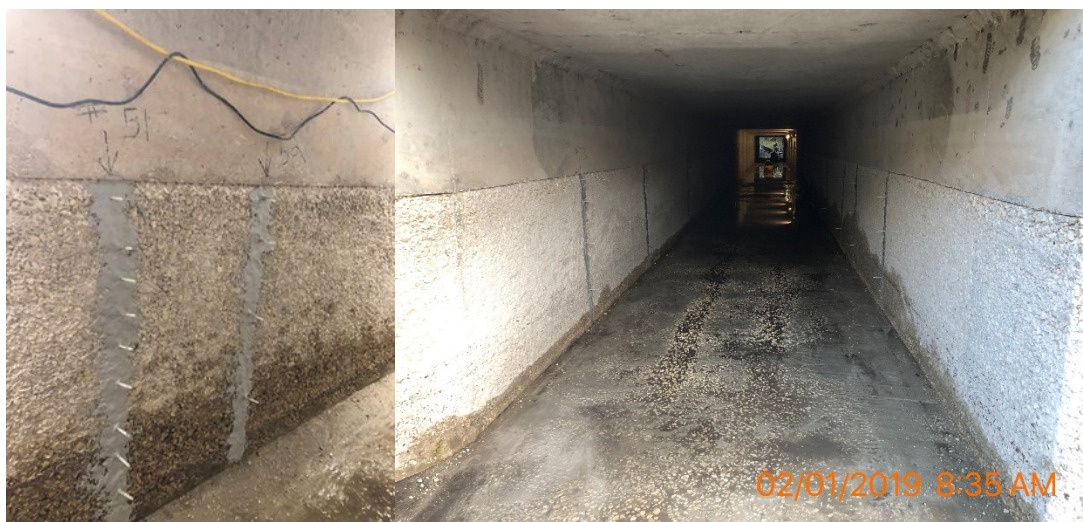
ISSUE SUMMARY: Once the inside surface of the double boxed culvert was hydro blasted and/or chipped away, the quantity crack repair far exceeded the Plan Quantity.

There were no crack repairs designated for the lined box culverts. One of the box culverts, once desilted, it was determined that there were cracks which were allowing water/soils to enter into the box culvert.

RESOLUTION: All cracks for the one double barrel box culvert (gunite) and one lined box culvert were repaired. The other box culverts were removed from this contract due to other issues.

LESSON LEARNED: The quantity for bid is based on only cracks which are found during design. There can be substantially more cracks found after culverts are desilted and/or after removal of the unsound layer. Crack repair estimates need to be based on anticipated cracking rather than observed. Desilting during design will help improve quantities but may still remain lower than needed.
