# LESSONS LEARNED

## SUMMARY REPORT

### CEI Consultant

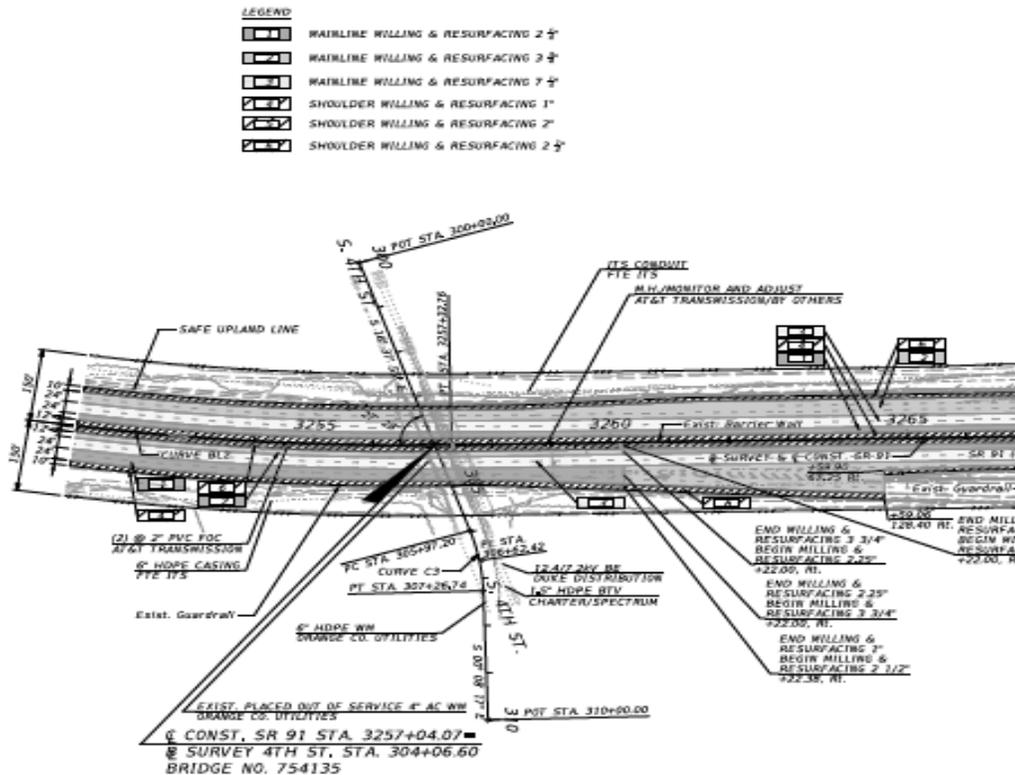
### 1) Plan Scale and Legends – Indicating Pavement Construction:

**ISSUE SUMMARY:** There is substantial information on each page, so when the scale is small, the Plan Views are more difficult to read. The legends are very helpful, but with just the variance of shading it is difficult to determine the limit of each area. The Contractor made various errors in milling and placement which had to be corrected at their cost.

**RESOLUTION:** The CEI reviewed areas to determine if placement was incorrect due to the Plans or the Contractor’s misreading of the Plans and requested the Contractor to make corrections.

**RECOMMENDATION:** Recommend providing a more definitive set of Plans for resurfacing/reconstruction of the roadway by providing more distinctive legends and delineation of milling and resurfacing areas, especially with the number of varying depths of resurfacing. The Contractor will be more likely to mill and resurface without having to go back and make corrections.

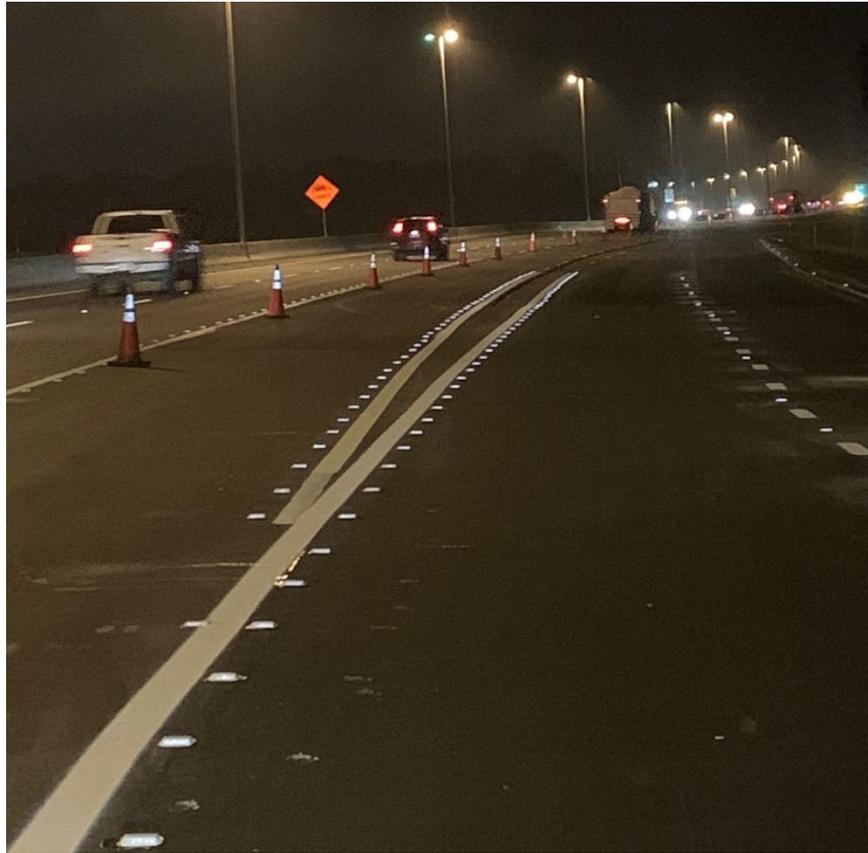
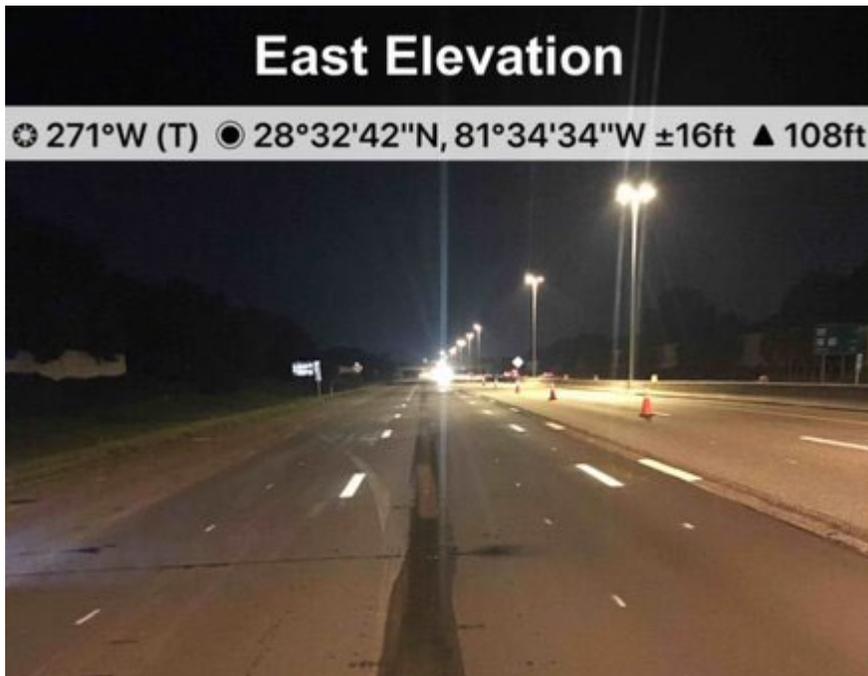
### 2) Drop-off Mitigation – Driver Expectation:

**ISSUE SUMMARY:** The roadway on this project consisted of four lanes in each direction. Without shifting traffic, resurfacing the second lane would have placed workers directly next to the third lane, requiring three lanes to be closed. Due to heavy traffic, a triple-lane closure would have significantly shortened the available time to work. Therefore, at certain points in the project, the original TCP required the lanes to be shifted onto the shoulder to allow the contractor to resurface the second lane, maintain two open lanes, and provide workers with a safe distance between the work and the open lanes of traffic. Unfortunately, the resurfacing of this project required a drop-off between resurfaced lanes and the lanes that had not yet been resurfaced. Prior to shifting traffic, the drop-off was at the lane line; however, once the traffic shift was installed, the drop-off was between the vehicles tires, requiring the drivers to drive with one side of the vehicle at a different elevation than the other side of the vehicle. Although no accidents were attributed to this condition, complaints came in from various travelers on the roadway that the ride was uncomfortable and the condition was perceived to be unsafe.

**RESOLUTION:** Midway through the project, the traffic shift was changed so the drop-off remained at the lane lines. In some areas, this required a triple-lane closure to perform the resurfacing. In other areas, a triple-lane closure was impractical. In those areas, to allow two lanes to remain open while the middle lane was being resurfaced (as was the goal of the original TCP), additional striping was placed so the lanes on either side of the drop-off were at least 4' apart, creating a buffer between the lanes. When the lane on one side of the drop-off was closed for resurfacing, the lane on the other side of the drop-off could be left open, affording workers at least a 4' buffer from the active traffic. During the day when all the lanes were open, the buffer formed a "no drive" area, which could be crossed for lane changes but better assured drivers that they would not have to straddle the drop-off. *Note: This was implemented as a field change.*

**RECOMMENDATION:** During design, provide traffic shifts, including the use of buffer zones if needed, to assure the drop-offs are contained at the lane lines and provide for smooth transitions when having to travel across the areas with the drop-offs to the next area where work has not been performed.

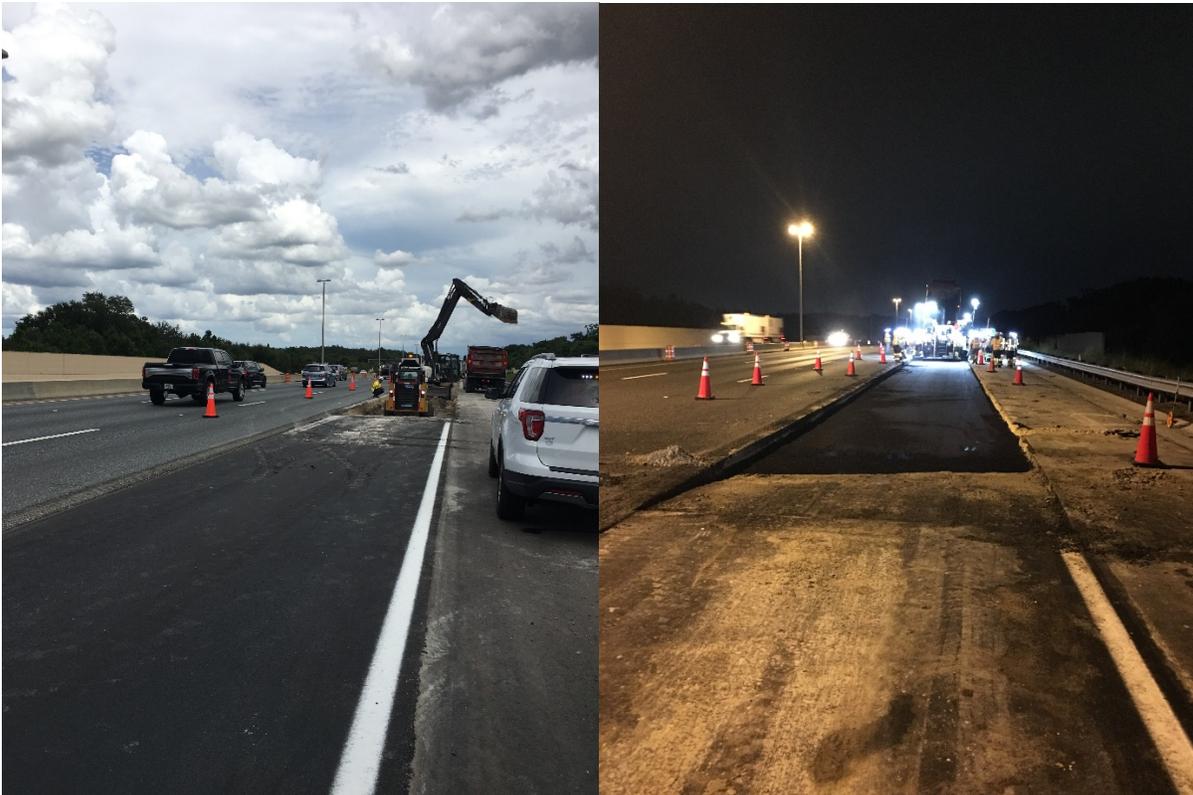
### 3) Base Failures

**ISSUE SUMMARY:** Within 24 to 48 hours after completing areas of deep milling into the base, base failures were discovered at three (3) locations.

**RESOLUTION:** Repaired each location by removing material between 24" and 36" deep, depending on the depth to firm and unyielding material, for the lane width. Type D2 geotextile fabric was then placed followed by 12" to 24" of #57 stone. Finally, 12" of asphalt was placed over the stone.

**RECOMMENDATION:** Add into contracts, where deep milling occurs, a means to pay for base repairs; excavation, geotextile fabric, #57 stone (24"), etc. Having items in the contract to account for these events would greatly reduce the cost of a repair based on time and materials.

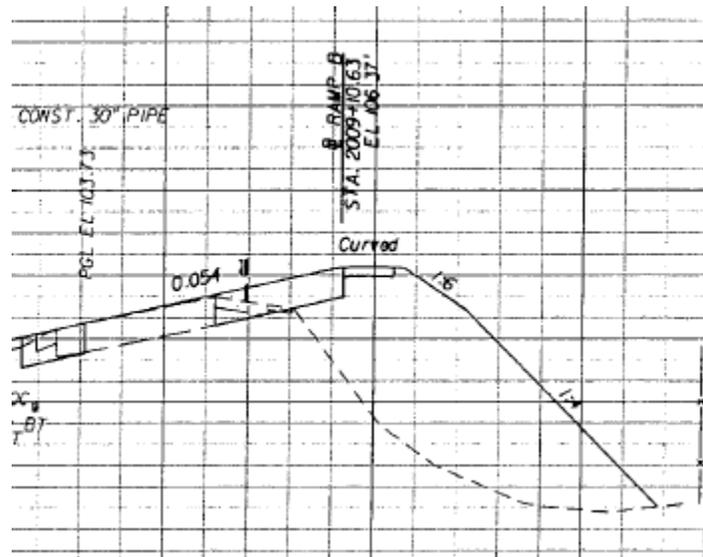
### 5) Identification of cross-slope changes in the shoulder

**ISSUE SUMMARY:** After resurfacing of the shoulder, water was being retained within the shoulder area, which was not an existing condition. When temporary pavement is being placed to shift traffic on to the shoulder, the existing shoulder slope can get lost especially for when the shoulder needs to break. The contractor continued paving through this section at the same slope as the shoulder coming into where the break needed to occur.

**RESOLUTION:** The CEI had procured the Final As-built Plans of the previous construction project and found there was break in the existing shoulder. The as-built plans show this as "Curved". (See below). The contractor was directed to mill and resurface the shoulder to match the existing condition.

**RECOMMENDATION:** Provide Station and grades for existing shoulder breaks in the Plans.
