Florida's Turnpike Enterprise

Annual Inspection Report

for the Fiscal Year ending June 30, 2021

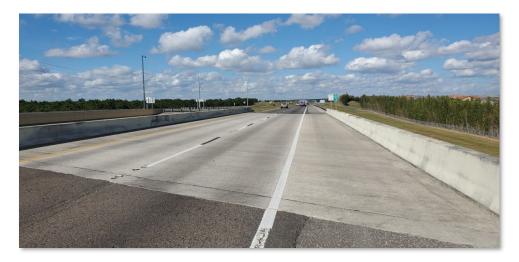
Figure 13: Bridge 750622 - SR 429 NB at MP 10.9

The State Maintenance Office Bridge Inventory 2021 – Annual Report, which uses the NBI guidelines, reported seven bridges in fair condition. FTE Maintenance directed a portion of its Periodic and Routine Maintenance funding in FY 2021 to rehabilitation and repair projects. Figure 13 shows an example of a bridge on the FTE system.

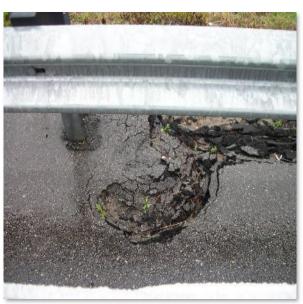
Undesired Guardrail Asphalt Condition – Deterioration

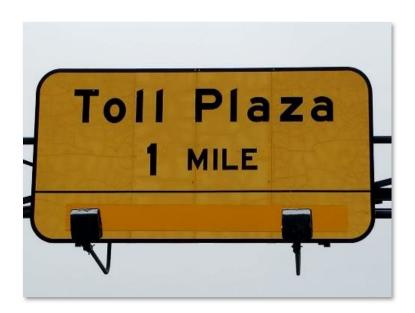
Undesired Sign Reflectivity Condition – Material Cracked and Faded
