EXTINGUISH THE TORCH MEETING

Project: Lake County Resurface and Roadside Improvements MP 287.8 to MP 297.9

LESSONS LEARNED

SUMMARY REPORT

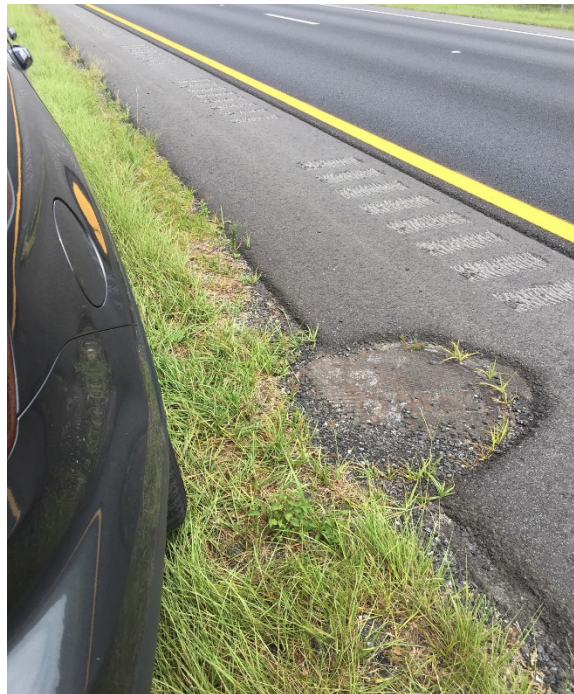
1) AT&T – Manhole Adjustments:

ISSUE SUMMARY: The Plans and Pay Items showed adjustment of manholes to be performed by the Contractor. When coordinating with AT&T, they informed the contractor that if they performed the adjustments, they would need to have an insurance policy in place, since the cost would be substantial if anything should go wrong. Also, not all manholes in the shoulder were identified.

RESOLUTION: AT&T agreed to perform any adjustments needed. Manholes were not raised and are 1-1/2” or lower in the shoulder area. Maintenance will get with AT&T if they ever need them adjusted.

LESSON LEARNED: Check with utility regarding adjustments being needed during construction and provide information as to their requirements to determine if the utility company should perform the work versus the Contractor.

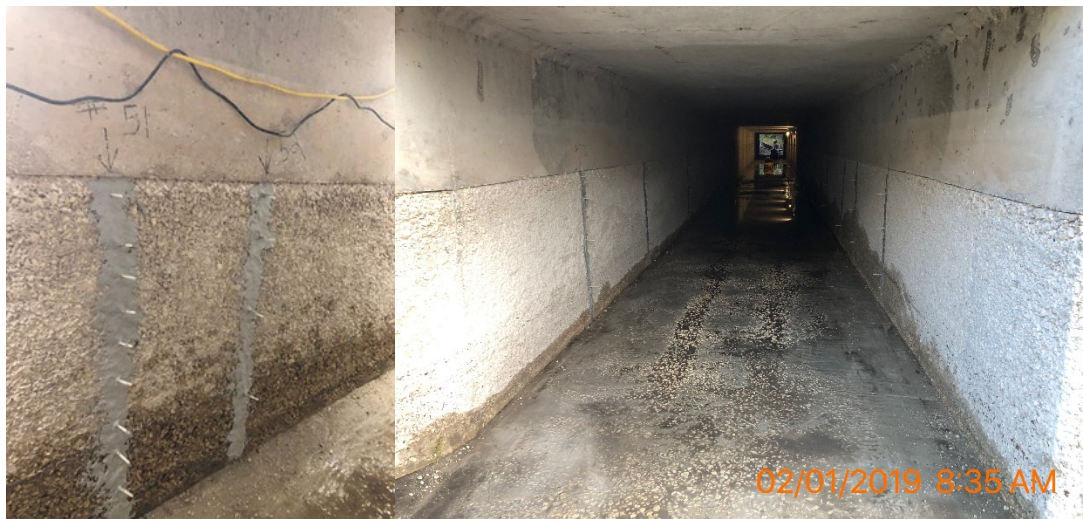
2) Box Culverts – Crack Repair:

ISSUE SUMMARY: Once the inside surface of the double boxed culvert was hydro blasted and/or chipped away, the quantity crack repair far exceeded the Plan Quantity.

There were no crack repairs designated for the lined box culverts. One of the box culverts, once desilted, it was determined that there were cracks which were allowing water/soils to enter into the box culvert.

RESOLUTION: All cracks for the one double barrel box culvert (gunite) and one lined box culvert were repaired. The other box culverts were removed from this contract due to other issues.

LESSON LEARNED: The quantity for bid is based on only cracks which are found during design. There can be substantially more cracks found after culverts are desilted and/or after removal of the unsound layer. Crack repair estimates need to be based on anticipated cracking rather than observed. Desilting during design will help improve quantities but may still remain lower than needed.

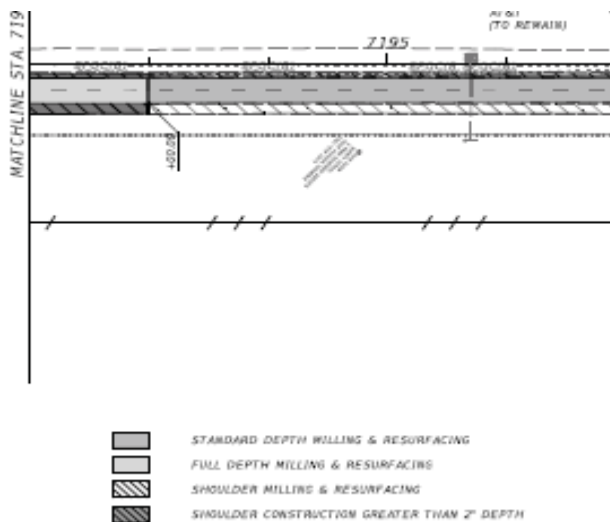
E8Q92 – Legend

ISSUE SUMMARY: The designer created a Legend to identify differences in milling and resurfacing depths. The Legend identified mainline milling as “Standard” or “Full Depth”, but with 21 milling depths provided in the Plans the Legend led to confusion. This confusion was compounded as the allowable the lane closure times varied based on milling depths.

LESSON LEARNED: In future Plans, where there are multiple thicknesses for milling and resurfacing, use additional numbering system to depict depths. At least in the Legend, state the range of thicknesses for area being represented. In another project, a box was utilized with a number representing depth and then a leader was shown to the area it represented.

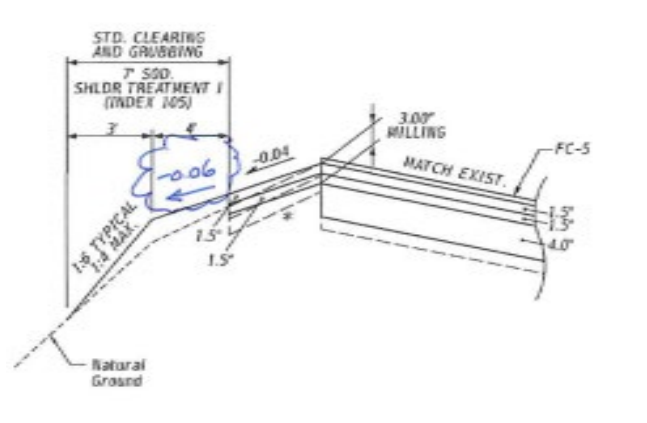
6) Shoulder Treatment, Grading, Filling and Sod:

ISSUE SUMMARY: On the inside shoulder, for a major portion of the project length, the Plans called for Shoulder Treatment per Standard Index 105, Type 1. Much of this area, the non-paved shoulder was being adjusted and required additional fill. This additional fill would not be part of a Type 1 treatment and was not quantified in the Plans. Since the quantity of embankment in the Plans was very low, the cost was extremely high.

RESOLUTION: The Contractor submitted an NOI for additional shoulder work. The EOR provided information as to the existing shoulder slopes to identify where additional fill would be required. In addition, the EOR changed the -0.04 slope to -0.06 reducing the quantity of embankment needed. The contractor will be paid; however, the contractor has yet to provide an accurate and justifiable quantity of material placed.

LESSON LEARNED: Need to specify Type II Treatment when the area requires fill. When there is embankment shown for shoulder work, need to quantify an amount and list it as embankment.
