Florida's Turnpike Enterprise

Annual Inspection Report

for the Fiscal Year ending June 30, 2022

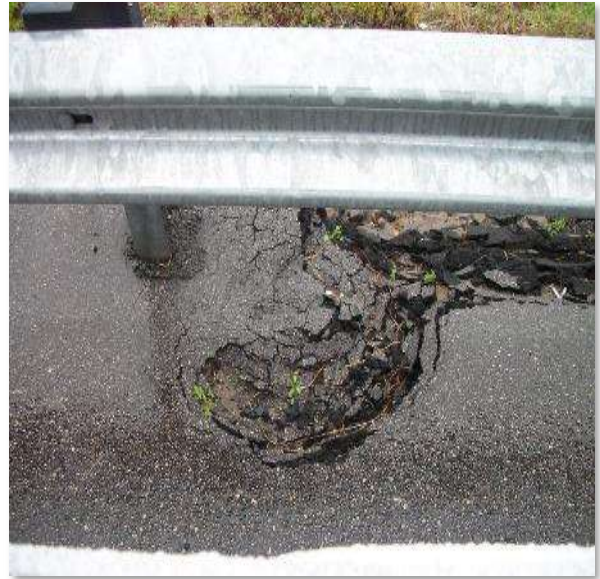
**Undesired Guardrail Asphalt Condition –
Deterioration**

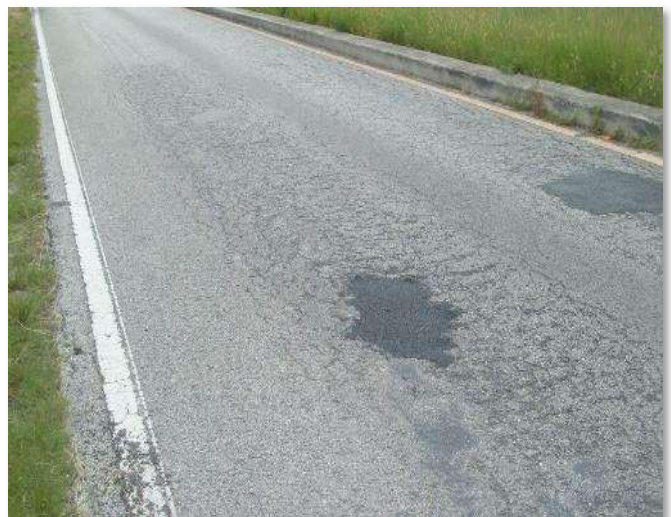
**Undesired Travel Lane / Ramp Condition –
Deterioration**

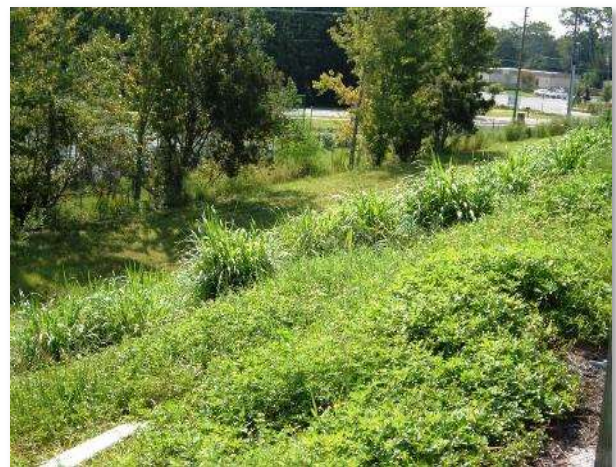
Undesired Soil, Shoulder and Front Slope Condition – Vegetation

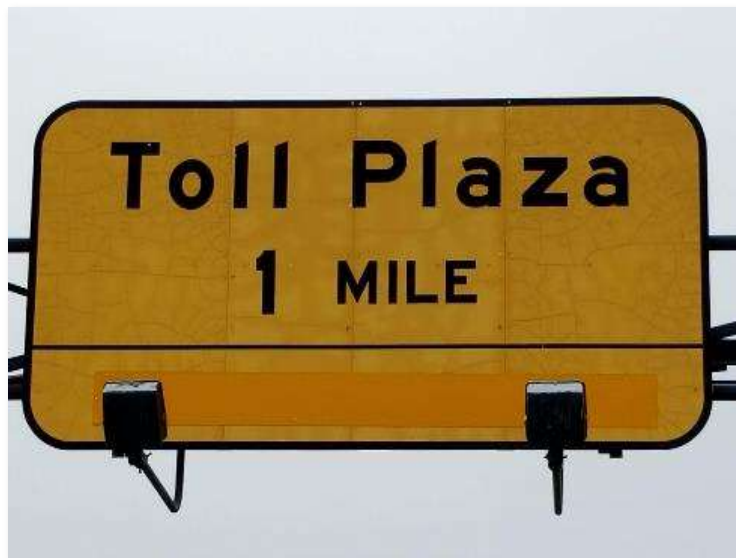
Undesired Sign Reflectivity Condition – Material Cracked and Faded
