Annual Inspection Report

for the Fiscal Year
ending June 30, 2024

As General Engineering Consultants to Florida's Turnpike Enterprise (Enterprise), AtkinsRéalis and HNTB are pleased to submit the annual asset condition inspection report of the Florida's Turnpike System (System) for the fiscal year (FY) ending June 30, 2024.

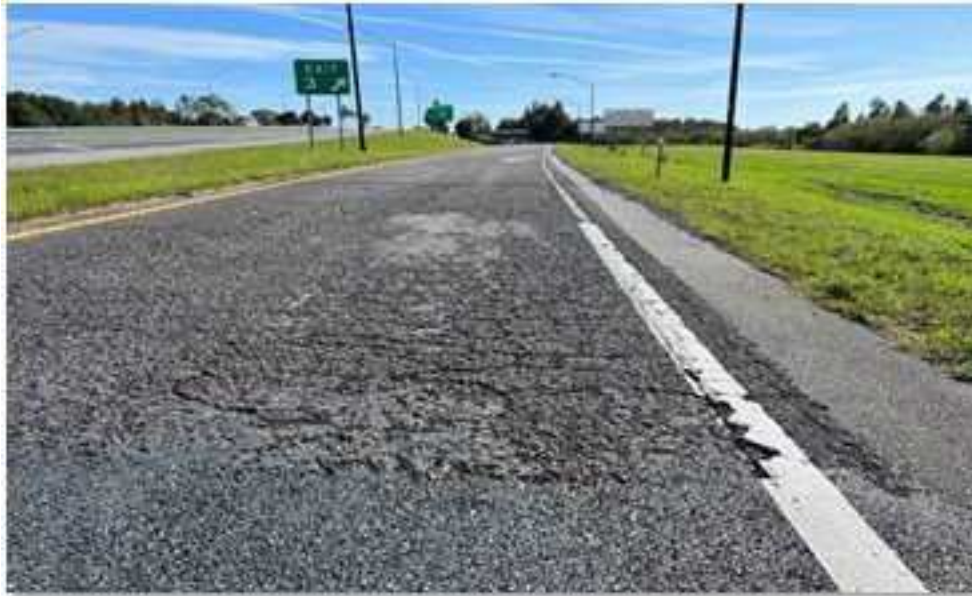
Figure 1: Undesirable Pavement Condition - Class III Cracking

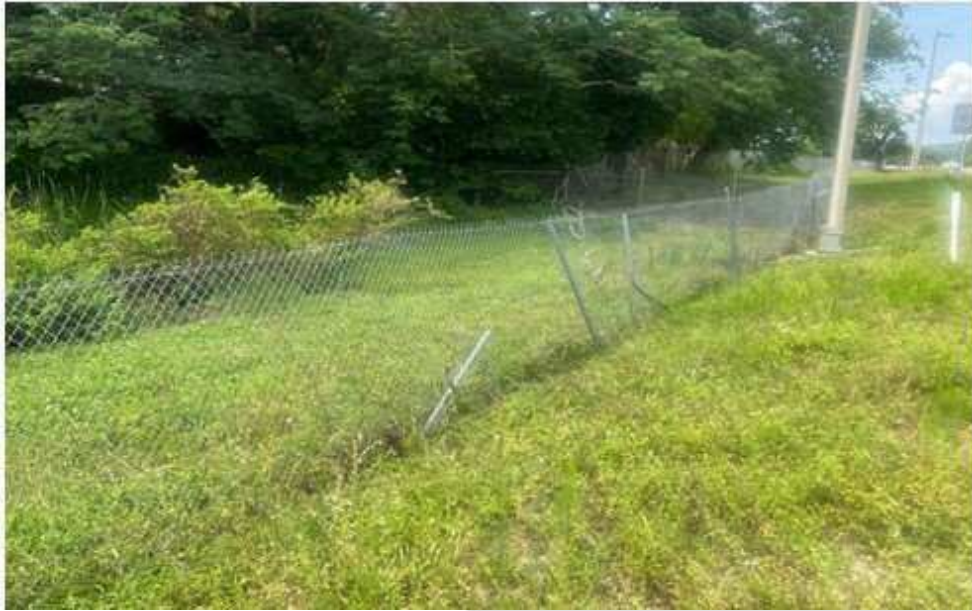
Figure 3: Undesirable Fence Condition - Damaged Fence Post

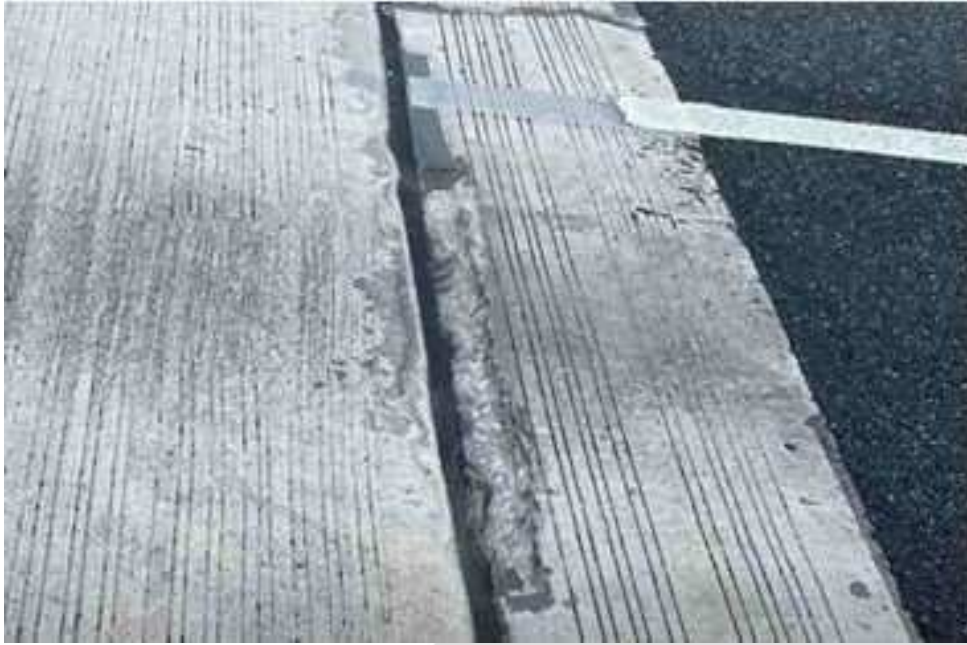
Figure 5: Undesirable Joint Condition

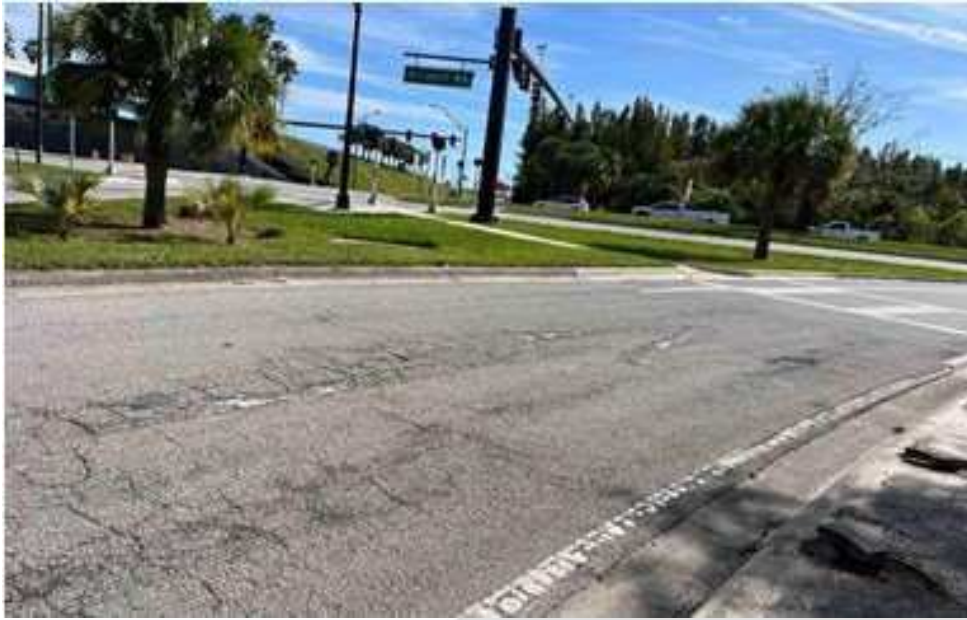
Figure 7: Undesirable Pavement Symbol / Cracking

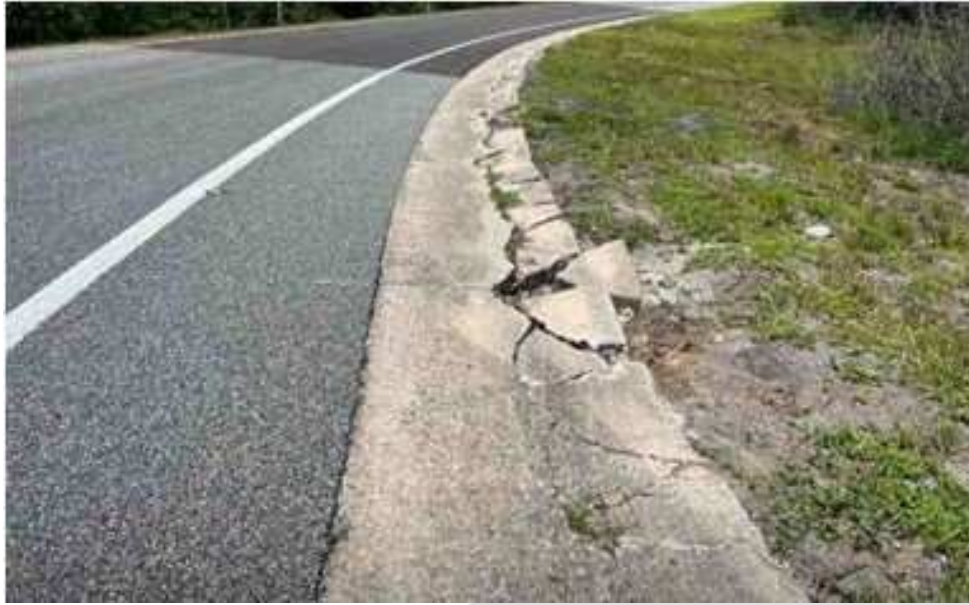
Figure 9: Undesirable Shoulder Gutter

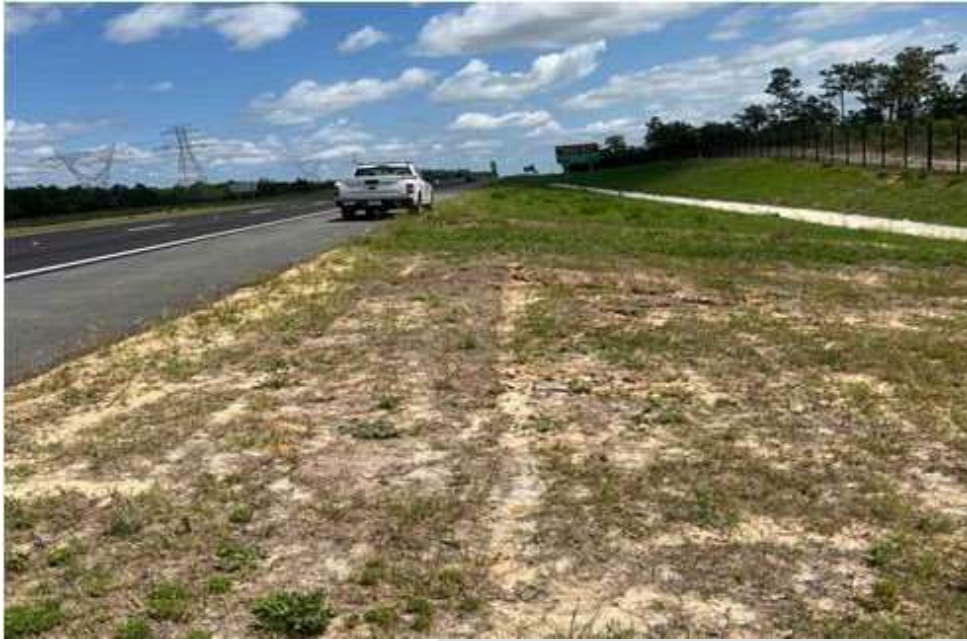
Figure 11: Undesirable Turf Condition - Front Slope
