**CCTV CAMERA INSTALLATION TURNPIKE WIDE
FINANCIAL PROJECT NUMBER: 435604-1-52-01
CONTRACT NUMBER: E8P84**

SUMMARY REPORT SESSION II

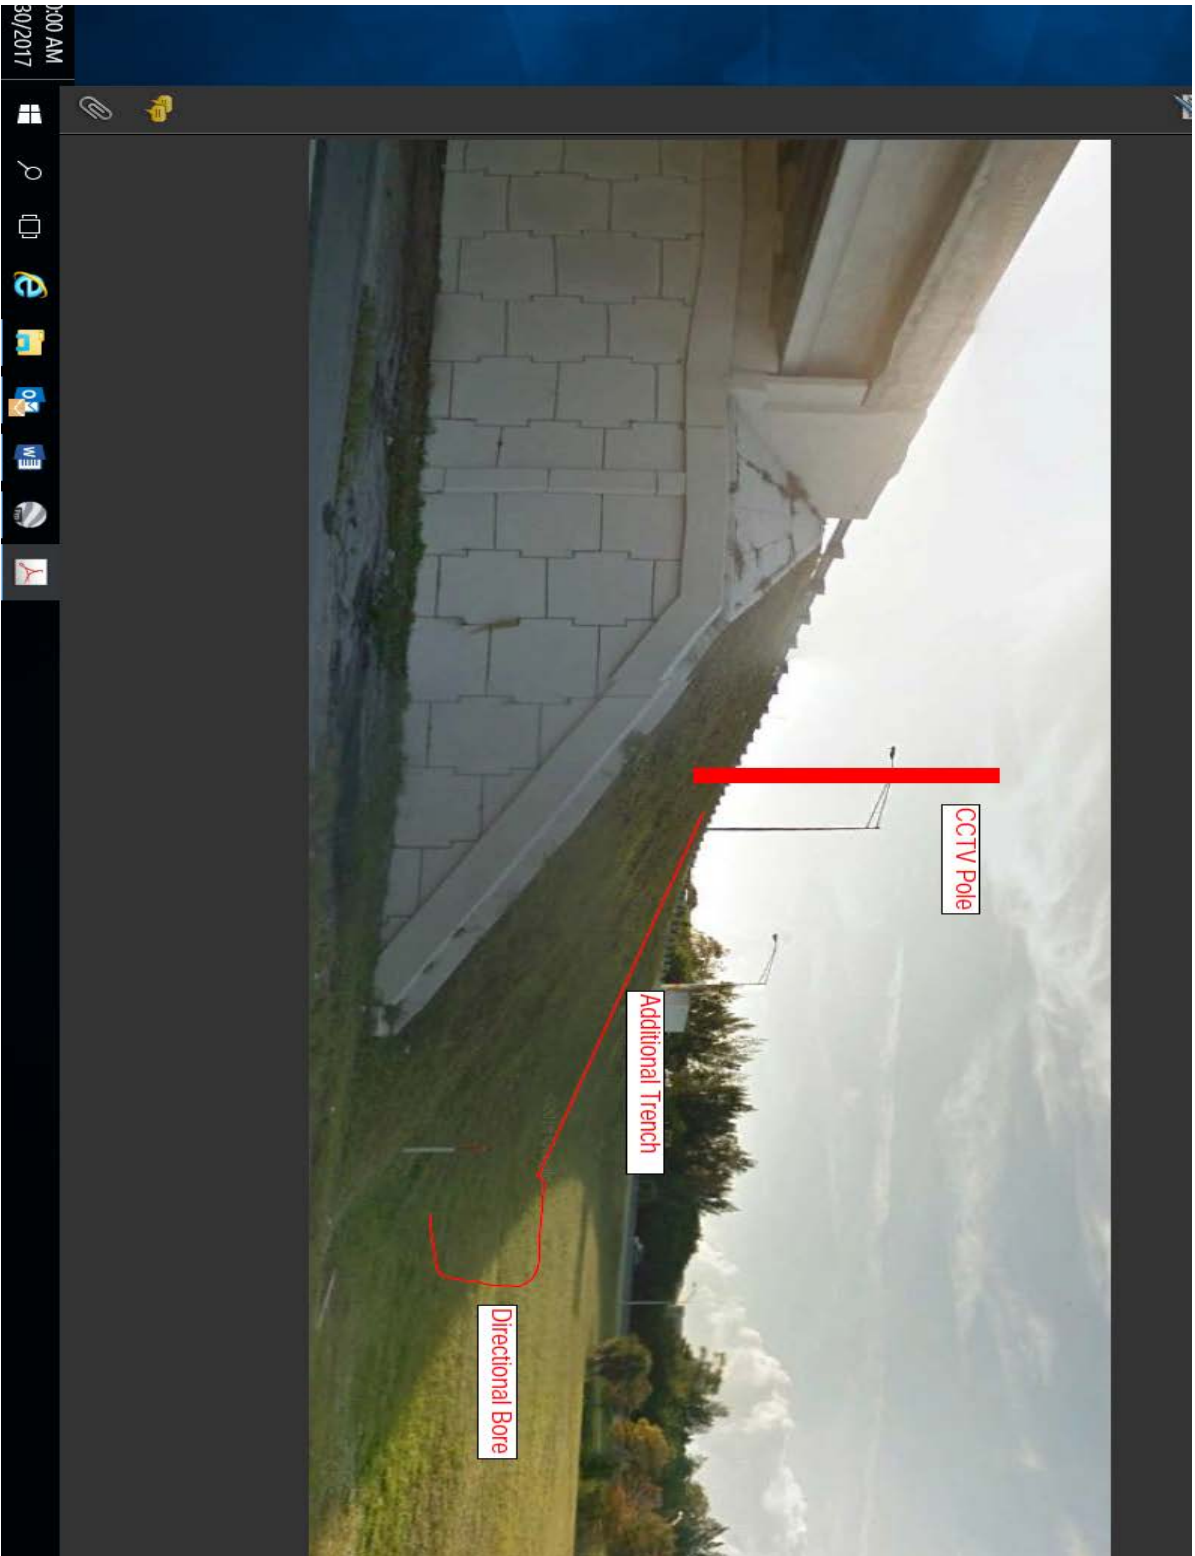
A. Directional Boring has limitations, entry angles are usually between 8 and 16 degrees from horizontal and exit angles between 5 and 10 degrees. The directional bore at Coconut Creek Blvd. had an MSE wall which extended fairly deep into the ground. At Okeechobee Blvd., the distance between the canal and the edge of roadway was very short which in discussions in how to make it work, the issue of not having a permit came up and resulted in finding another solution all together. At the high ramp areas, the directional bore was made under the ramp and then couplers were placed and conduit was extended and was placed in a trench which made a large loop at the base and then proceeded up the hill to the CCTV camera.

B. The pull boxes are set next to the CCTV Poles at the top of the high fill. Consideration for those performing maintenance needs to be taken into consideration. If you build out the slope to flatten, then at some point the slope below becomes steeper unless slope is pushed out from top to bottom. Note: Consideration needs to also account for the amount of right-of-way available. The pull boxes were placed on a slant to minimize the amount of fill to be placed and lessen the amount the slope needed to be steepend.

C. With trenching up the slopes, then additional sod needs to be placed versus using seed and mulch as was shown in the Plans. Sod was placed on all slopes and erosion prone areas.

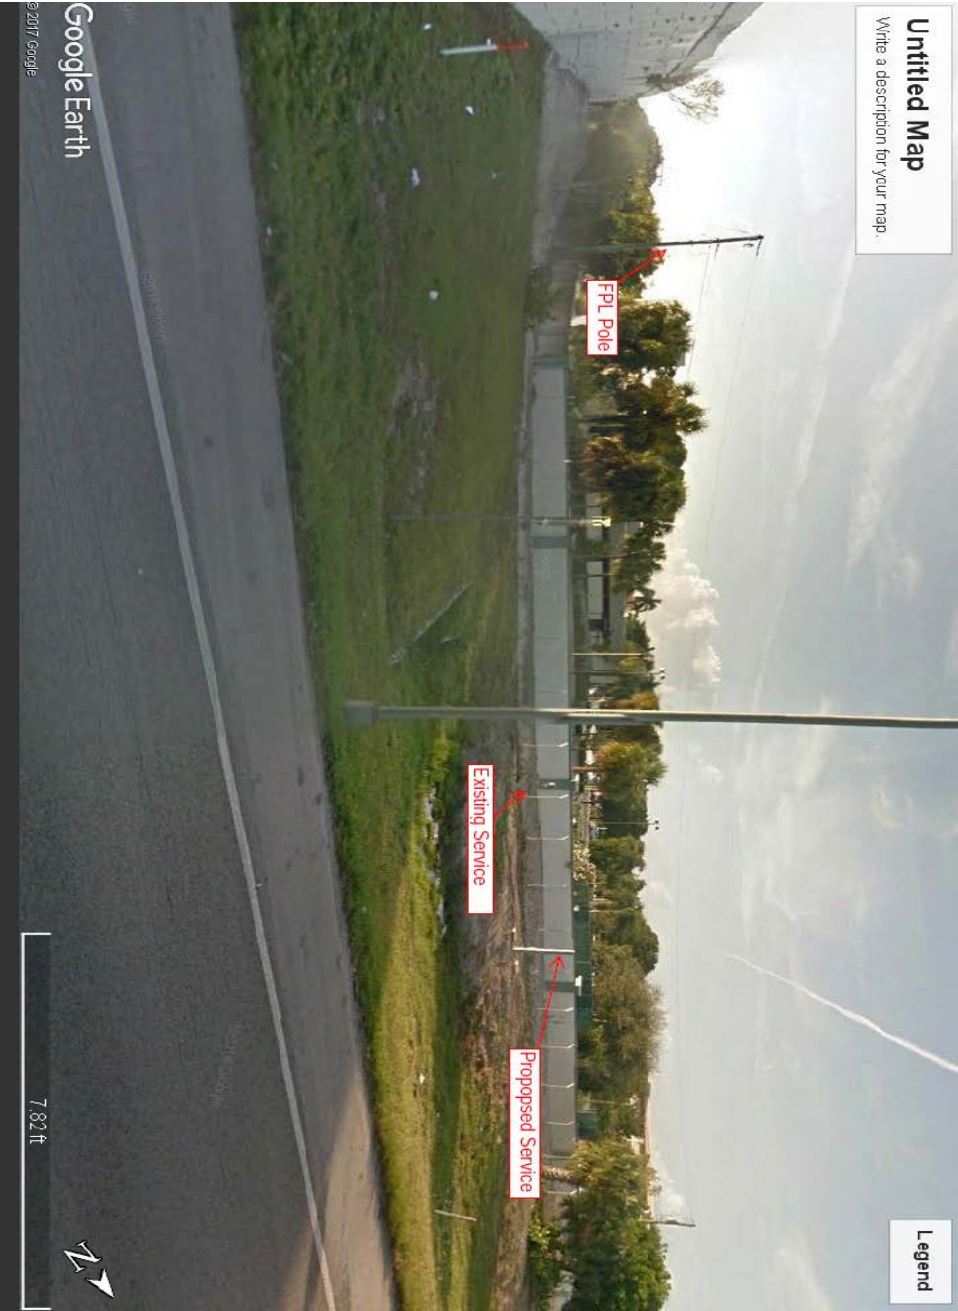
A. A number of pull boxes and splice vaults were shown to be on the Plans, but were very difficult to find or were not found. Pull boxes which were located were buried by a couple feet of dirt at Ft. Pierce and at SW Martin were found under dirt and asphalt. A substantial amount of effort was used to locate boxes and Contractor was paid for uncovering those which were found. For those not found, field reviews were performed and a new routing of conduit was determined and field adjustments made and paid by overrunning quantities. (Example: At Port St. Lucie, in lieu of being able to utilize existing system to the south, utilized trenching and direction boring to the splice vault north of the interchange.)

B. Land use was different at PGA Blvd. Interchange then show on the plans and trenching could not be performed. Direction boring was utilized. Also, at several locations, new landscaping had just been placed; therefore, rerouting the conduit through the treed area took place.

C. The right-of-way was not indicated on the plans, but when determine, the right-of-way was too close to building features at the Okeechobee Toll Plaza and there was a row of trees; therefore, trenching could not be accomplished.

Direction boring was utilized in lieu of trenching at the back of the building Okeechobee Blvd. and went deep under the building, since the right-of-way did not provide enough room to keep the directional bore equipment within the right-of-way machine. This work was accomplished by field direction and overrunning quantities.

D. When tying into the Patch Panels - Field Terminations, all fibers are terminated to better assure the fiber is not damaged, although most of the fibers terminated are not used. Since the patch panel is full, another patch panel is called for in the Plans and then the fibers are all terminated. In lieu of spending the money to terminate all fibers, determine which ones are not being utilized and not add another patch panel. It is our understanding that the fiber cable is going to be 24 vs. 48, then possibly determine from the new cable and the existing cable which 24 should be terminated at the patch panel and not add new panels.

E. At Coconut Creek Interchange, the electrical pull box utilized to bring in power from the FPL source ended up being connected to the existing CCTV and was within the Turnpike Electrical System. Placing a meter would not do anything; therefore, the Contractor utilized a connector in the meter box to assure the power was maintained. FPL will monitor the use of the new camera and bill out on a monthly basis based on load versus from the meter. FPL requested that the EOR and others go through their training to better assure the design is handled correctly, since they want any new service on the Turnpike system to be metered as per their current policy.

F. The Contractor had terminated the fiber at both CCTV camera locations and then went to terminate into the splice vault shown on the Plans. It was at this time, the Contractor determined that this was not the FTE Fiber backbone. It was determined that the vault was AT&T's. Plan Revision No. 1 was provided, all work which was performed and the removal and any other additional cost is in Work Order No. 2 as premium costs.

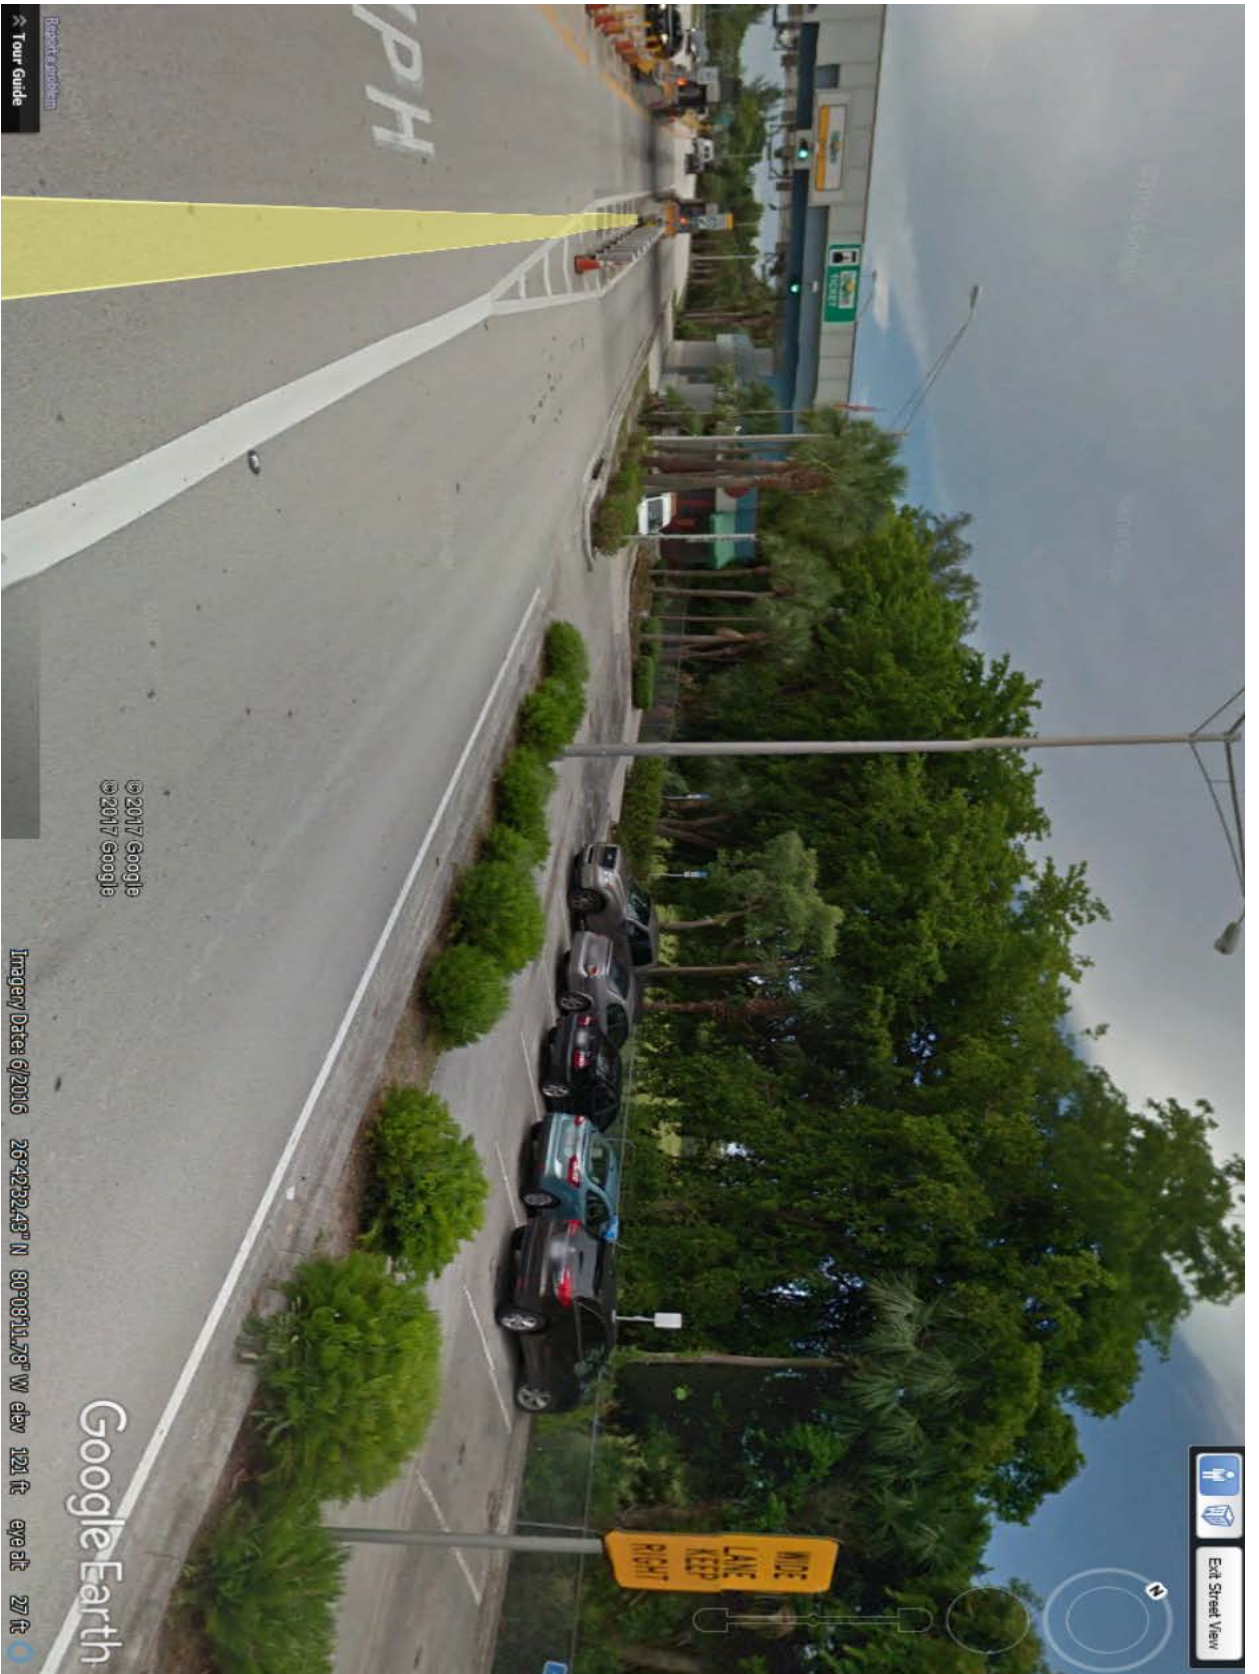
Lesson Learned No. 2

All canal crossings, whether over or under, should be reviewed for permitting conditions from the Drainage District.

From prior experience, Lake Worth Drainage District does require permits for crossing their canal. There were no permits obtained for the direction bore under the LWDD canal. Also, in this case, the direction bore could not be performed due to the steepness of the angle needed for placement.

An alternative to cross the road through existing spare ITS conduits was performed. The spare ITS conduit was removed from the fiber pull boxes and placed into separate electrical pull boxes.
