EXTINGUISH THE TORCH MEETING - SESSION ONE

FIN: 439051-1-52-01

Project: ITS Electrical Improvements

SUMMARY REPORT

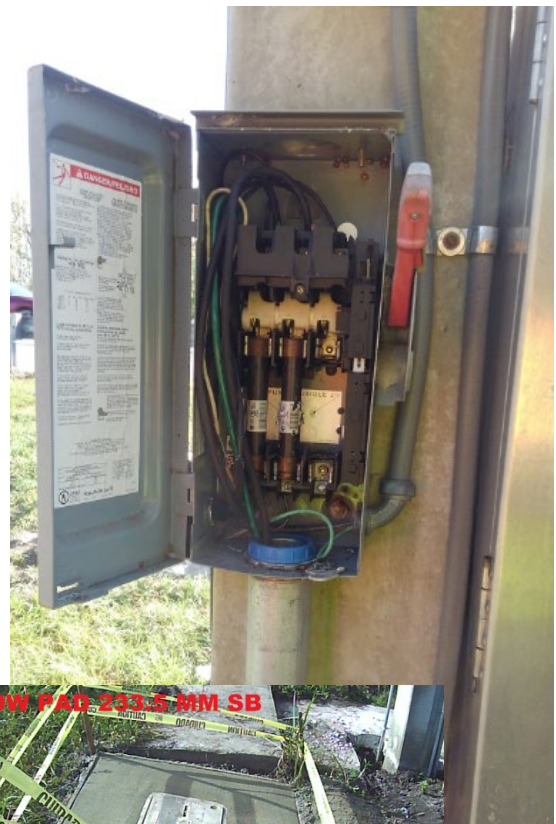
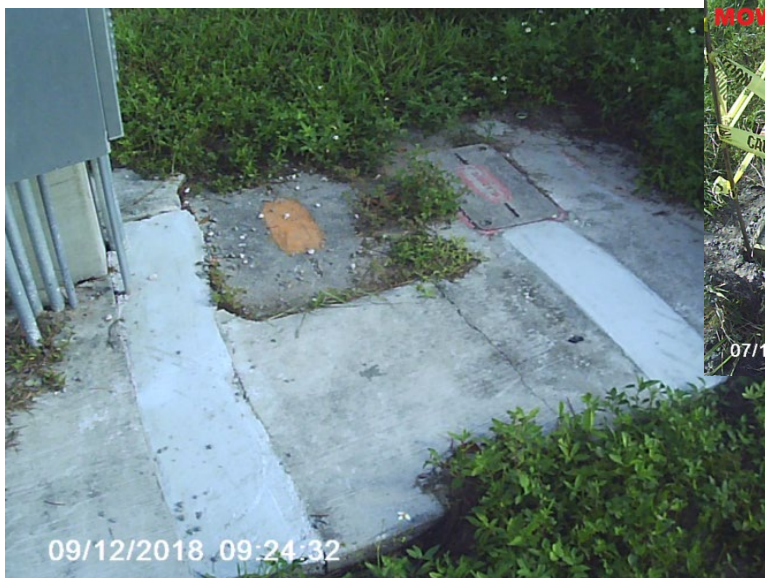
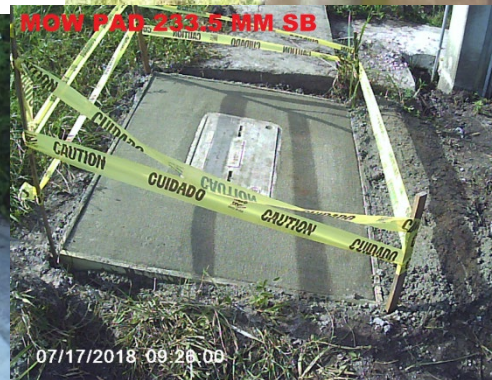
1) Using existing conduit/disconnects vs F&I new conduit/disconnects for grounding upgrade:

ISSUE SUMMARY: The existing disconnect boxes at the 31 pole locations within the project limits were not planned to be replaced. After construction started, the existing disconnects were found to not meet current code. RFIs 13 and 14 questioned the planned approach to utilize existing conduit and disconnects for upgrading the grounding to current code at each pole location. Based on past experience, the contractor made a recommendation for a quicker and more cost effective solution to the original plan to intercept the existing grounding conduit under the existing concrete slab to run new wiring. The planned approach would require undermining the existing slab to locate the existing conduit which could result in destroying the entire slab and risk damaging the existing fiber-optic line at all 31 locations.

RESOLUTION: The contractor suggested cutting the existing slab to run new conduit from the cabinet to the pull box for the new grounding wire. It would require new and restorative work to the concrete mow pads and an increase of the existing pay item for new disconnect boxes.

The cost of labor, equipment and materials for the extra work involved with sawcutting and restoring concrete mow pads at 31 locations was added. The existing pay item for Electrical Service Disconnects was overrun by 31.

LESSON LEARNED: While it is understood that re-using existing features is a good practice to reduce cost, it is not always feasible when applied in the field. Consideration should be given to impacts created by reusing existing features and the relatively low differential cost of replacing with new features.

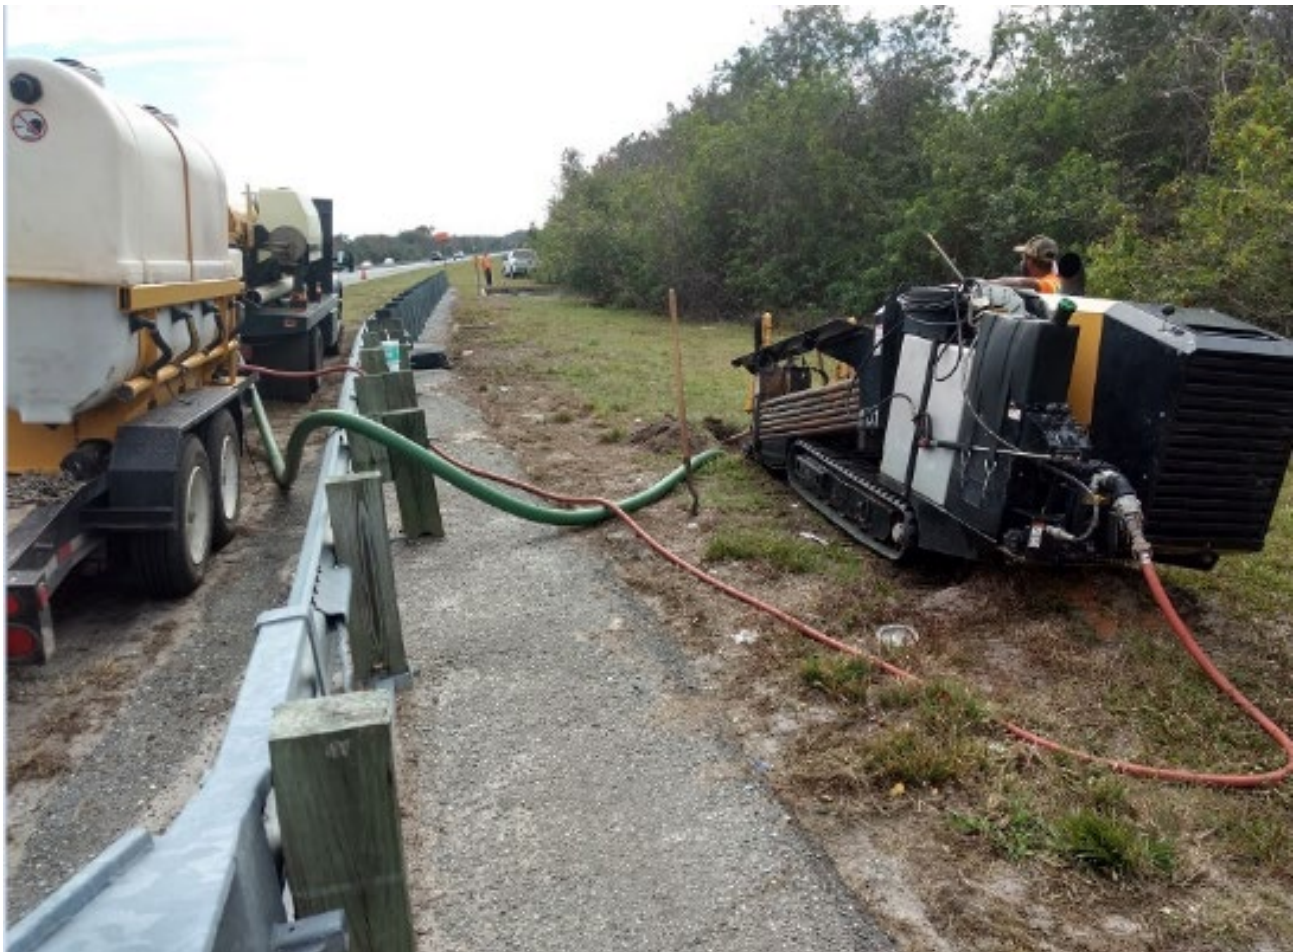
2) 630-2-12, Conduit, F&I, Directional Bore Quantity:

ISSUE SUMMARY: Storm drains and features were found to conflict with the planned open trenching of conduit.

RESOLUTION: Contractor suggested increasing the directional bore quantity and correspondingly decreasing the open trench quantity.

LESSON LEARNED: Provide for directional bores wherever conflicts may exist to open trenching, especially where conduit runs will coincide with drainage structures or cross an area that is much less conducive to open trenching, like ditches, drainage swales and other significant changes in topography.

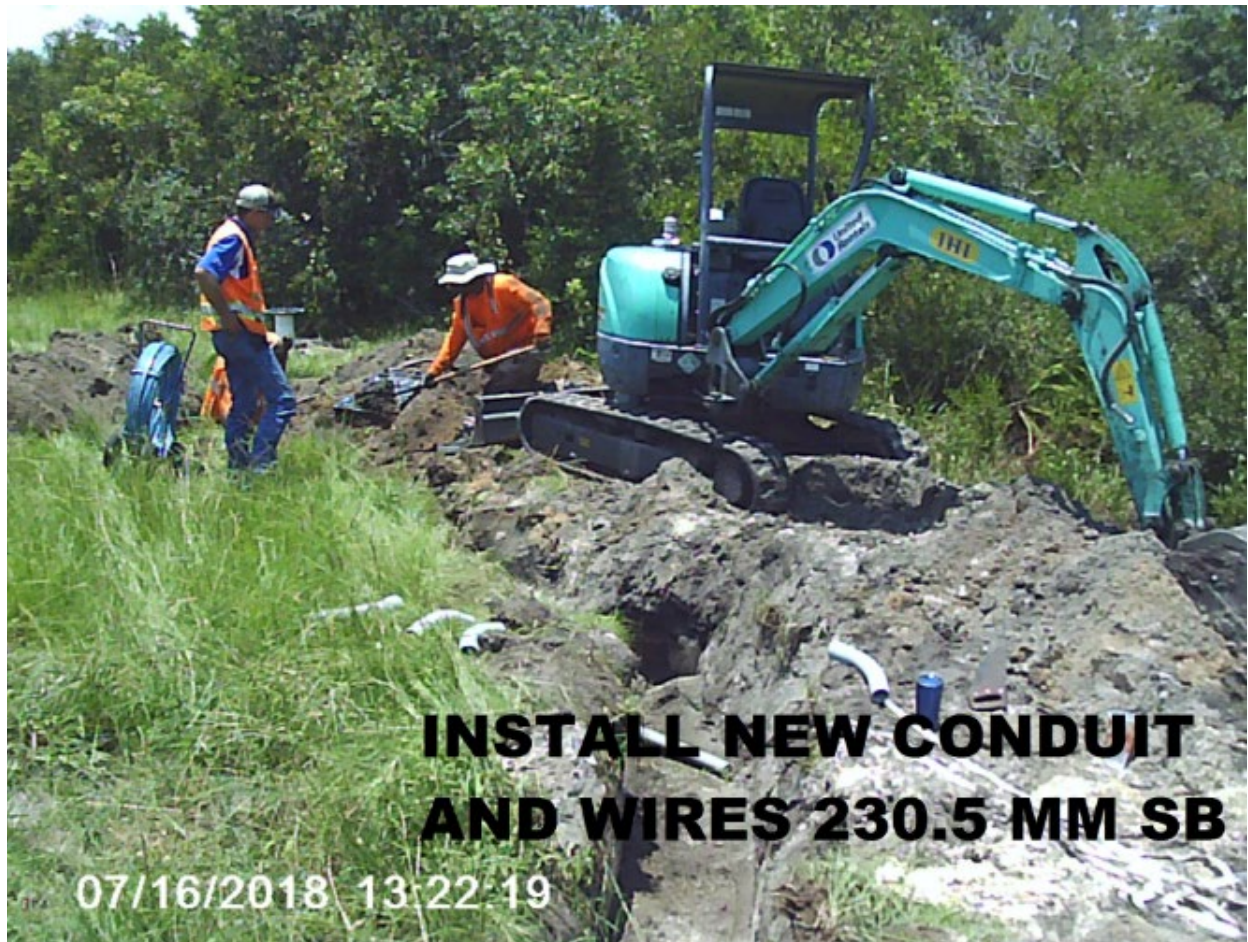
3) Proposed Running Line Conflicts with Existing Conduits / Maintaining 5' Offset:

ISSUE SUMMARY: IT-50/IT-51 at approx. Sta 2879+50, the proposed running line is approximately 37' offset, and the existing power and fiber lines are 35'/36' offset. At Sta 2788+00, which is the south side of the overpass, the running line is 35' offset and the existing lines are approximately 36'/37' offset. The proposed running line encroaches into the existing lines, making it impossible to maintain the 5' minimum required offset from the the existing lines and the designed offset from the edge of roadway.

RESOLUTION: Contractor and CEI worked together to locate the new running line at a minimum offset from the existing lines.

LESSON LEARNED: As-builts of existing lines are not always reliable in providing accurate location information to the designer to be able to show the proposed lines at a suitable offset. This was a minimal impact issue that resulted in changes to the quantities of existing pay items, but could be improved with more accurate as-built information.

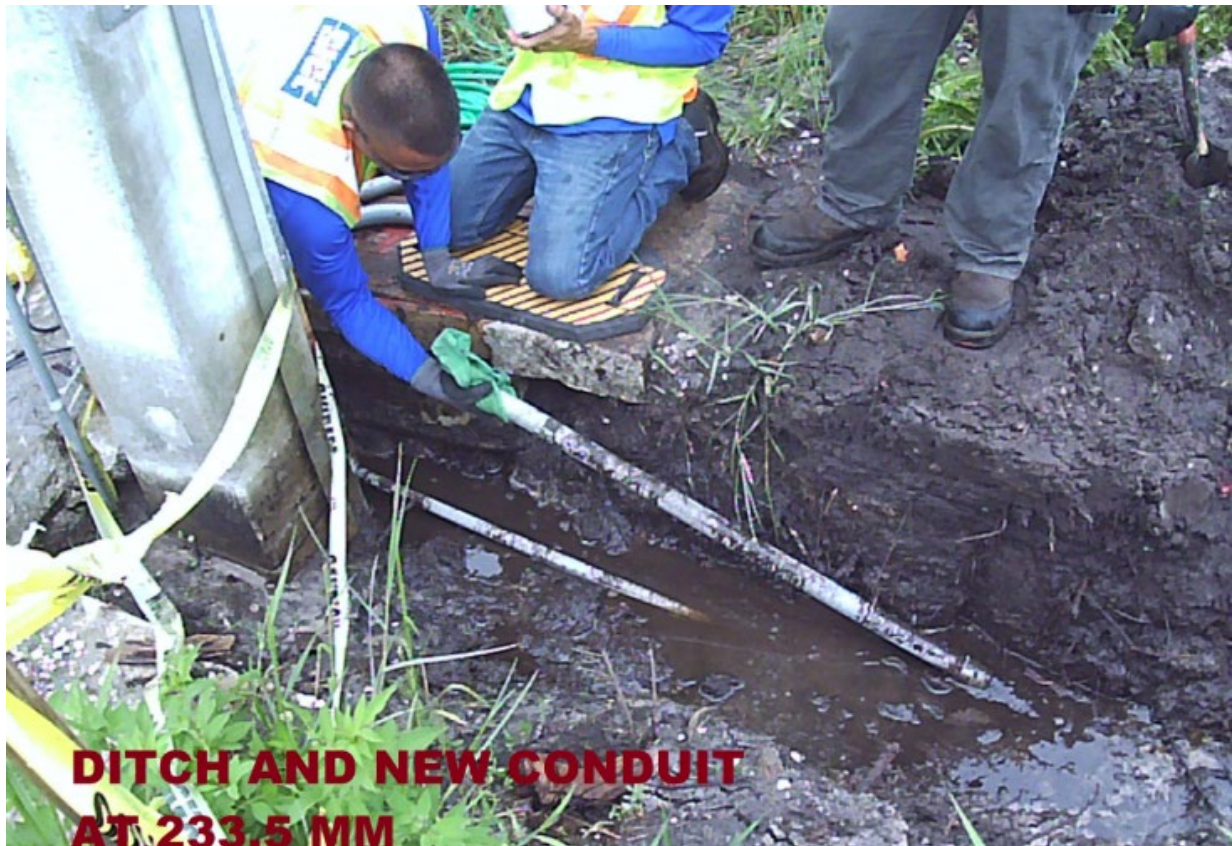
4) Use of Alternative Materials (PVC in lieu of HDPE):

ISSUE SUMMARY: Contractor requested to use 2" PVC instead of 2" HDPE at every ITS Pole location, from the EPB to the base of the pole. FDOT's Standard Spec 630-3, reads: "Use HDPE with an SDR number less than or equal to 13.5, Schedule 80 PVC, or Schedule 40 PVC for underground installations of electrical conduit in earth for lighting applications and landscape irrigation applications".

RESOLUTION: PVC was allowed by the EOR between the electrical pull box and the pole.
