# Annual Inspection Report

*for the Fiscal Year ending June 30, 2019*

**Annual Inspection Report**  
for the fiscal Year ending June 30, 2019

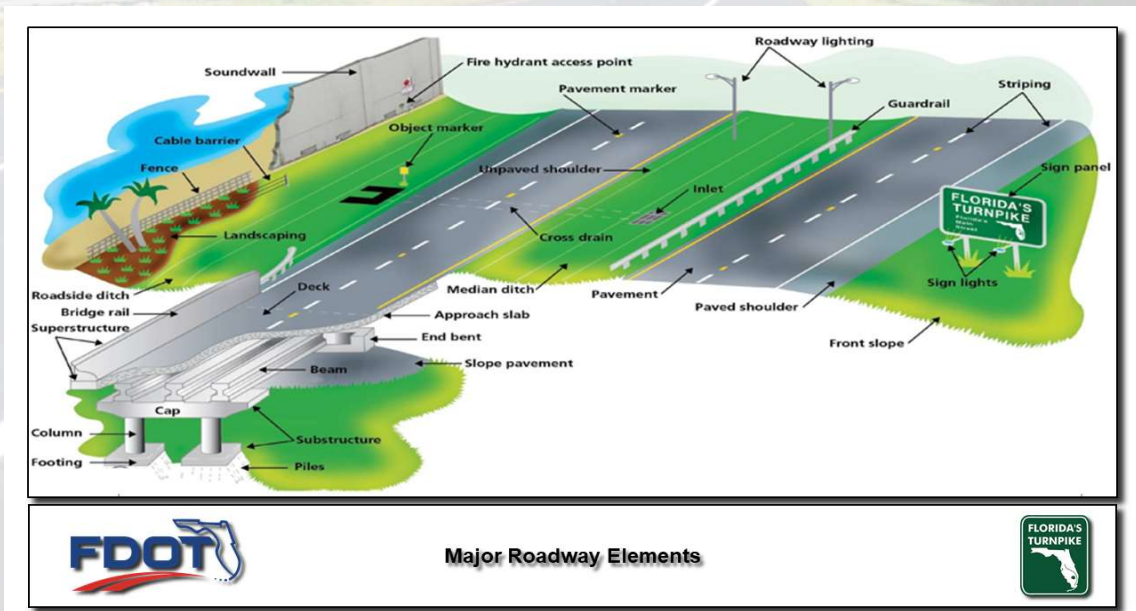
Figure 1 Major System Elements

The conditions of the roadway elements found in the RRP inspection for each of the maintenance zones are summarized in Tables 4 through 8. A sketch identifying the major elements of a typical roadway is included as Figure 1 above.

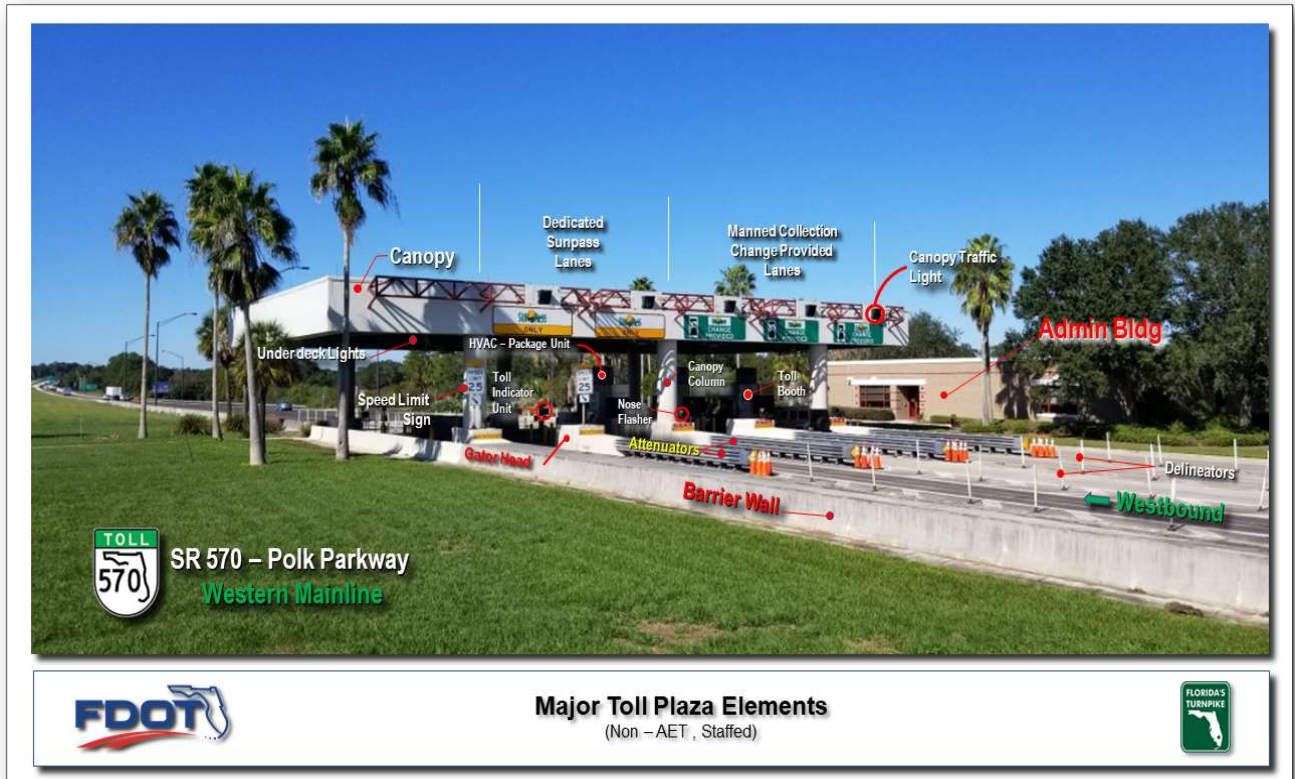
Figure 2 Major Toll Plaza Elements (Non-AET, Staffed)

The administration buildings may also be connected to the toll collection booths/equipment by means of an underground tunnel, which facilitates the transport of personnel, toll collection data, and supplies. A sketch identifying the major elements of Toll Plaza is included in Figure 2 above.

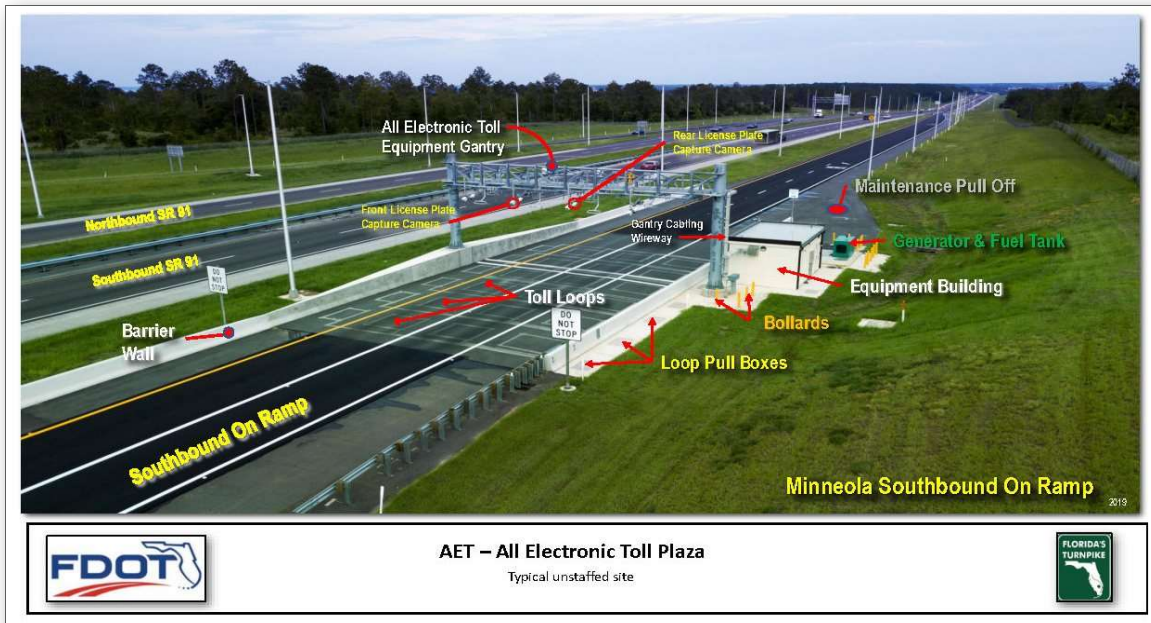
Figure 3 AET All-Electronic Toll Plaza (Unstaffed Site)

Some Toll Plaza Buildings have been replaced with All-Electronic Toll Plazas (AET) which consist of toll equipment buildings, generators, and fuel tanks. These are mainly on the HEFT section. Others can be found at Golden Glades, Sawgrass, Veterans, Southern Coin section, some off ramps, and "SunPass Only" lanes along the Turnpike Mainline, and elsewhere. AETs are currently under construction in various other areas of the System. See Figures 3 and 4 for examples.

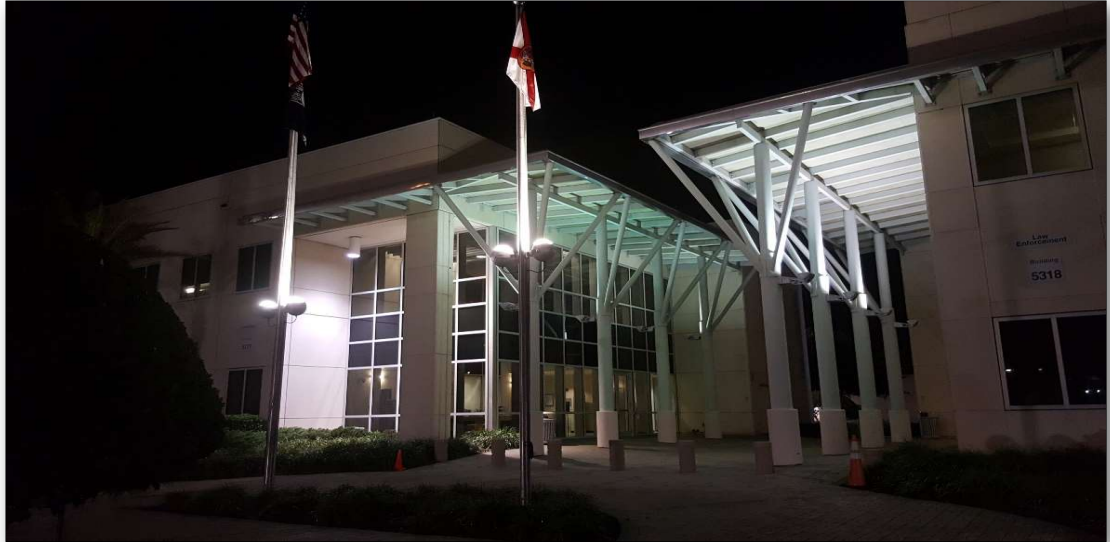
Figure 5 Operations Building – Turkey Lake

The FTE's 42 administrative buildings are used by a variety of FDOT functional areas as well as other Florida agencies, including: the Florida Highway Patrol, Troop K, Troop L, MCCO (Motor Carrier Compliance Office); the FTE's Office of Toll Operations; FDOT Districts 4 and 6; and the FTE's Operations and Concession Management and Marketing Offices. See Figures 5 and 6 for examples.

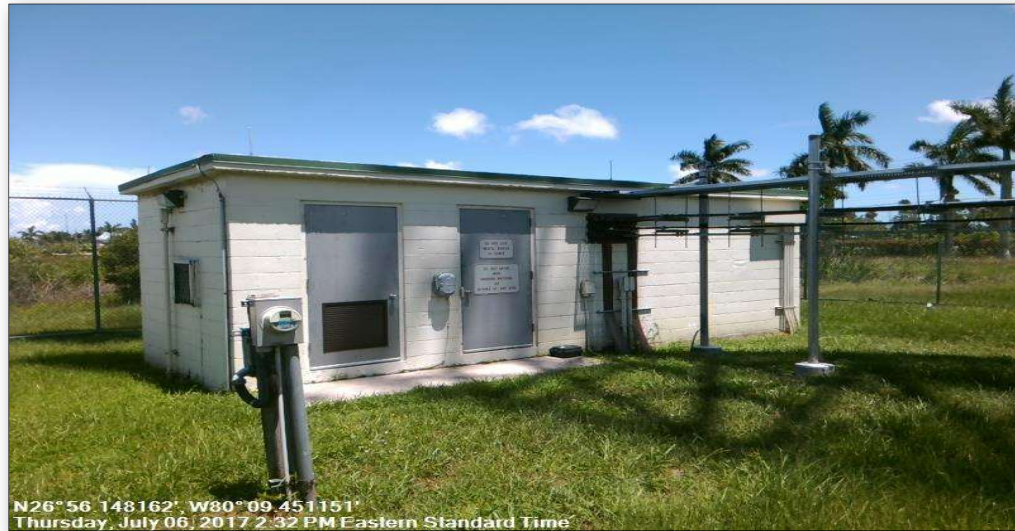
Figure 7 Communications Building – Jupiter

The communication tower buildings: often constructed of concrete and block, are typically small structures. These structures house the electronic circuitry and equipment that support the microwave radio communications system, which is relied upon by the FTE Operations Offices. See Figures 7 and 8 for examples.

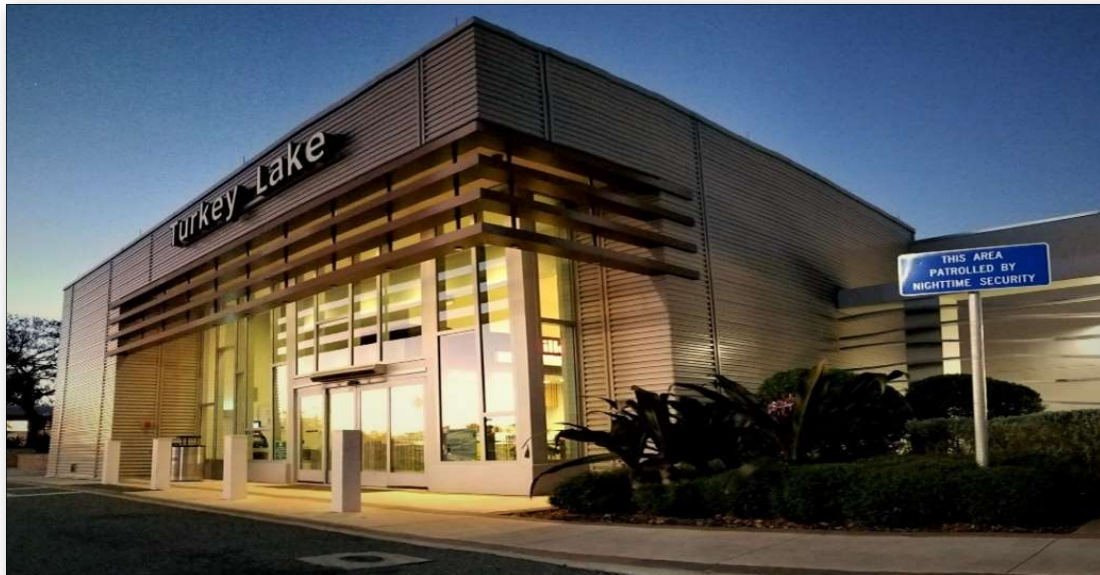
Figure 9 Turkey Lake Service Plaza

The FTE recently renovated eight service plaza restaurant buildings, like the one shown in Figure 9. These restaurant buildings are leased to Areas USA, Inc., who operate and maintain these facilities. The completed refurbishing includes an expanded new lineup of restaurant choices for patrons traveling the Turnpike.

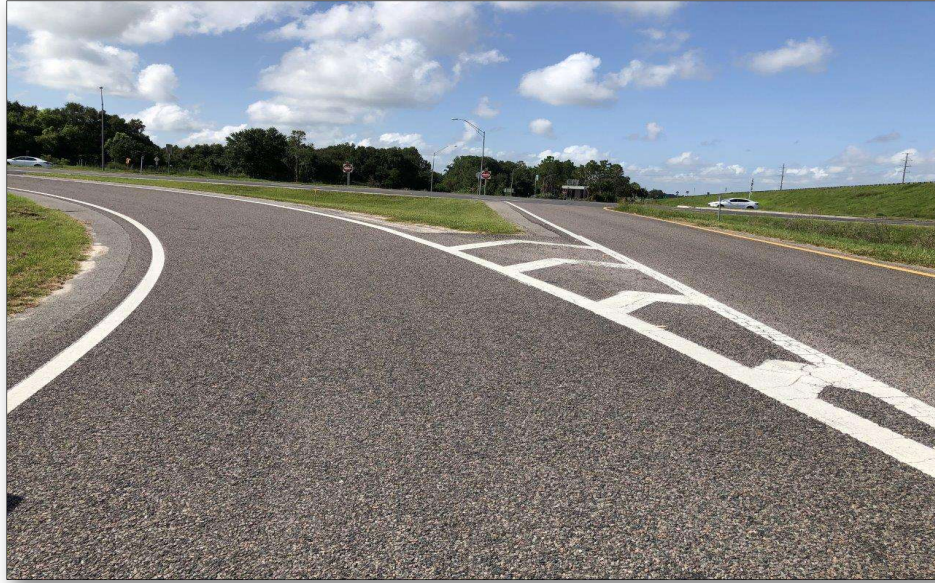
Figure 10 Typical Ramp Section

No major roadway deficiencies were identified by the FTE's annual inspection. Many of the minor deficiencies identified may already been addressed through the execution of several periodic or routine maintenance contracts or as part of renewal and replacement efforts. The MRP ratings and minor deficiencies for each of the five general categories of roadway elements are discussed in the following sections. A typical ramp section on the FTE System is shown in Figure 10.

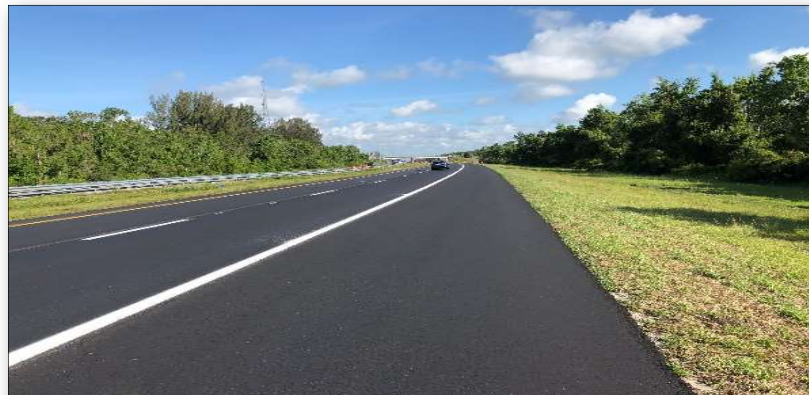
Figure 11 Paved and Soil Shoulder

The determination of an MRP rating for roadside features is generally based upon the consideration of all grading, shoulder, slopes, and other elements located outside of the paved travel way (Figure 1). The roadside category has achieved an MRP rating of 87 which remained unchanged from 2018. The overall RRP rating for Roadside was 85.76. There are no characteristics rated lower than 85 in the MRP. A typical paved and soil shoulder section on the FTE System is shown below in Figure 11.

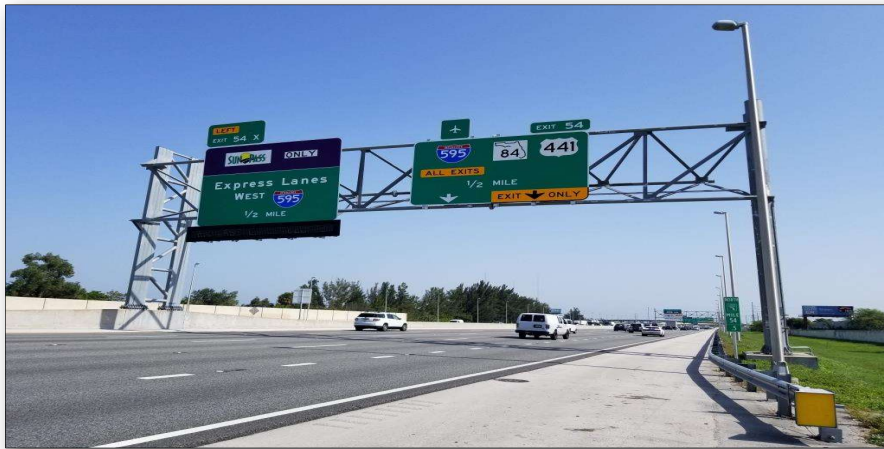
Figure 12 Overlane Truss Sign

The Traffic Services category rating is based on the condition of all features that guide, protect, and assist the patron while traveling the FTE's roadways, interchanges, and service areas. An MRP rating of 84 was achieved in this category, which is one-point lower than in FY 2018. The characteristics rated lower than 85 in the MRP were pavement symbol (76), guardrail (77), lighting (77), raised marker (80) and signs < 30 SF (82). The overall RRP rating for Traffic Services was 89.30. The annual inspection RRP indicates a well-maintained program with no characteristics being more than 2.77 percent deficient overall for 11 elements in this category. Typical overlane truss sign and typical guardrail examples on the FTE System are shown in Figures 12 and 13.

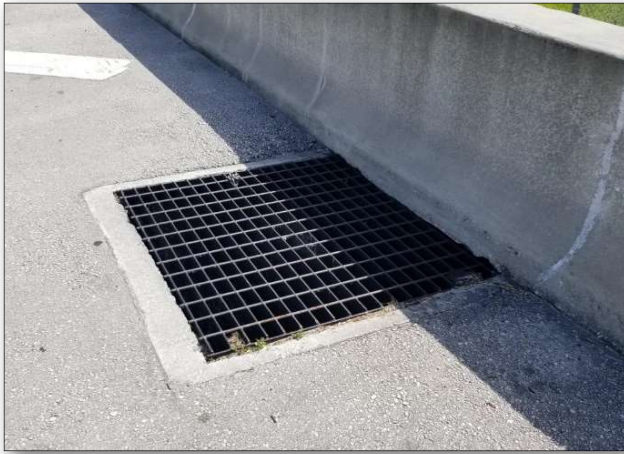
Figure 14 Drainage Inlet

defective. Typical erosion control section on the FTE System is shown in Figure 14.

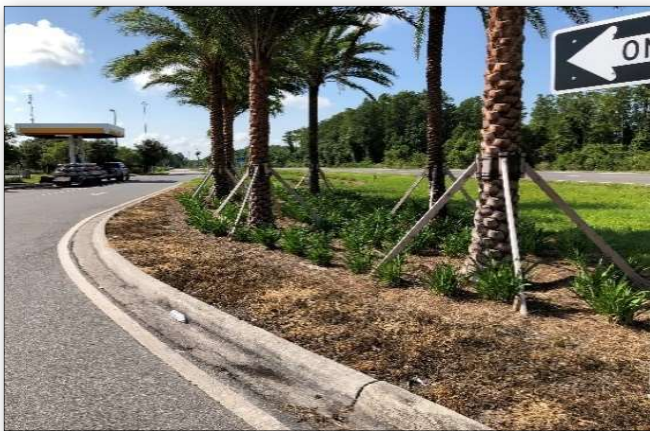
Figure 15 Excellent landscaping

96.15. The lowest rated items were turf condition rated at 77, litter removal rated at 80, and landscaping rated as 83 in the MRP spreadsheet, in contrast to a 98.50 rating in the RRP in this category.

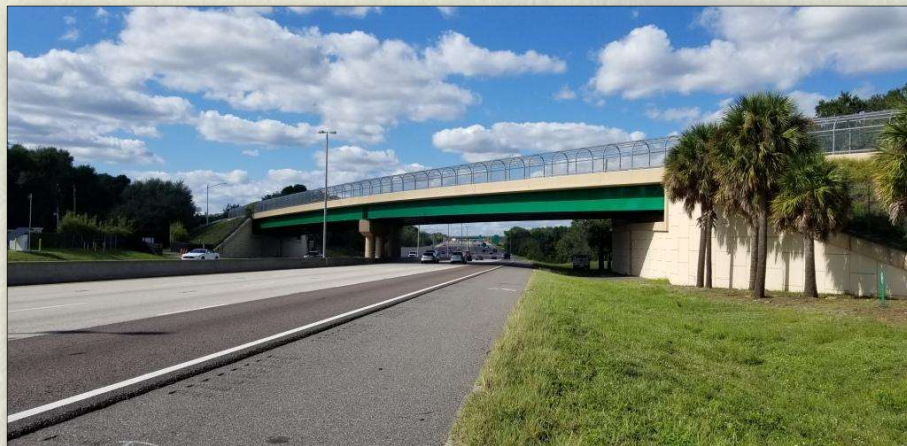
Figure 16 Bridge over SR 91 - Florida Turnpike Enterprise

The State Maintenance Office Bridge Inventory 2019 – Annual Report, which uses the National Bridge Inspection guidelines, reported five bridges in fair condition. FTE Maintenance directed a portion of its periodic and routine maintenance funding in FY 2019 to rehabilitation and repair projects.

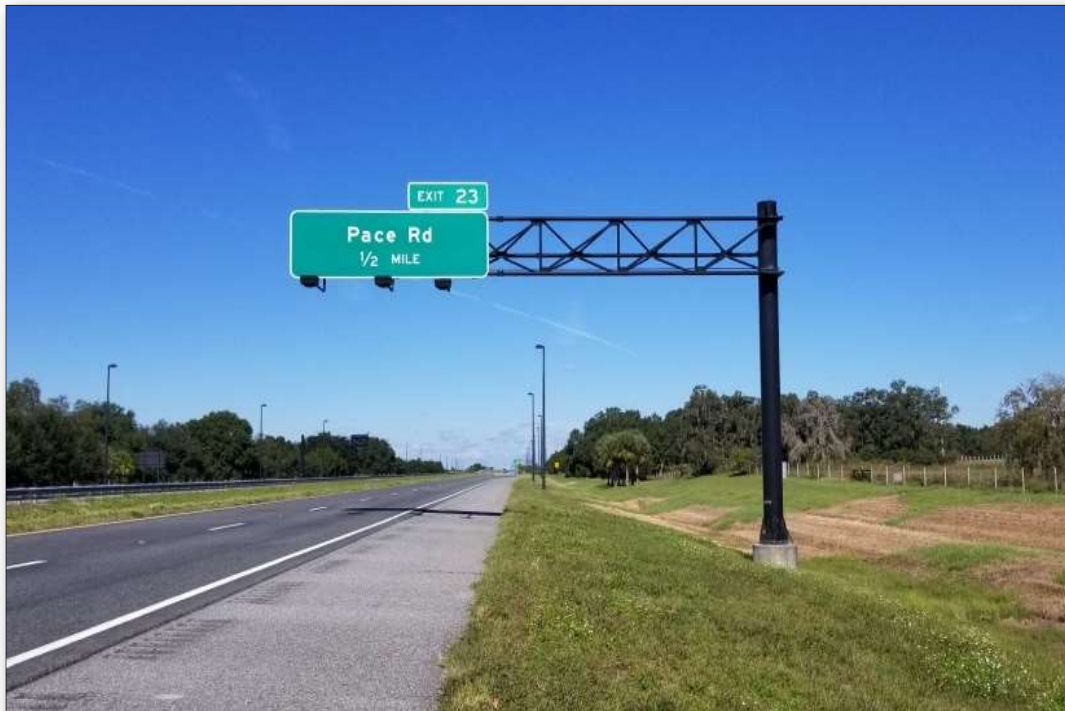
Figure 17 Typical Cantilever Sign - SR 570

Overhead sign structures are inspected separately from those signs in the traffic services element due to being suspended above the travel way by large support structures, such as the one pictured in Figure 17. These signs provide critical directional information, guiding the patron throughout FTE System. The Overhead sign structures inspection noted a 25.49% overall deficiency rating for the 2019 inspection period. All deficient notations were for the sign foundations. Overhead sign structures are shown by location in Table 11.

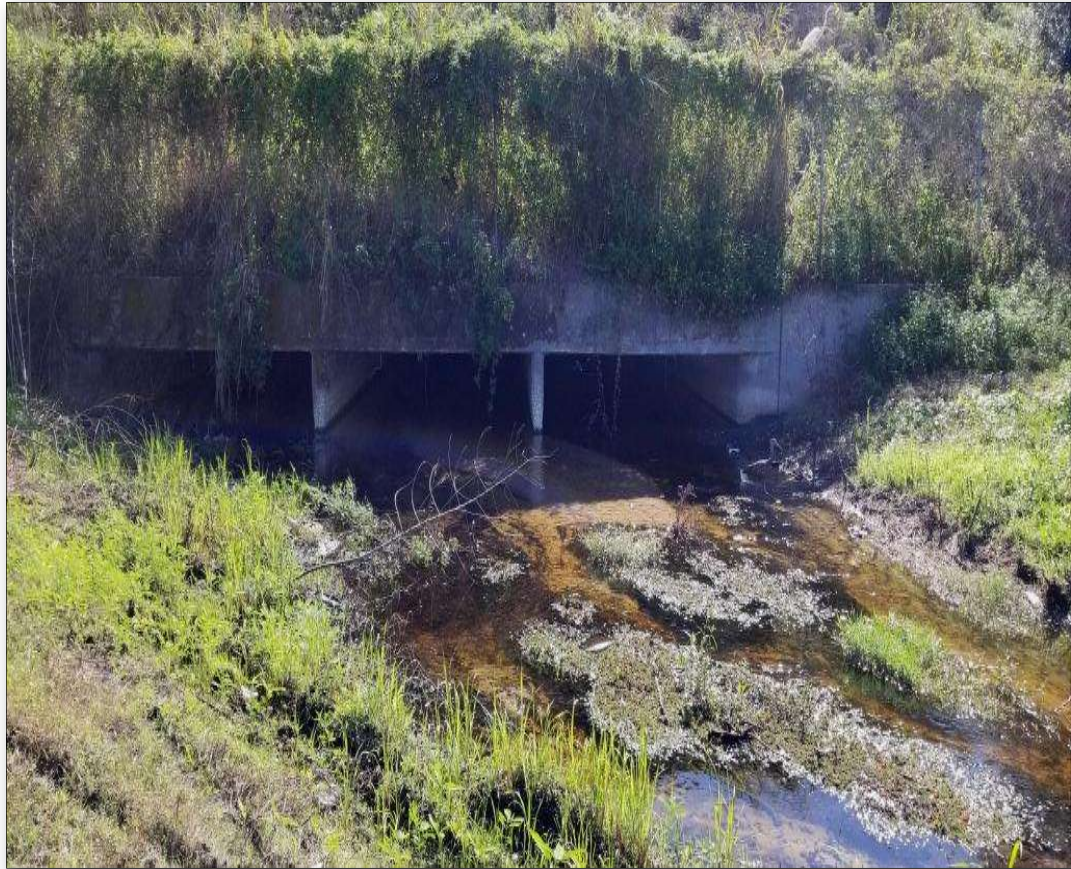
Figure 18 Box Culvert

An LNQC is a structure that does not meet the statutory definition of a bridge. LNQCs is defined as a circular, elliptical arch, or box type of culvert with a height greater than four (4) feet, or clear span of ten feet or greater, but less than 20 feet (see Figure 18 as an example). Like the other Structures, (Bridges, Signs, and High Mast Light Towers), LNQCs are included in the structure's inspection. The LNQCs are

inspected once every six years. Each cycle is a two-year period with 1/3 of the total LNQCs inspected during the cycle. It takes three cycles for the entire LNQC inventory to be inspected. The LNQCs are in good condition with minor repairs ongoing as part of the routine maintenance contracts.

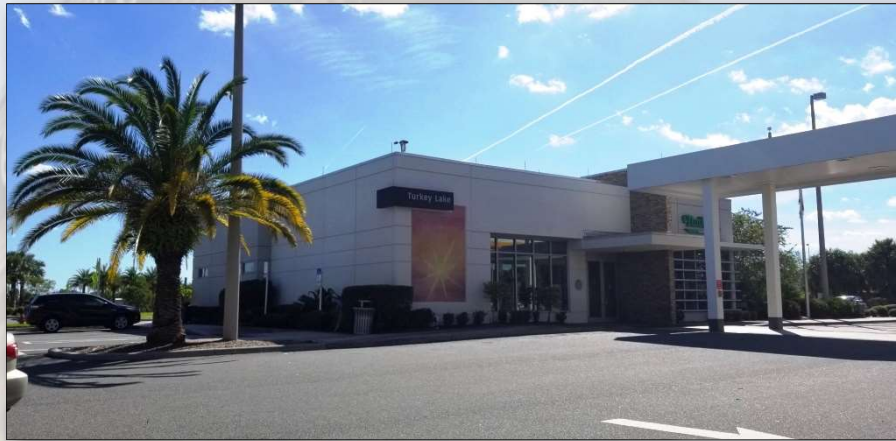
Figure 19 Turkey Lake Service Plaza Gas Station

The annual inspection of the FTE's facilities is based on a visual inspection and rating of the condition of 486 buildings (see below Figures 19 and 20 for examples). This is the only building-type inspection performed in the state. Overall 31,882 comments were made of building asset items inspected, of which, 636 were rated as being in condition four or below, for a deficiency rate of 1.99% percent. However, in many cases, these deficiencies represented an aesthetics problem and not structural or safety issues. Further, the FTE's facilities are more susceptible to deterioration due to time, weather, and other elements than are its roadways. The results of the overall inspection are reported in Table 14.

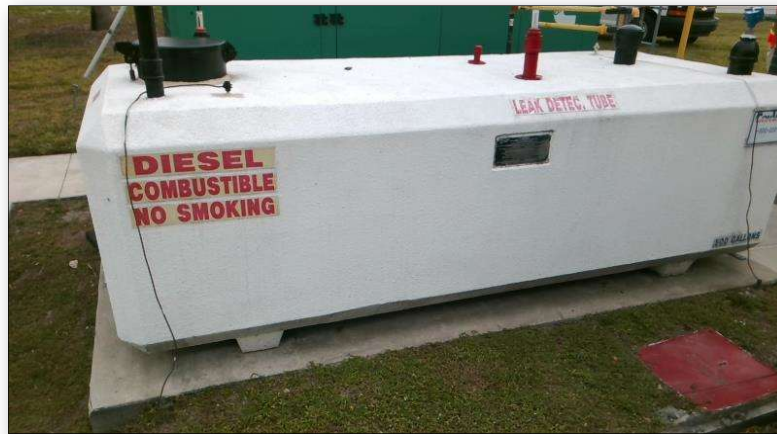
- **Receptacle (15.40%)** – The majority of deficiencies reported for this element are GFI receptacles that are not functioning as intended and more focus is needed on maintenance of this element.
- **Fuel Tank (14.68%)** – This element refers to tanks supplying fuel to the stand-by generators. The majority of deficiencies reported for this element are missing tie-down straps and more focus is needed on completion of the program to assure all tanks are tied down.

Figure 21 Fuel tank Missing Tie Down Straps

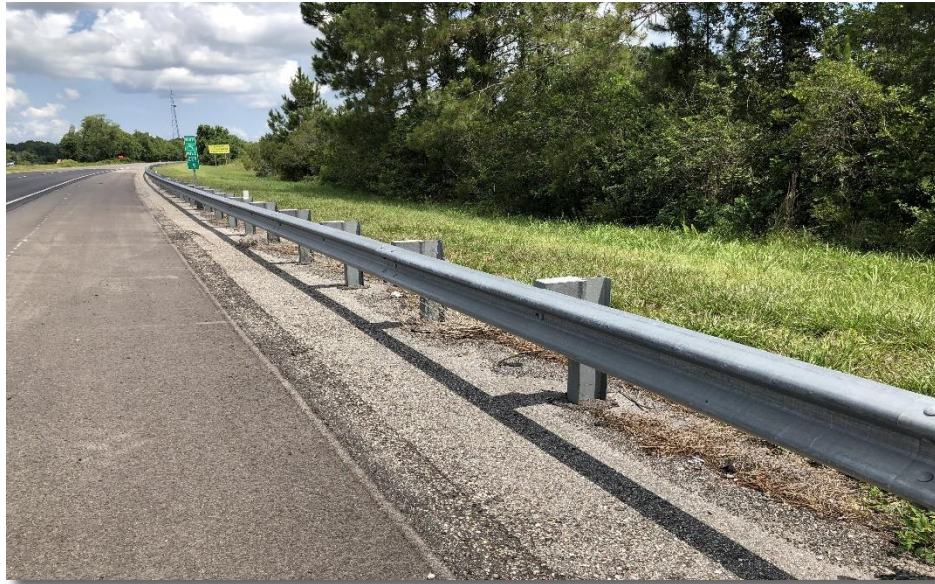
Desired Guardrail Asphalt Condition

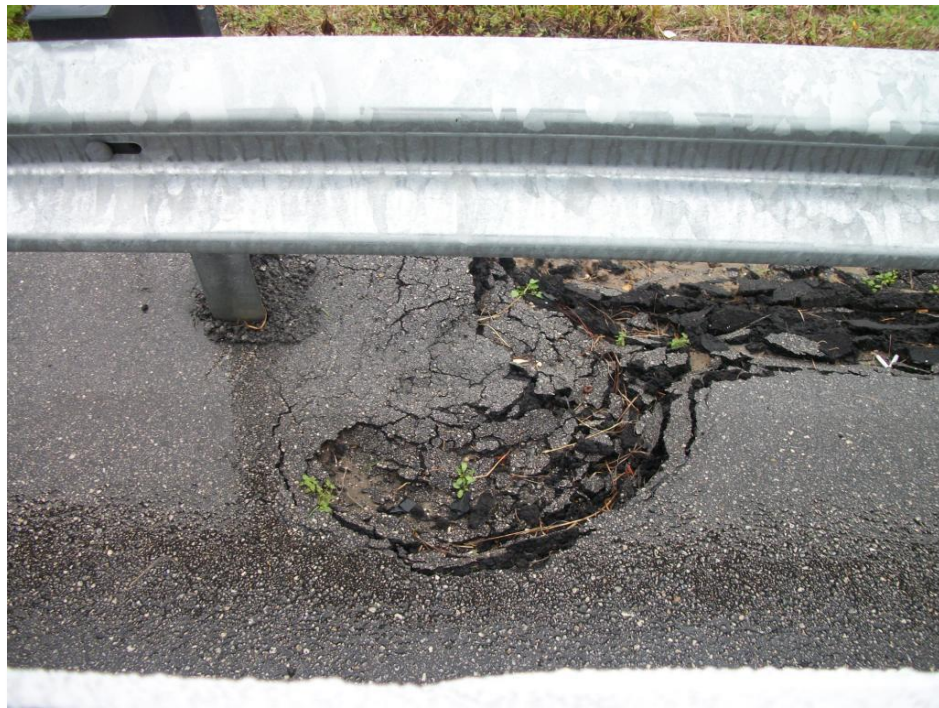
Undesired Guardrail Asphalt Condition – Deterioration

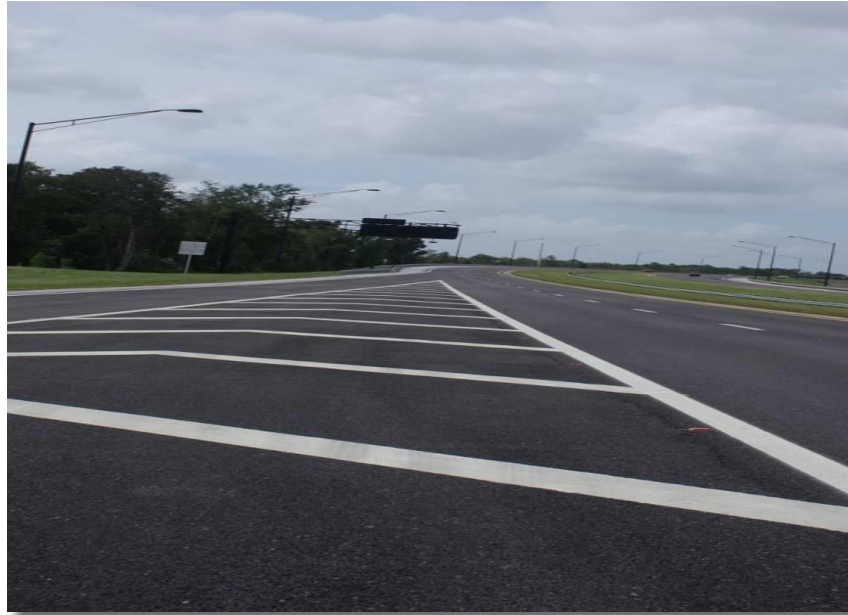
Desired Travel Lane / Ramp Condition

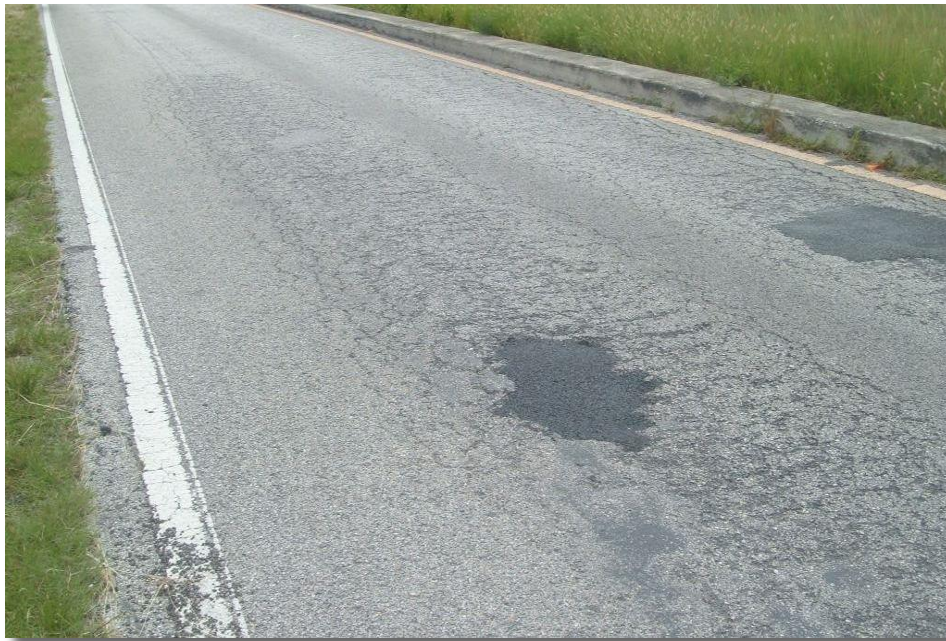
Undesired Travel Lane / Ramp Condition – Deterioration

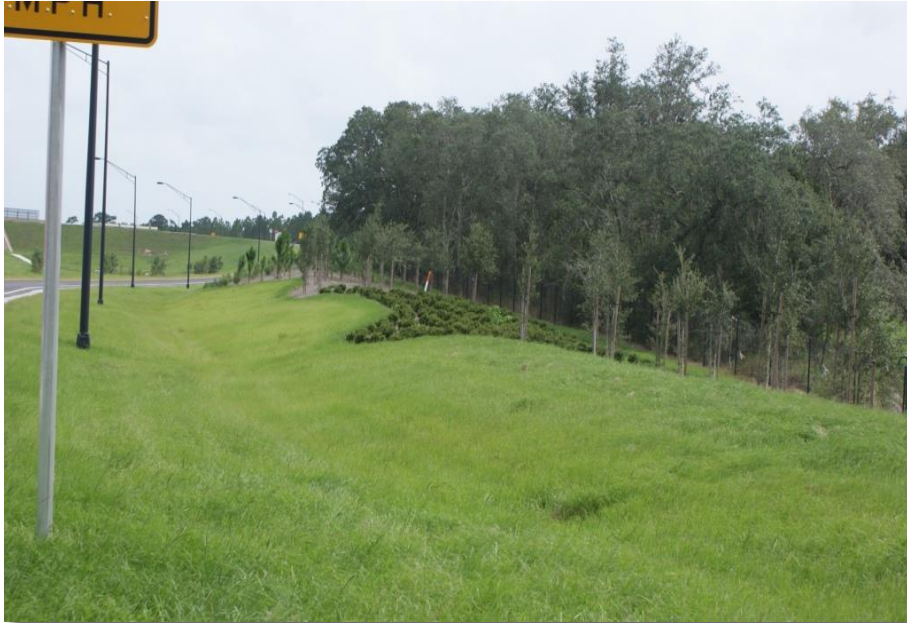
Desired Soil, Shoulder and Front Slope Condition

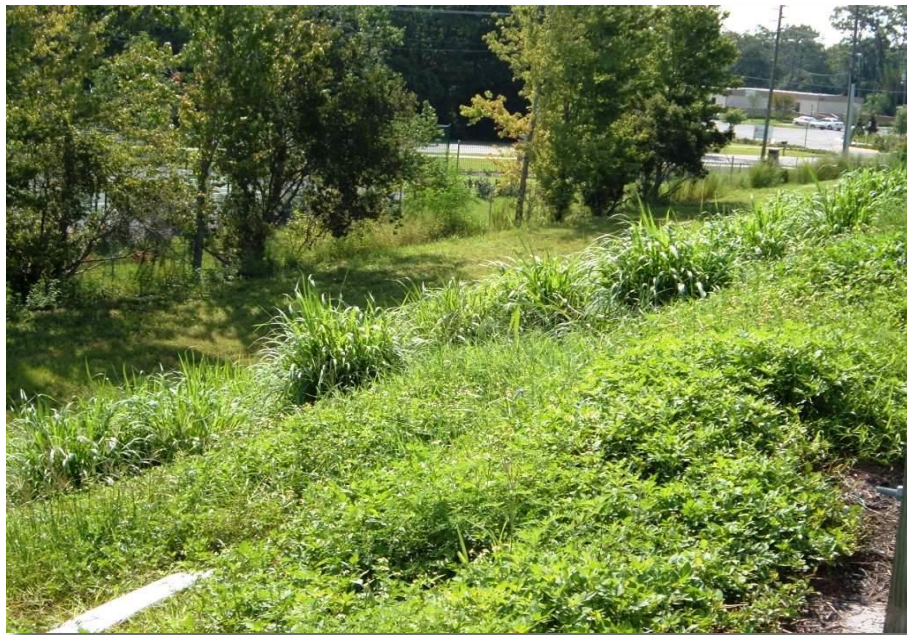
Undesired Soil, Shoulder and Front Slope Condition – Vegetation

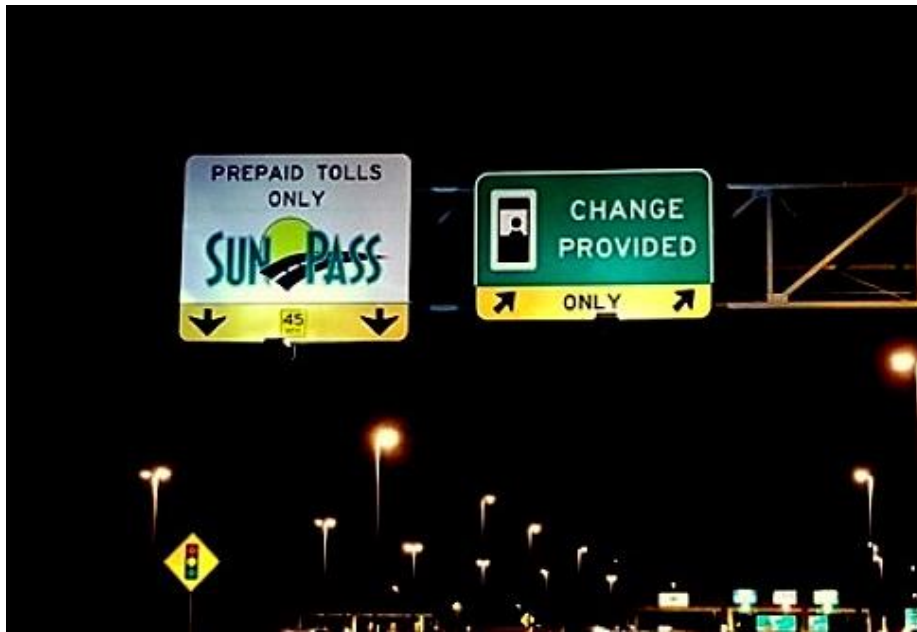
Desired Sign Reflectivity Condition

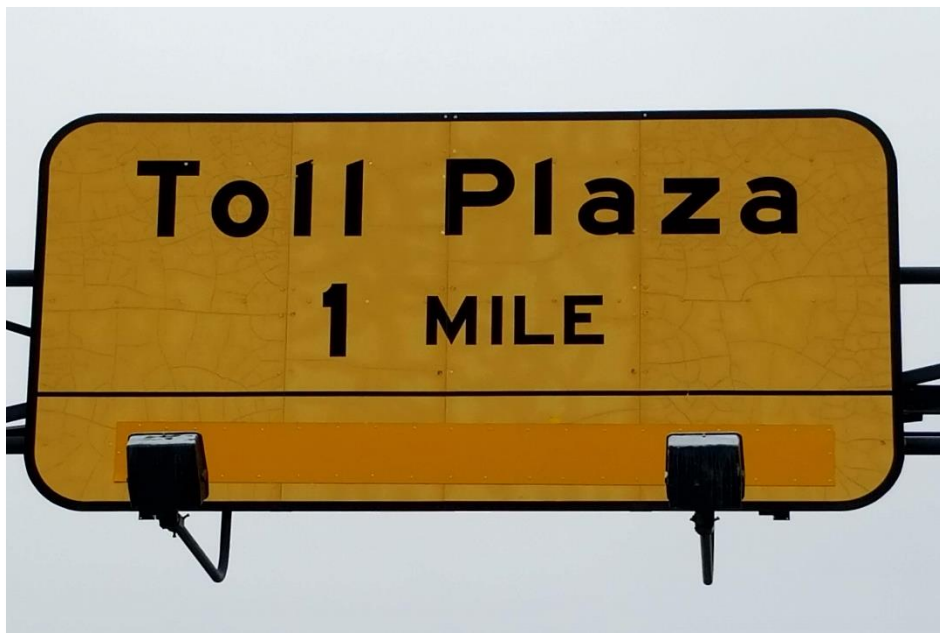
Undesired Sign Reflectivity Condition – Material Cracked and Faded
