CENTRAL POLK PARKWAY (SR 570B)

From Polk Parkway (SR 570) to US 17 (SR 35)

FPID: 440897-2-52-01
CONTRACT NO: C9Y59

BALD EAGLE NEST EVALUATION DESIGN MEMORANDUM

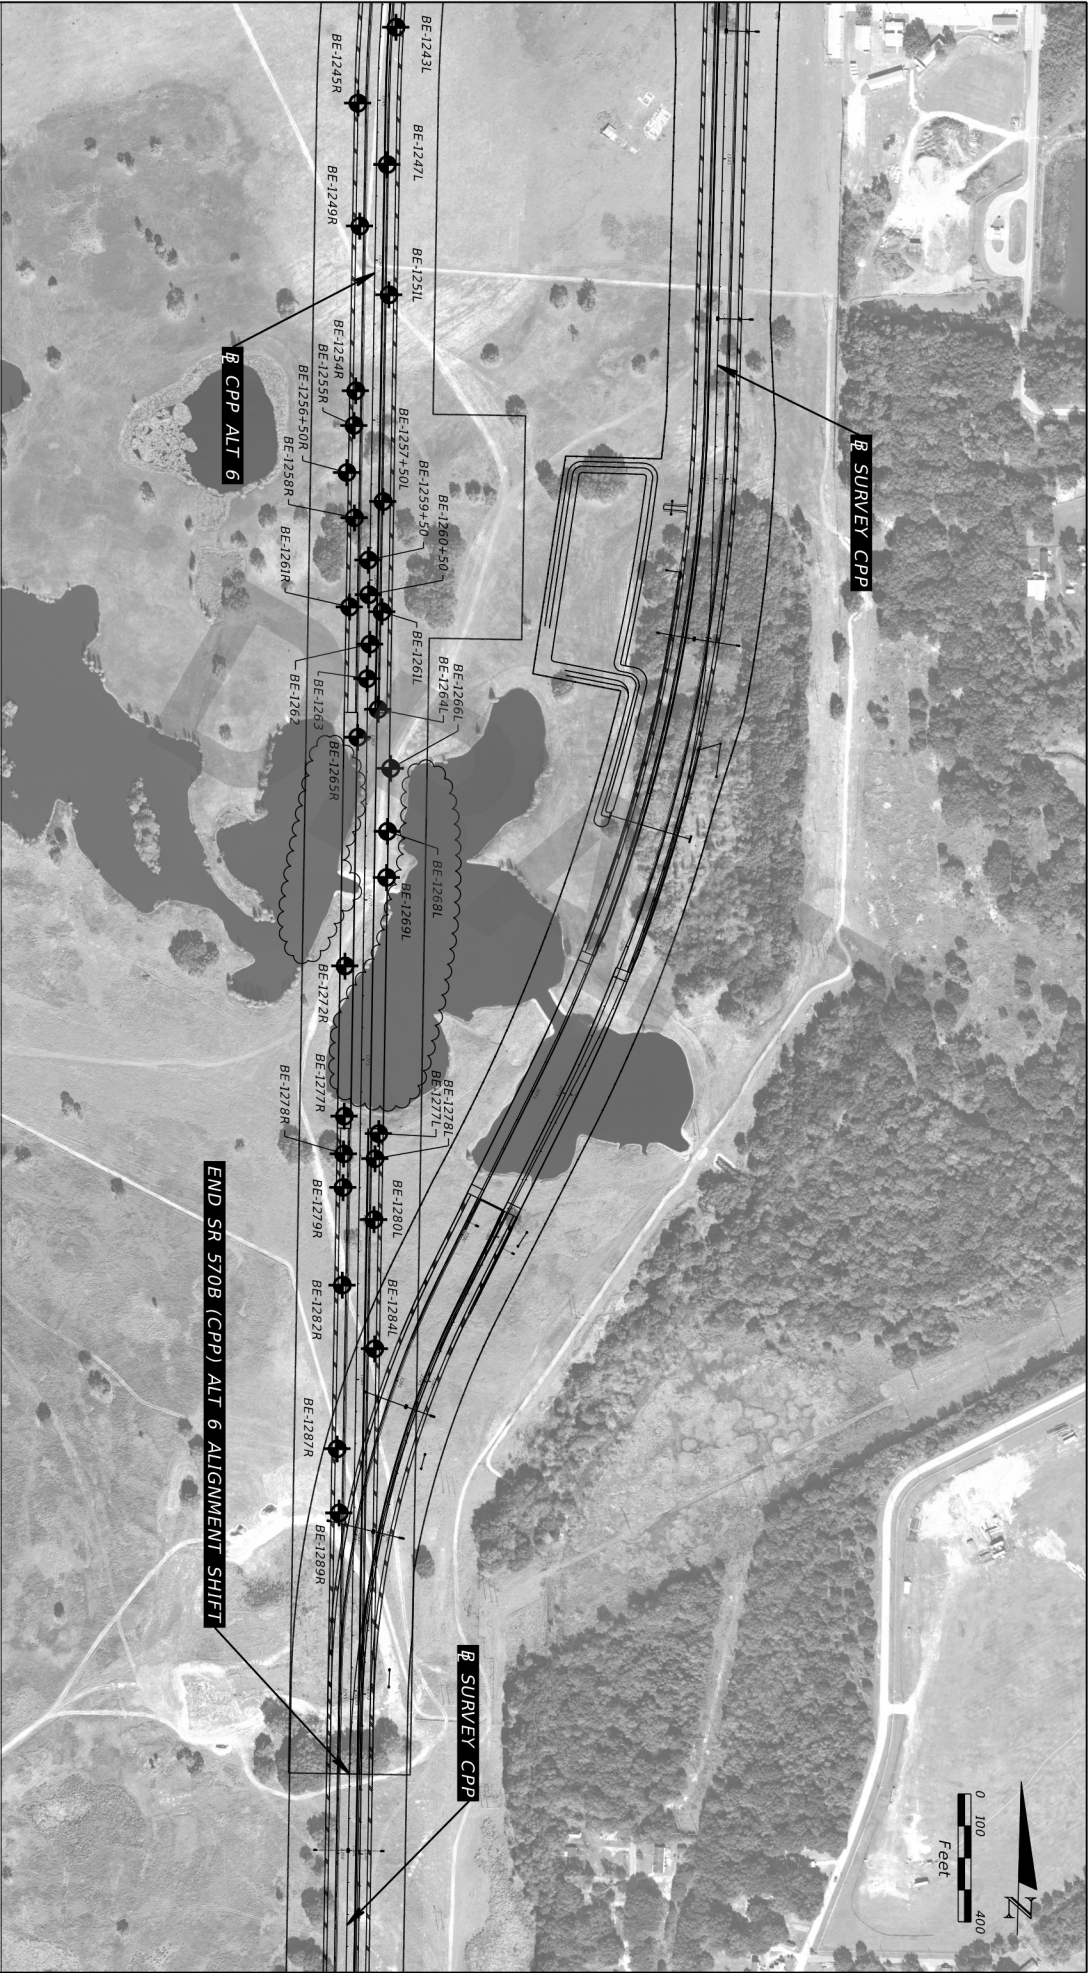
- APPROXIMATE SPT BORING LOCATION
- APPROXIMATE AUGER BORING LOCATION
- REFER TO MINE PIT LAKES PROBING PLAN
