LEVEL I
CONTAMINATION SCREENING
EVALUATION REPORT (PONDS)

Suncoast Parkway 2
From State Road 44 to County Road 486

Citrus County, Florida

FPID: 442764-1-32-01

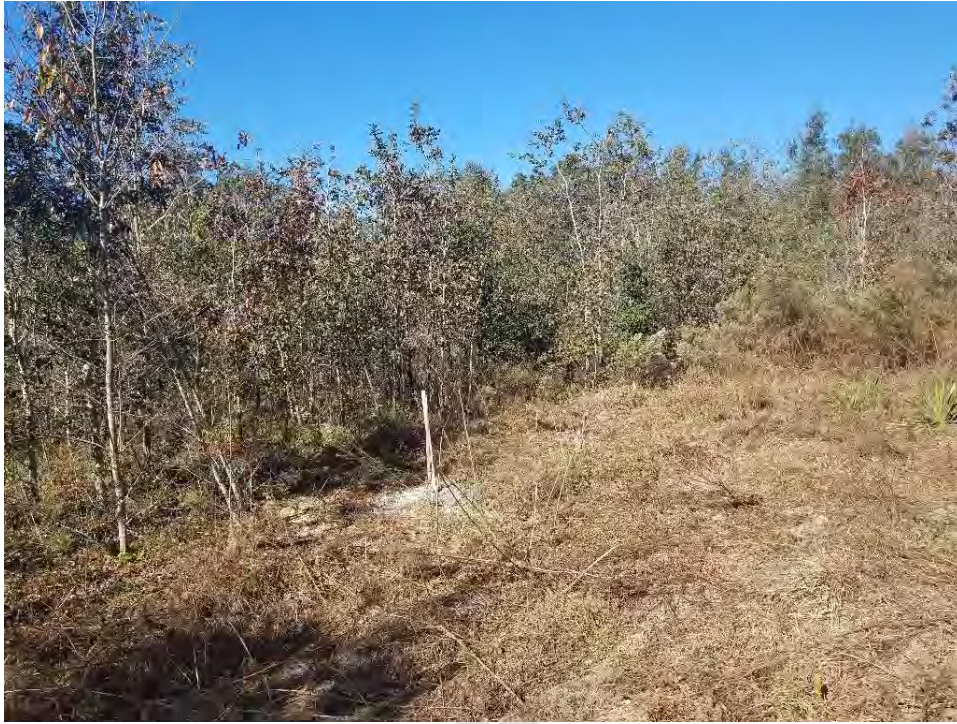
Pond 2-5, Alternative 1 – central portion of the pond site looking north

Table 5: Pond Site Risk Rating Summary			
Basin	Pond Site	Risk Rating	Comments
2-5	Alt 1	Low	<p>Current Land Use: During the site reconnaissance, the majority of Pond 2-5, Alternative 1 was observed as woods and overgrown field with West Shady Knoll Place located within the southeastern area of the pond site. Residences are located onsite along the south side of West Shady Knoll Place. No obvious signs of fuel storage tanks, hazardous materials, buried debris, or other contamination concerns were noted. Surrounding properties in the vicinity of the pond site include Saint Michael the Archangel Church and a utility easement to the north; SR 44 to the south and west; and residences followed by a utility easement to the east.</p> <p>Contamination Concern(s): No contamination sites/facilities that would be expected to impact the project were noted within or in close proximity to the pond site boundaries.</p> <p>Risk rating: No contamination concerns were identified, therefore Pond 2-5, Alternative 1 is assigned a risk rating of Low.</p>

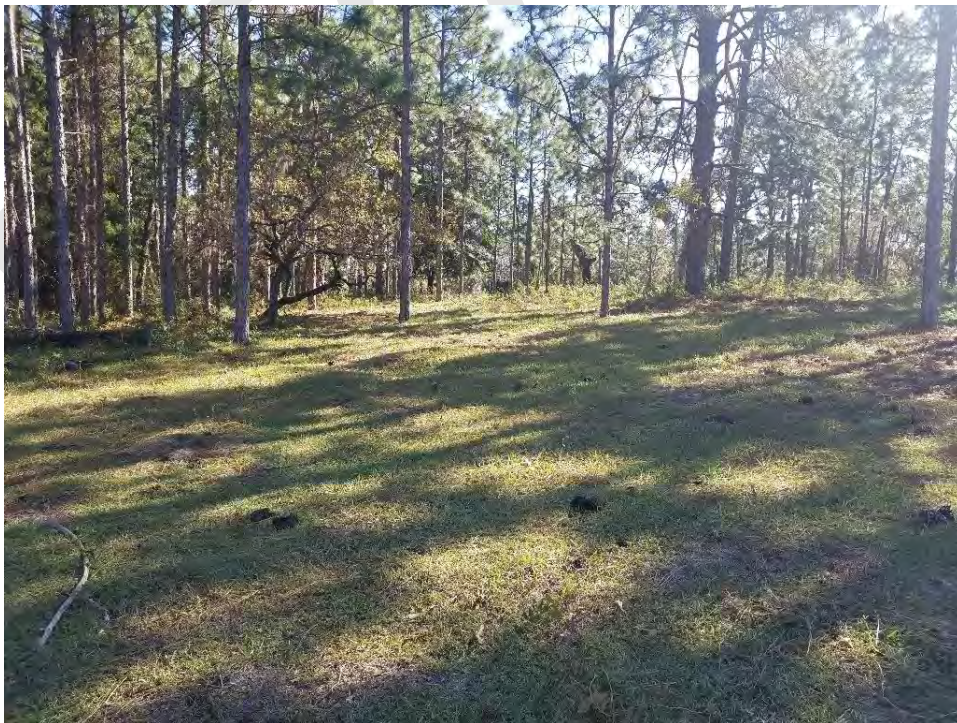
Pond 2-5, Alternative 2 – central portion of the pond site looking south

Alt 2	Low	<p>Current Land Use: During the site reconnaissance, Pond 2-5, Alternative 2 was observed as woods. No obvious signs of fuel storage tanks, hazardous materials, buried debris, or other contamination concerns were noted. Surrounding properties in the vicinity of the pond site include woods and a residence to the north; Woods to the east; grassy field followed by a utility easement to the west; and a utility easement to the south.</p> <p>Contamination Concern(s): Maylen Property, located approximately 250 feet east of Pond 2-5, Alternative 2 – this listing was identified as Site 31 in the 2009 PD&E report and was assigned a risk rating of Medium. The 2009 PD&E noted several types of agricultural equipment and containers on the property. No regulatory information is available for this listing. During the site reconnaissance conducted on December 4, 2019, no agricultural equipment or suspect containers were observed within the boundaries of Pond 2-5, Alternative 2. This listing is not considered a contamination concern to Pond 2-5, Alternative 2.</p> <p>Risk rating: No contamination concerns were identified, therefore Pond 2-5, Alternative 2 is assigned a risk rating of Low.</p>

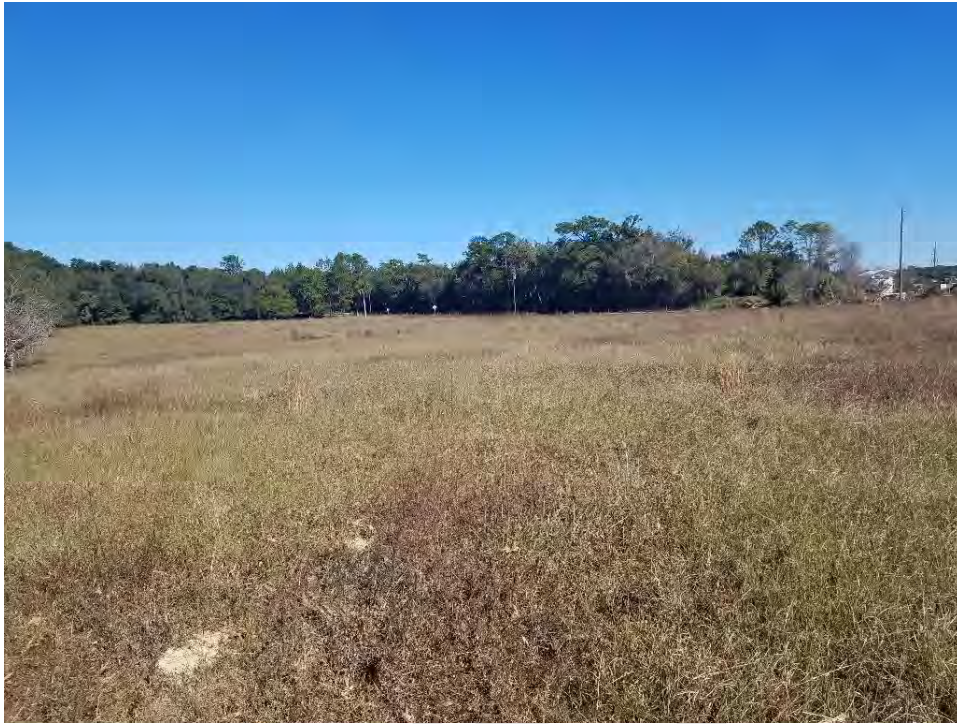
Pond 2-5, Alternative 3 – southwest area of the pond site looking northeast

Alt 3	Low	<p>Current Land Use: During the site reconnaissance, the majority of Pond 2-5, Alternative 3 was observed as open field with woods at the southwest boundary. No obvious signs of fuel storage tanks, hazardous materials, buried debris, or other contamination concerns were noted. Surrounding properties in the vicinity of the pond site include woods to the north and west; a utility easement to the south; and North Maylen Avenue followed by overgrown field and Crystal River Quarries to the east.</p> <p>Contamination Concern(s): Maylen Avenue DDMS, 261 North Maylen Avenue, located approximately 100 feet east of Pond 2-5, Alternative 3 – During the site reconnaissance, this site was observed as an overgrown field with no structures onsite. According to the EDM report and files found on FDEP’s OCULUS database, this site is an inactive Disaster Debris Management Site (DDMS). When a hurricane/storm occurs, DDMS sites are utilized to store and process disaster debris. This site has not been utilized to store disaster debris as of the writing of this report. Therefore, this site is not considered a contamination concern to Pond 2-5, Alternative 3.</p> <p>Crystal River Quarries, 287 North Maylen Avenue, located approximately 70 feet east of Pond 2-5, Alternative 3 – During the site reconnaissance, this facility was observed as an active mine. This listing was identified as Site 30 in the 2009 PD&E report and was assigned a risk rating of Low. The facility currently maintains one 10,000-gallon diesel fuel aboveground storage tank (AST). No discharges or current violations are noted. Due to the regulatory status, this facility is not considered a contamination concern to Pond 2-5, Alternative 3.</p> <p>Risk rating: No contamination concerns were identified, therefore Pond 2-5, Alternative 3 is assigned a risk rating of Low.</p>

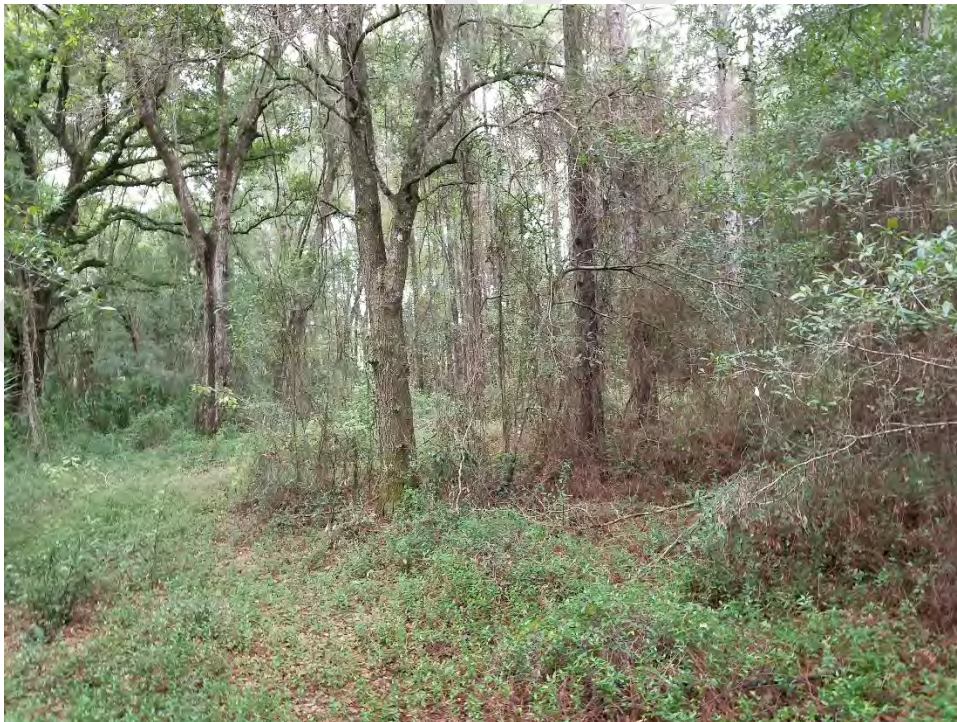
Pond 2-5, Alternative 4 – Central area looking south

Alt 4	No	<p>Current Land Use: During the site reconnaissance, Pond 2-5, Alternative 4 was observed as an existing retention pond in the southwest area and woods throughout the remaining area of the pond alternative. No obvious signs of fuel storage tanks, hazardous materials, buried debris, or other contamination concerns were noted. Surrounding properties in the vicinity of the pond site include woods to the north, east, and west; and SR 44 to the south.</p> <p>Contamination Concern(s): No contamination sites/facilities that would be expected to impact the project were noted within or in close proximity to the pond site boundaries.</p> <p>Risk rating: No contamination concerns were identified, therefore Pond 2-5, Alternative 4 is assigned a risk rating of No.</p>

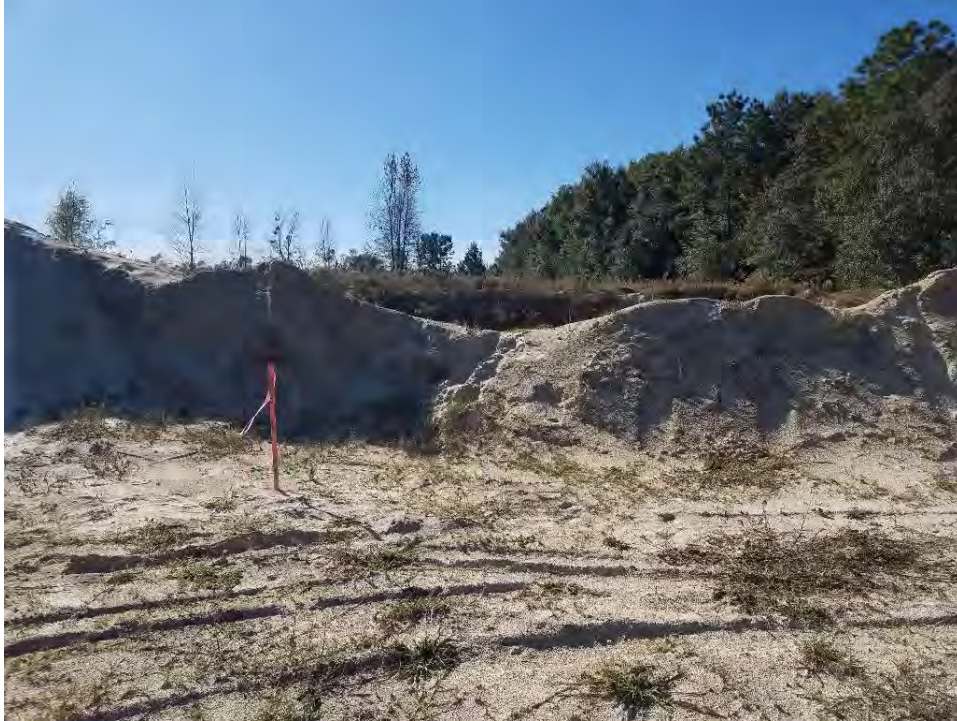
Pond 2-6, Alternative 1 – north-central area looking south

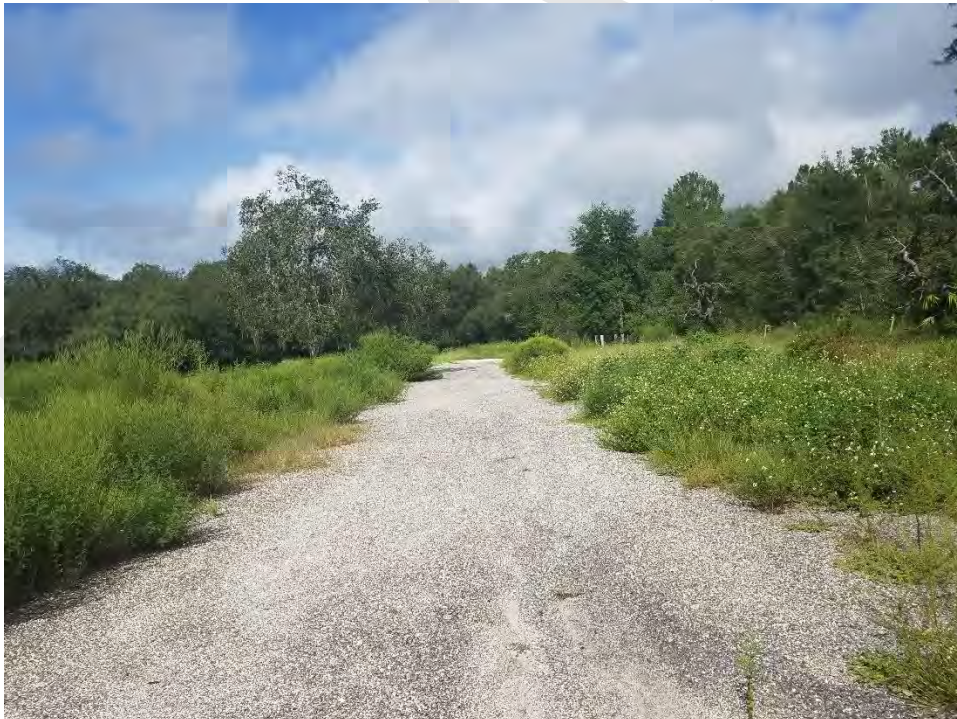
Pond 2-6, Alternative 2 – northern area looking west

Alt 2	Low	<p>Current Land Use: During the site reconnaissance, Pond 2-6, Alternative 2 was observed as open field and woods. No obvious signs of fuel storage tanks, hazardous materials, buried debris, or other contamination concerns were noted. Surrounding properties in the vicinity of the pond site include woods to the north and east; a former limerock mine to the south; and residences to the west.</p> <p>Former Limerock Mine, 1150 North Maylen Avenue, located adjacent south of Pond 2-6, Alternative 2 – during the site reconnaissance, this site was observed as an inactive limerock mine with vegetation growing in the remaining open excavation pits. This facility was identified as Site 33 in the 2009 PD&E report and was assigned a risk rating of No. The 2009 PD&E noted a large excavated area with overgrown vegetation throughout. No contamination concerns were observed in 2009 or during the site reconnaissance conducted on December 4, 2019. Documents found on the USGS Mineral Resource database indicates that this facility formerly operated as a limerock mining facility known as Carroll’s Lecanto Pit (AKA Lecanto Materials Co.). No further information is available on the USGS online database. An email was sent to FDEP’s Public Records department requesting additional information about this site. No response was received as of the writing of this report. See email and USGS excerpts in CSER Appendix F. This facility is not considered a contamination concern to Pond 2-6, Alternative 2.</p> <p>Risk rating: No contamination concerns were identified, therefore Pond 2-6, Alternative 2 is assigned a risk rating of Low.</p>

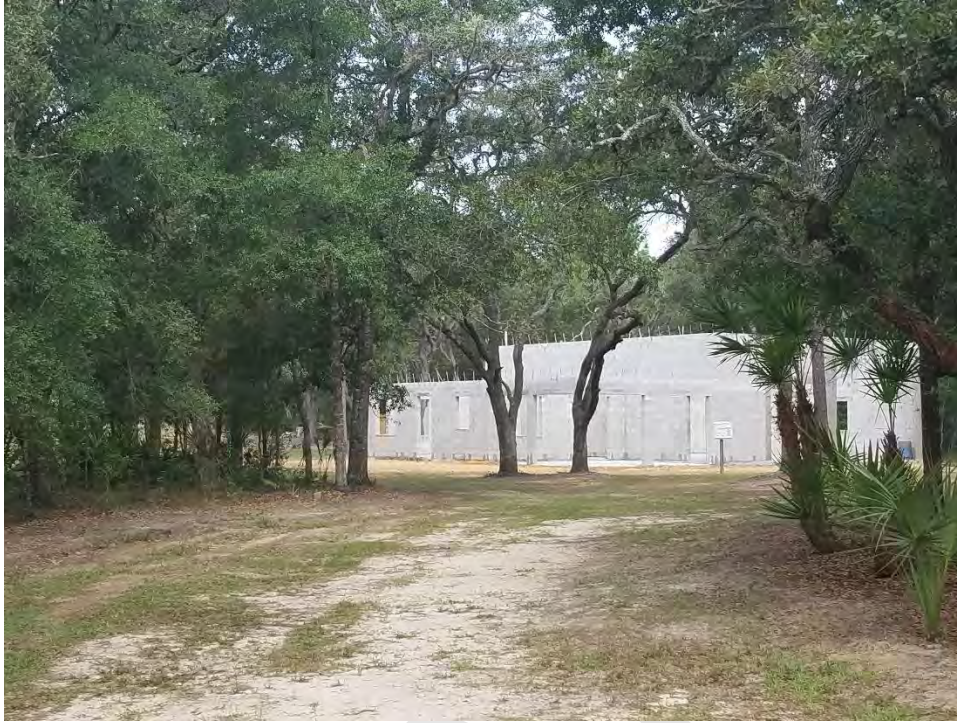
Pond 2-6, Alternative 3 – construction site located in eastern area

Alt 3	Low	<p>Current Land Use: During the site reconnaissance, Pond 2-6, Alternative 3 was observed as open field, woods, and a construction site. The south and east ends of the pond site are comprised of open field. The majority of the pond site consists of woods. What appears to be a residence is being constructed onsite in eastern area of the pond site. A small shooting range with assorted targets and spent bullet casings on the ground were situated in front of a soil berm located offsite north of the northwest corner of the pond site. The shooting range is not a commercial operation. It appears to be associated with personal use. Surrounding properties in the vicinity of the pond site include woods to the north and east; open field to the south; and open field followed by a residence to the west.</p> <p>Contamination Concern(s): Shooting range, located approximately 60 feet north of Pond 2-6, Alternative 3 – A small shooting range was observed approximately 60 feet north of the pond site (coordinates: 28.88448611° -82.50888889°). The range consisted of household plastic items placed directly on land surface and paper targets attached to wooden boards in front of a soil berm measuring approximately 5 feet tall and 30 feet wide. Spent bullet casings were noted throughout the shooting range area. Due to the separation distance (60 feet), the soil berm is not considered a contamination concern to Pond 2-6, Alternative 3.</p> <p>Risk rating: No contamination concerns were identified, therefore Pond 2-6, Alternative 3 is assigned a risk rating of Low.</p>

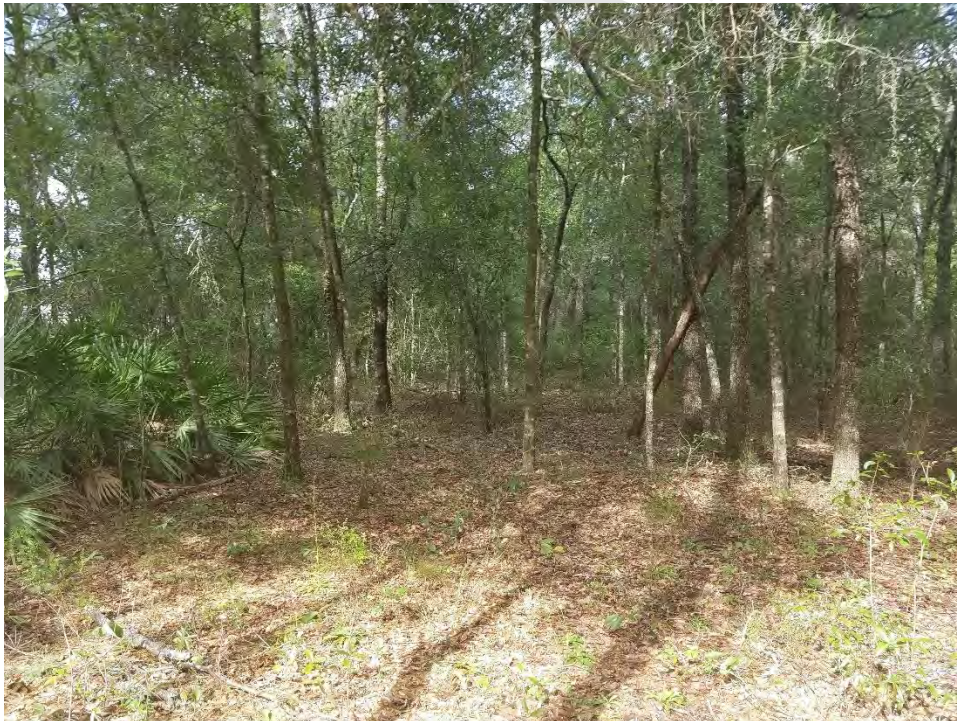
Pond 2-6, Alternative 3 – northeast area looking west

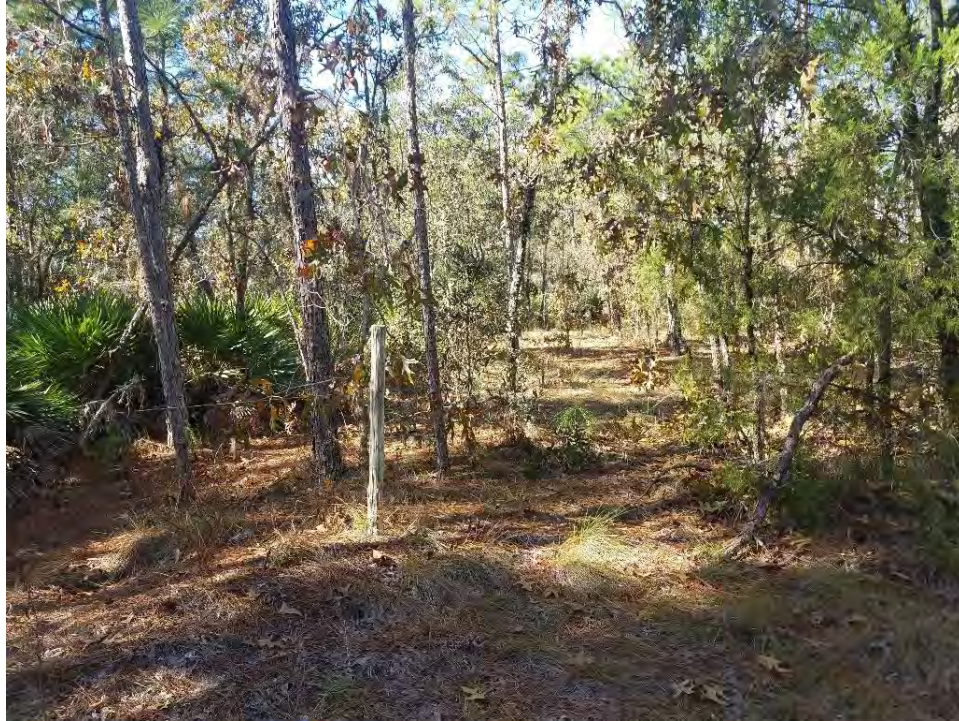
Pond 2-7, Alternative 1 – central portion looking west

Table 5: Pond Site Risk Rating Summary			
Basin	Pond Site	Risk Rating	Comments
2-7	Alt 1	Low	<p>Current Land Use: During the site reconnaissance, Pond 2-7, Alternative 1 was observed as woods. Two steel 55-gallon drums, wooden boards, and metal shelves were observed in the east central area of the pond site. Surrounding properties in the vicinity of the pond site include Damron Auto Salvage to the north; and woods to the south, east, and west.</p> <p>Contamination Concern(s): <i>Damron Auto Salvage/LKQ, located approximately 60 feet north of Pond 2-7, Alternative 1</i> – During the site reconnaissance, this facility was observed as an active automotive salvage yard. This listing was identified as Site 15 in the 2009 PD&E report and was assigned a risk rating of Low. The 2009 PD&E noted this facility as an automotive salvage yard that maintained a 500-gallon non-regulated diesel fuel AST and was identified as a registered small quantity generator (SQG) of hazardous waste with no violations reported. Currently, this facility maintains two 500-gallon unleaded gasoline ASTs. One diesel fuel discharge was reported on August 9, 2016 and was granted No Further Action (NFA) status on October 6, 2016. No current contamination concerns are reported. Therefore, this facility is not considered a contamination concern to Pond 2-7, Alternative 1.</p> <p><i>Empty drums, located in east central area of Pond 2-7, Alternative 1</i> – Two steel 55-gallon drums, wooden boards, and metal shelves were observed in the east central area of the pond site. A small amount of shotgun shells were observed near the area. The drums were rusted and empty with bullet holes visible. These discarded items did not appear to be used extensively for target practice such that spent bullets would be a concern. No unusual odors, stressed vegetation, soil staining, or other indications of contamination were noted. This site is not considered a contamination concern to Pond 2-7, Alternative 1.</p> <p>Risk rating: No contamination concerns were identified, therefore Pond 2-7, Alternative 1 is assigned a risk rating of Low.</p>

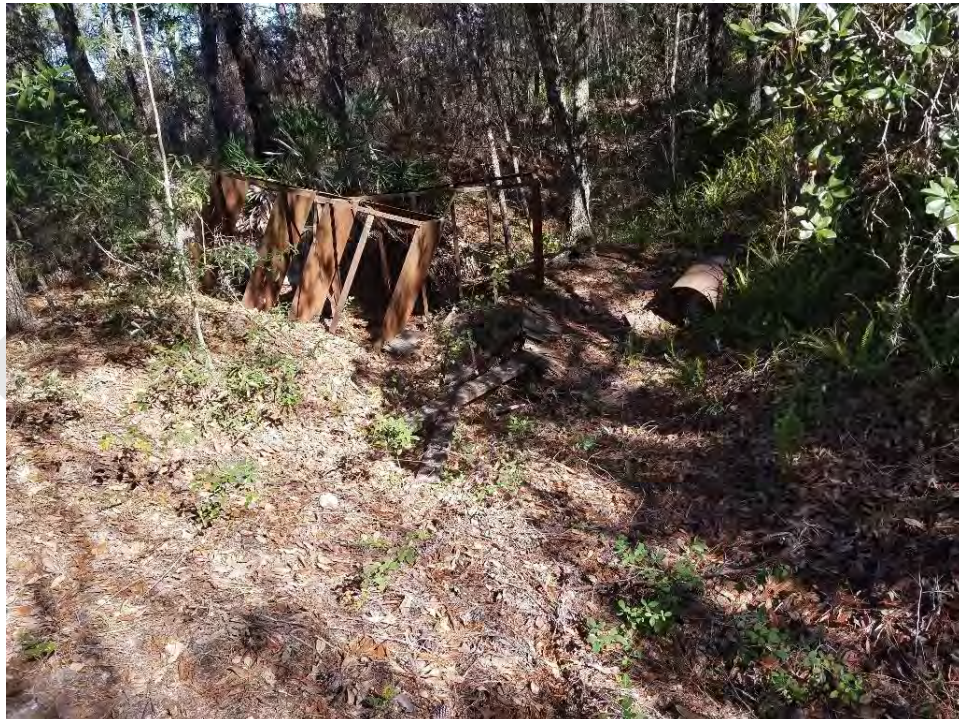
A residential shooting range was discovered near Pond 2-6, Alt 3 and empty drums were found onsite at Pond 2-7, Alt 1 during the site reconnaissance. Details about these sites are included in **Section 8.1**. The site reconnaissance in conjunction with the review of historical aerial photography, regulatory database searches, and review/evaluation of available data allows the site to be rated as to the degree of contamination concern as discussed in **Section 4.4**.

Pond 2-7, Alternative 1 – two empty 55-gallon drums and metal shelves located in the central area of the pond site

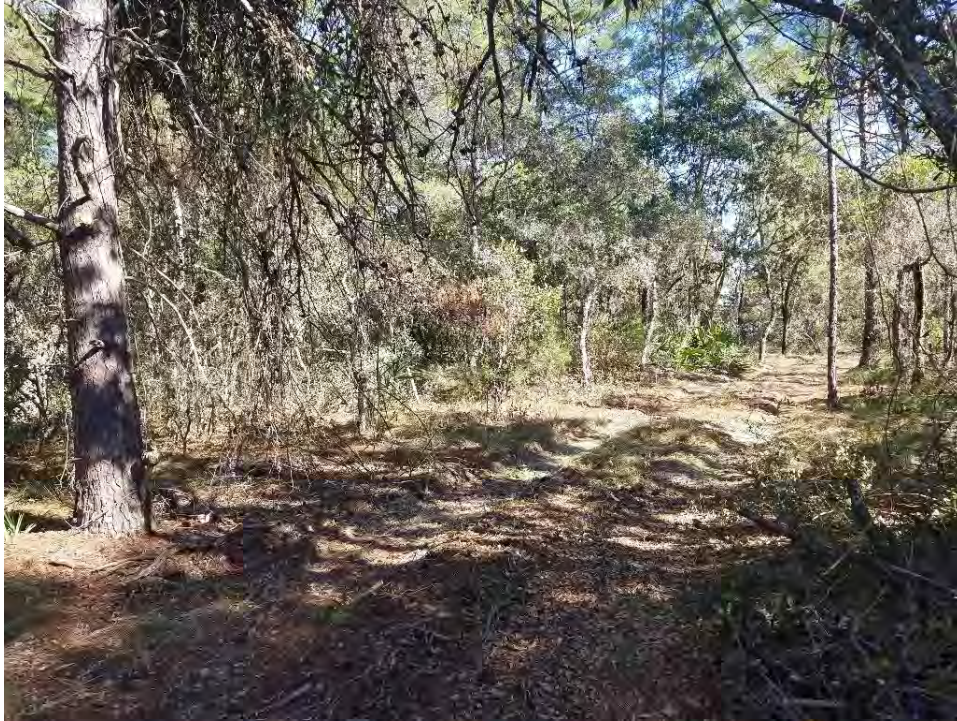
Pond 2-7, Alternative 2 (north portion) – central area looking east

Alt 2	Low	<p>Current Land Use: During the site reconnaissance, Pond 2-7, Alternative 2 was observed as woods with an area of overgrown field at the south end of the pond site. No obvious signs of fuel storage tanks, hazardous materials, buried debris, or other contamination concerns were noted. Surrounding properties in the vicinity of the pond site include Damron Auto Salvage to the north; and woods to the south, east, and west.</p> <p>Contamination Concern(s): <i>Citrus Sand and Debris, Inc., 1590 North Quarterback Terrace, located approximately 180 feet west of Pond 2-7, Alternative 2</i> – During the site reconnaissance, this facility was observed as an inactive open pit sand mine. This listing was identified as Site 17 in the 2009 PD&E report and was assigned a risk rating of Low. The 2009 PD&E identified this facility as an open pit sand mining operation. No regulatory information was provided during the 2009 evaluation. Three closed landfill cells are located in the southeast portion of the property. The landfill cells were permitted to receive Construction and Demolition (C&D) waste, yard trash, tires, asbestos, carpet, glass, plastic, and furniture. The most recent analytical data included in the 1st Semi-annual Water Quality Monitoring report dated July 10, 2019 indicates that concentrations of arsenic above the Groundwater Cleanup Target Level (GCTL) were detected in one monitoring well (MW-7R), dissolved iron concentrations were detected above GCTLs in three monitoring wells (MW-4R, MW-5R, MW-7R), and concentrations of nitrogen ammonia above GCTLs were detected in one monitoring well (MW-4R). The dissolved iron concentrations are presumed to be naturally occurring aquifer constituents based on historical sampling data. The nearest contaminated monitoring well is located approximately 800 feet southwest of Pond 2-7, Alternative 2. Groundwater flow direction was measured to the southwest (away from Pond 2-7, Alternative 2). Additionally, two 1,000-gallon ASTs were formerly maintained onsite (one removed in 2012, one removed at an unknown date). No location information was found. No discharges are reported. Although GCTL exceedances were detected onsite during the most recent sampling event, due to the separation distance from the pond site (800 feet), this facility is not considered a contamination concern to Pond 2-7, Alternative 2.</p> <p><i>Mars LLC, 1959 North Iron Point Road, located adjacent east of the northern portion of Pond 2-7, Alternative 2</i> – During the site reconnaissance, this facility was observed as warehouses with numerous tenants including Keep it Safe Storage & Moving and Penske Truck Rental. This site was registered as a SQG on July 14, 2008. The facility was closed on May 28, 2009 and is no longer regulated. No discharges or other contamination concerns were reported. This site is not considered a contamination concern to Pond 2-7, Alternative 2.</p> <p>Risk rating: No contamination concerns were identified, therefore Pond 2-7, Alternative 2 is assigned a risk rating of Low.</p>

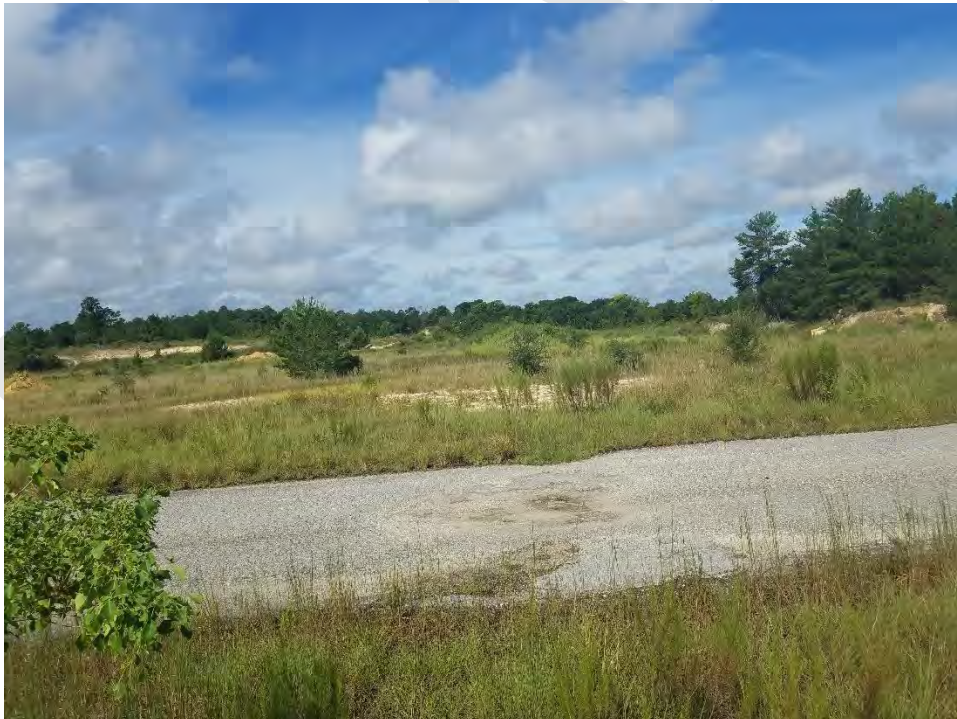
Pond 2-7, Alternative 3 – central area looking west

Alt 3	Low	<p>Current Land Use: During the site reconnaissance, Pond 2-7, Alternative 3 was observed as part of an inactive open pit sand mine. Woods were noted in the northwest area of the pond site and soil stockpiles were observed sporadically throughout the western portion of the pond site. No obvious signs of fuel storage tanks, hazardous materials, buried debris, or other contamination concerns were noted. Surrounding properties in the vicinity of the pond site include CR 486 to the north; and an inactive sand mine to the south, east, and west.</p> <p>Contamination Concern(s): <i>Citrus Sand and Debris, Inc., 1590 North Quarterback Terrace, located within the boundaries of Pond 2-7, Alternative 3</i> – During the site reconnaissance, this facility was observed as an inactive open pit sand mine. This listing was identified as Site 17 in the 2009 PD&E report and was assigned a risk rating of Low. The 2009 PD&E identified this facility as an open pit sand mining operation. No regulatory information was provided during the 2009 evaluation. Three closed landfill cells are located in the southeast portion of the property. The landfill cells were permitted to receive C&D waste, yard trash, tires, asbestos, carpet, glass, plastic, and furniture. The most recent analytical data included in the 1st Semi-annual Water Quality Monitoring report dated July 10, 2019 indicates that concentrations of arsenic above the GCTL were detected in one monitoring well (MW-7R), dissolved iron concentrations were detected above GCTLs in three monitoring wells (MW-4R, MW-5R, MW-7R), and concentrations of nitrogen ammonia above GCTLs were detected in one monitoring well (MW-4R). The dissolved iron concentrations are presumed to be naturally occurring aquifer constituents based on historical sampling data. The nearest contaminated monitoring well is located approximately 1,400 feet south of Pond 2-7, Alternative 3. Groundwater flow direction was measured to the southwest (away from Pond 2-7, Alternative 3). Additionally, two 1,000-gallon ASTs were formerly maintained onsite (one removed in 2012, one removed at an unknown date). No location information was found. No discharges are reported. Although GCTL exceedances were detected onsite during the most recent sampling event, due to the separation distance from the pond site (1,400 feet), this facility is not considered a contamination concern to Pond 2-7, Alternative 3.</p> <p>Risk rating: No contamination concerns were identified, therefore Pond 2-7, Alternative 3 is assigned a risk rating of Low.</p>

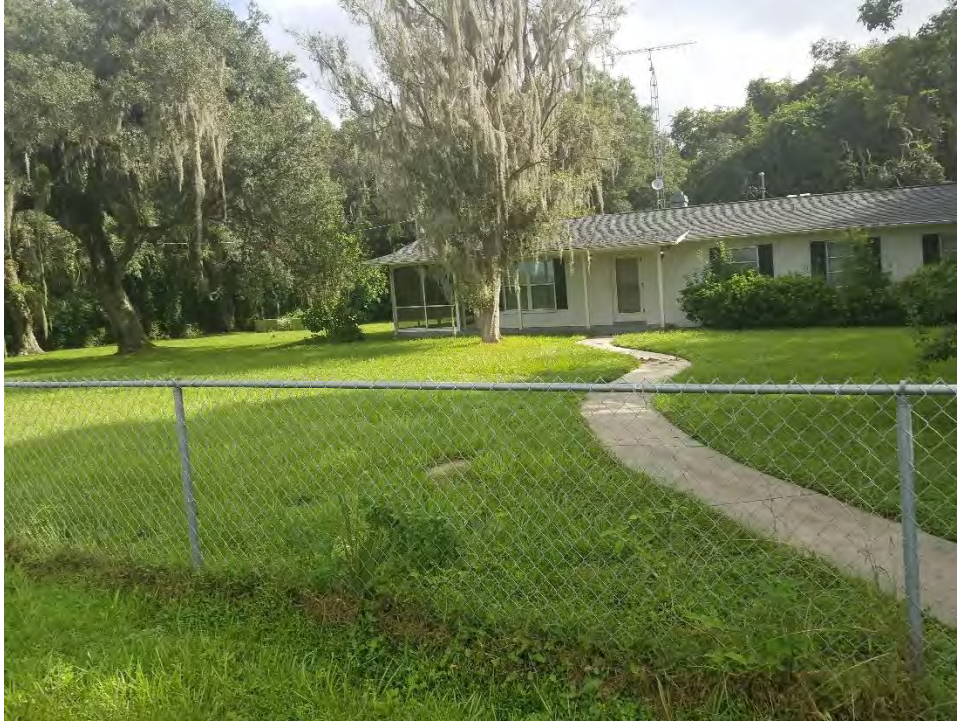
DRA-E – offsite looking north toward west portion of pond site.

Table 5: Pond Site Risk Rating Summary			
Basin	Pond Site	Risk Rating	Comments
2-5	DRA-E	Low	<p>Current Land Use: During the site reconnaissance, DRA-E was observed as woods with a residence onsite in the western area. No obvious signs of fuel storage tanks, hazardous materials, buried debris, or other contamination concerns were noted. Surrounding properties in the vicinity of the pond site include woods to the north, east, and west; and SR 44 to the south.</p> <p>Contamination Concern(s): No contamination sites/facilities that would be expected to impact the project were noted within or in close proximity to the pond site boundaries.</p> <p>Risk rating: No contamination concerns were identified, therefore DRA-E is assigned a risk rating of Low.</p>
2-6	Alt 1	Low	<p>Current Land Use: During the site reconnaissance, Pond 2-6, Alternative 1 was observed as open excavations with soil stockpiles throughout. The excavations and stockpiles onsite do not appear to be associated with the former mining operations located offsite, adjacent east. No obvious signs of fuel storage tanks, hazardous materials, buried debris, or other contamination concerns were noted. Surrounding properties in the vicinity of the pond site include woods to the north and west; a former limerock mine to the east; and open field followed by Providence Baptist Church to the south.</p> <p>Contamination Concern(s): Former Limerock Mine, 1150 North Maylen Avenue, located offsite, adjoining east of Pond 2-6, Alternative 1 – during the site reconnaissance, this site was observed as an inactive limerock mine with vegetation growing in the remaining open excavation pits. This facility was identified as Site 33 in the 2009 PD&E report and was assigned a risk rating of No. The 2009 PD&E noted a large excavated area with overgrown vegetation throughout. No contamination concerns were observed in 2009 or during the site reconnaissance conducted on December 4, 2019. Documents found on the USGS Mineral Resource database indicates that this facility formerly operated as a limerock mining facility known as Carroll’s Lecanto Pit (AKA Lecanto Materials Co.). No further information is available on the USGS online database. An email was sent to FDEP’s Public Records department requesting additional information about this site. No response was received as of the writing of this report. See email and USGS excerpts in CSER Appendix F. This facility is not considered a contamination concern to Pond 2-6, Alternative 1.</p> <p>Risk rating: No contamination concerns were identified, therefore Pond 2-6, Alternative 1 is assigned a risk rating of Low.</p>

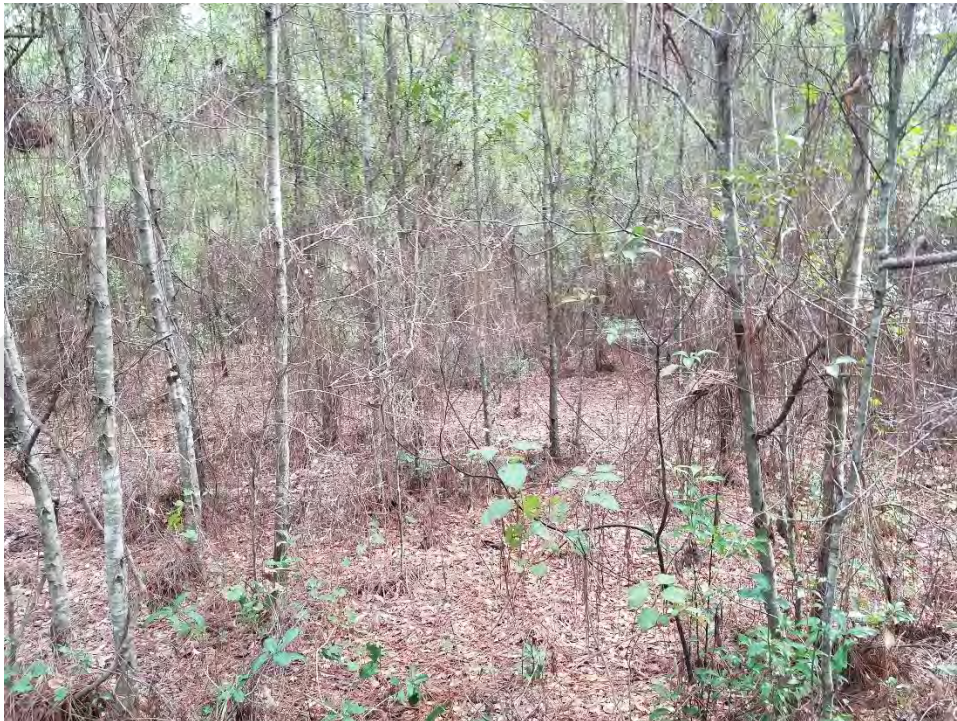
DRA-E – southeastern portion of the pond site looking north
