# **Level I Contamination Screening Evaluation Report (Mainline)**

**Florida's Turnpike Enterprise**

**Central Polk Parkway  
Project Development and Environment Study**

**From US 17 (SR 35) to SR 60  
New Alignment Project  
Polk County, Florida**

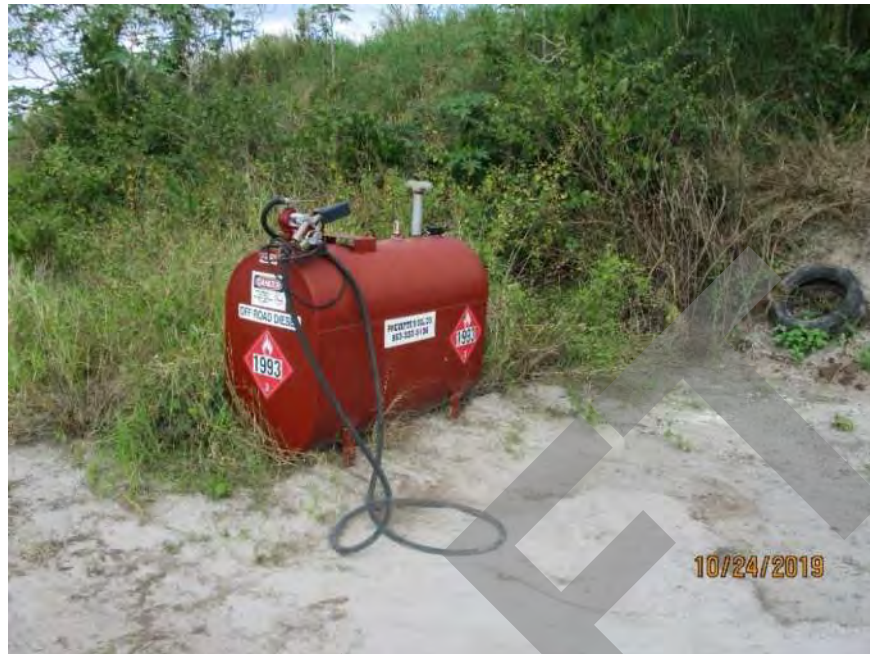
**Site 4 - Earth Materials Mining, Inc. – Tice Mine**  
**500-gallon diesel AST with stained soil located in the central area of this site;**  
**southeast of AST looking northwest**

Table 2: Mainline Potential Contamination Sites Summary						
Site Number (EDM ID)	Site Name & Address	Database/ Facility ID	Approximate Distance From Alt 4 ROW	Contaminants of Concern	Risk Rating	Comments
4	Earth Materials Mining, Inc. – Tice Mine / Geo Mining, Inc. 477 N. 91 Mine Rd.	Mine ID: MMR_223348 Mine ID: MMR_ZW700	Within ROW	pH, PAHs, Radium 226, petroleum	Medium	<p>During the site reconnaissance, this facility was observed as an active sand mine which also accepts concrete and asphalt for fill materials. Mined areas are illustrated in <b>CSER Appendix A, Sheet A-3</b>. Within the Alt 4 ROW, the mine was excavated approximately 8 to 12 feet below land surface. Concrete, asphalt and red brick were piled in the north and south-central areas. The southern area was primarily filled with piles of mulch. Signage at the entrance states “Fill Dirt Available also accepting concrete and asphalt.” Based on site observations, landfill activities were not noted. The materials appear to be stored at this location for resale or reuse. One 500-gallon diesel Aboveground Storage Tank (AST) was observed on bare soil in the east-central area (coordinates 27.916354, 81.797160 WGS_1984), along the south side of the paved entrance. The AST and stained soil appear to be located within and/or adjacent to the Alt 4 ROW. A 10 foot by 5 foot area of petroleum stained soil was observed on the east side of the AST. Approximately ten 5-gallon buckets of hydraulic oil, and one water AST were scattered within 100 feet west of the AST along the south side of the entrance.</p> <p>A site inspection report dated October 21, 1992 (found on OCULUS) stated this mine was used for clay and sand. A file note dated October 6, 1989 states this site was used for phosphate mining. The FDEP Mining database stated mining began in 1935 for clay.</p> <p>Phosphate mining may present additional contamination concerns such as low pH, Radium 226, and polynuclear aromatic hydrocarbons (PAHs). Depending on the mining and/or processing method (wet, dry, float and washer plant, etc.), other contaminants may be a concern. At least portions of this facility was used for phosphate mining. No graphics depicting the mine limits were found on the OCULUS database.</p> <p>Due to the petroleum stained soil east of the AST, and the historic use as a phosphate mine, this facility is assigned a risk rating of Medium.</p>

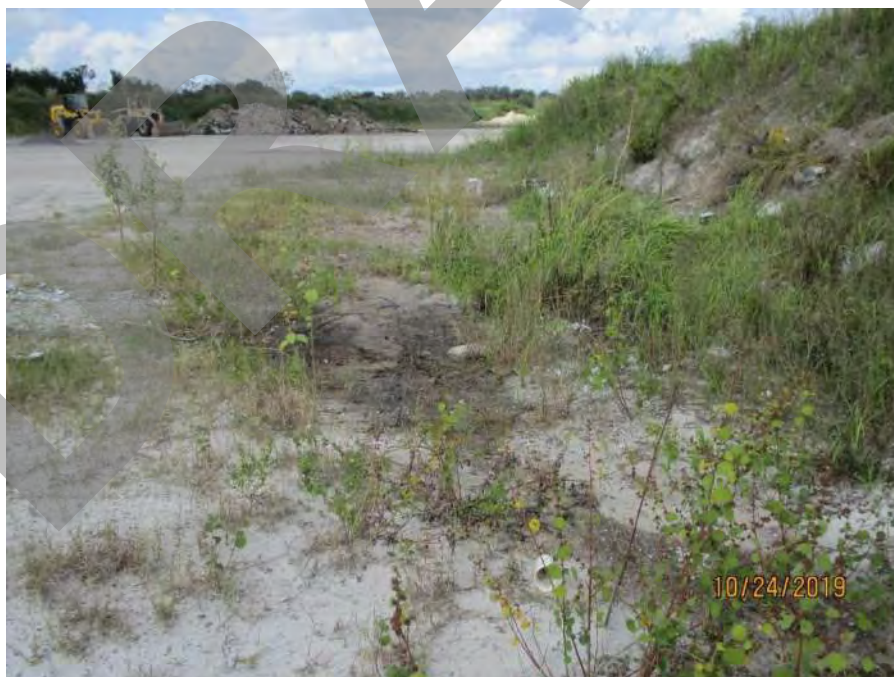
**Site 4 - Earth Materials Mining, Inc. – Tice Mine**  
**Petroleum stained soil located in the central area of this site;**  
**Approximately 20 feet west of AST in previous photo**

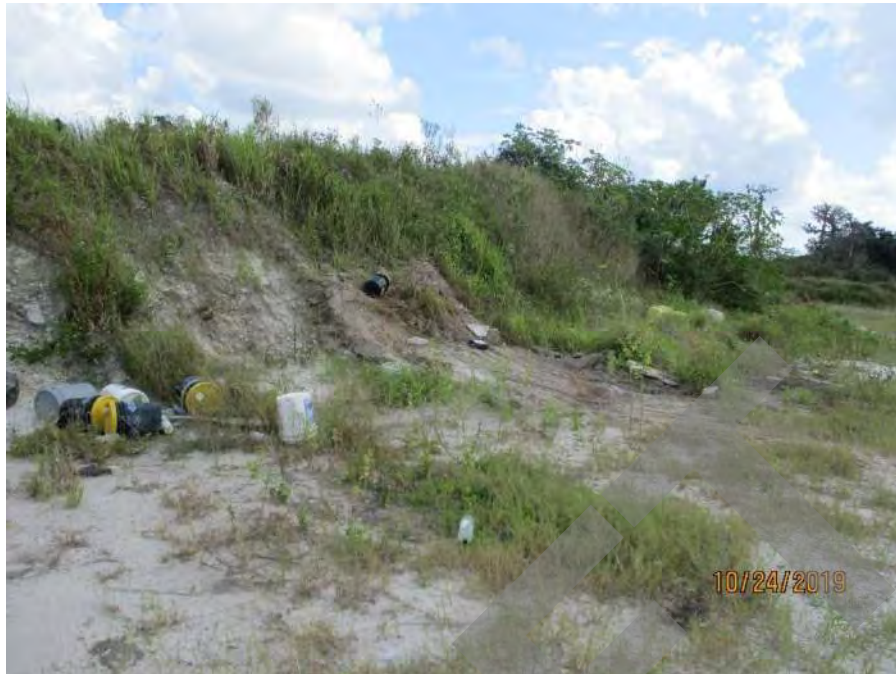
**Site 4 - Earth Materials Mining, Inc. – Tice Mine**  
**5-gallon hydraulic oil buckets in the central area of this site**  
**Southwest of buckets looking northeast**

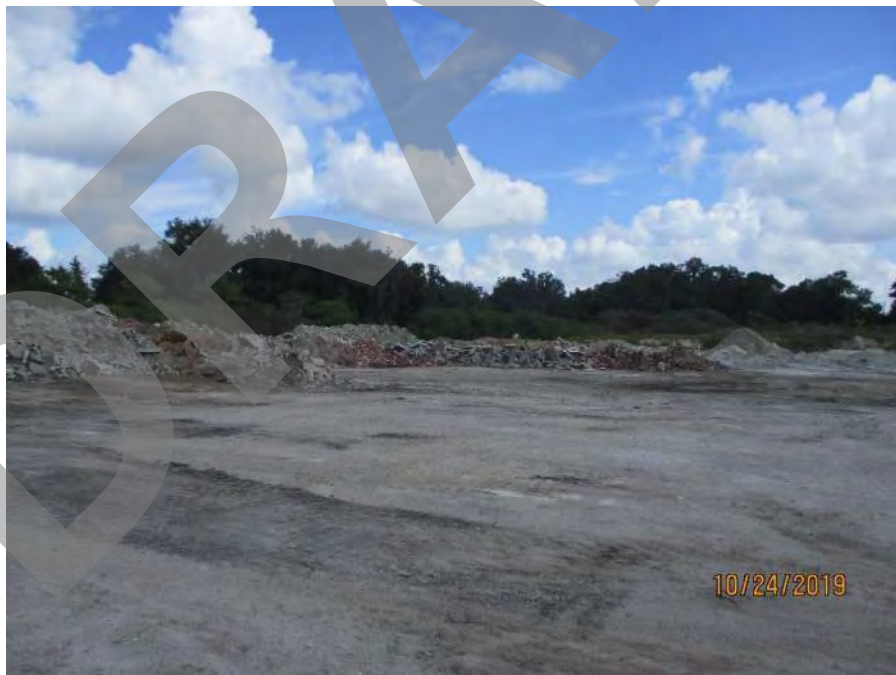
**Site 4 - Earth Materials Mining, Inc. – Tice Mine**  
**Concrete and brick rubble in the north-central area of this site looking northeast**

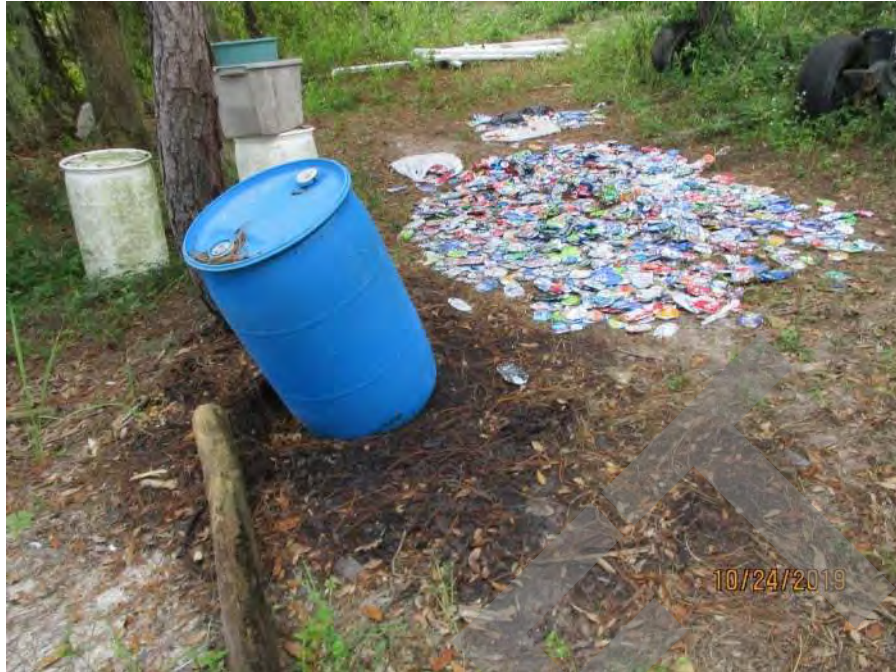
**Site 5 Former Groves – 55-gallon drum with soil stain  
located approximately 80 feet south of storage shed**

5	Former Groves 713-925 91 Mine Rd. (3 parcels)	NA	Within ROW	Used Oil for stained soil around 55-gallon drum; and Herbicides, pesticides, arsenic, and petroleum at former pole barn	Medium	<p>During site reconnaissance, this site was observed as primarily woods in the northern area, and overgrown fields in the central and southern areas. A mobile home was observed within and adjacent to the Alt 4 ROW. An equipment (vehicle and heavy equipment) storage area was located on the north side of the mobile home on concrete. A wooden shed (8 feet by 6 feet) with a wood floor was located west of the mobile home. Household items, tools and small containers (2-gallon containers and smaller) of paints and lubricants were noted inside the shed. Aerial photographs initially depict the mobile home in 2007. During the site visit, a resident stated the septic tank/drainfield was located along the west side of the mobile home.</p> <p>A shed was added approximately 300 feet northwest of the mobile home in 2010. Based on the contents, the shed appeared to have been used as a residence and storage building. One mobile AST (approximately 1,000-gallons, presumably herbicide/pesticide) was stored on the west side of the shed. Visibility and access was limited by overgrowth. One 55-gallon drum with stained soil (coordinates 27.920324, 81.797790 WGS_1984) was observed approximately 80 feet south of the shed. The stained soil appeared to be used oil, and was approximately 8 feet by 8 feet (64 square feet) in size. Abandoned equipment, including vehicle parts, metal and wood debris was scattered around the area.</p> <p>Groves were identified on both the topographic maps, and historical aerial photographs from at least 1941 to 2016. Agricultural land uses such as citrus groves/row crops can be associated with contamination from residual pesticides, herbicides, heavy metals, and petroleum contaminants in the soil and/or groundwater. The potential for contamination is more concentrated in the mix/load areas, storage/maintenance facilities (i.e. pole barns, equipment maintenance shops, etc.), and at diesel-powered irrigation pumps. Agricultural uses of organic and inorganic pesticides and herbicides are exempt from most RCRA provisions, provided that the farmers apply the chemicals on their own farms and in accordance with labeled instructions. Spills, improper application, too much application and application of disallowed pesticides are not exempted from these requirements. Historic aerial photographs (1980s and 1990s) depict one structure located within the Alt 4 ROW (western edge of grove). Tierra presumes this structure was a pole barn used to store/mix agrichemicals and maintain equipment associated with the grove. The pole barn was gone by 2004. One irrigation well was observed approximately 30 feet east of the Alt 4 ROW.</p> <p>Based on the petroleum stained soil observed around a 55-gallon drum of used oil (northwest of mobile home), and a former pole barn (southwest of mobile home) used to support a grove, both located within the Alt 4 ROW, this site is assigned a risk rating of Medium.</p>

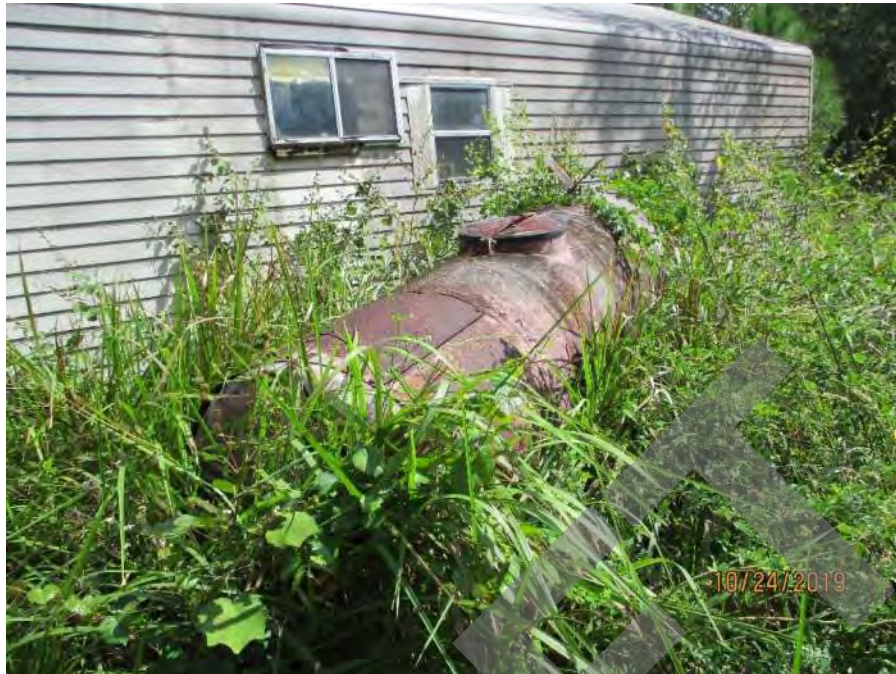
**Site 5 Former Groves**  
**Possible herbicide/pesticide AST**  
**East side of shed looking south**

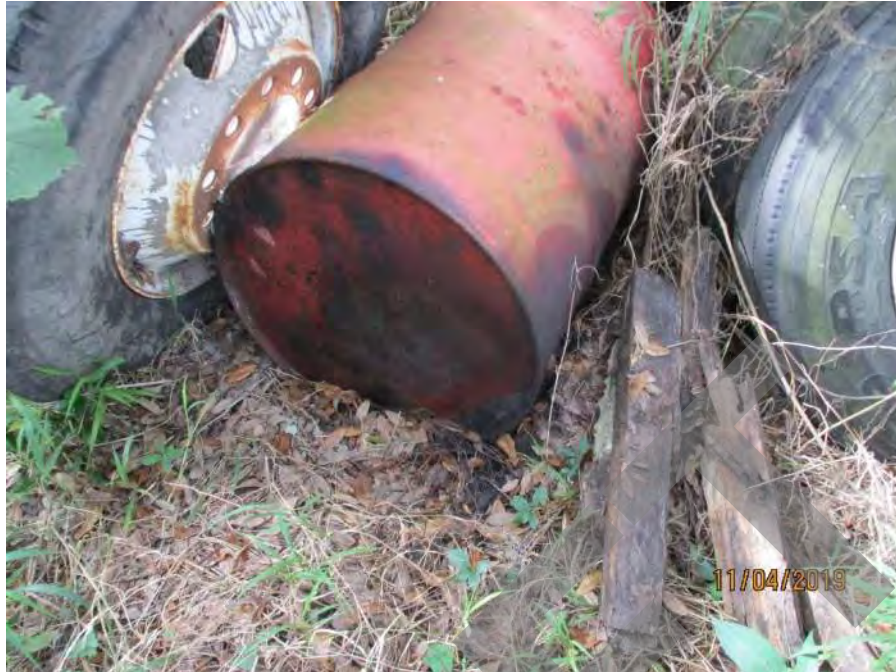
**Site 7 – Equipment Storage**  
**55-gallon drum with stained soil in central area**

7	<b>Equipment Storage</b> 925 91 Mine Rd.	NA	Within ROW	Petroleum, automotive/heavy equipment fluids	Medium	<p>During site reconnaissance, this site was observed as woods with several clearings. Approximately 20 pieces of heavy equipment were observed scattered in the clearings and in the woods. Tree services labels were observed on several trucks. Cut trees were scattered on the north side of the clearing. One tanker truck was labeled “jet fuel” (uncertain if empty or with contents) was observed. Approximately 20 five-gallon buckets labeled mostly as hydraulic oil (some empty, some with contents) were scattered about the area, some on bare soil. One rusted 55-gallon drum (coordinates 27.922548, 81.797636 WGS_1984) was observed with stained soil (approximately 2 square feet in size). The soil stain appeared to be used oil. Based on the stained soil and poor house-keeping practices, this site is assigned a risk rating of Medium.</p>

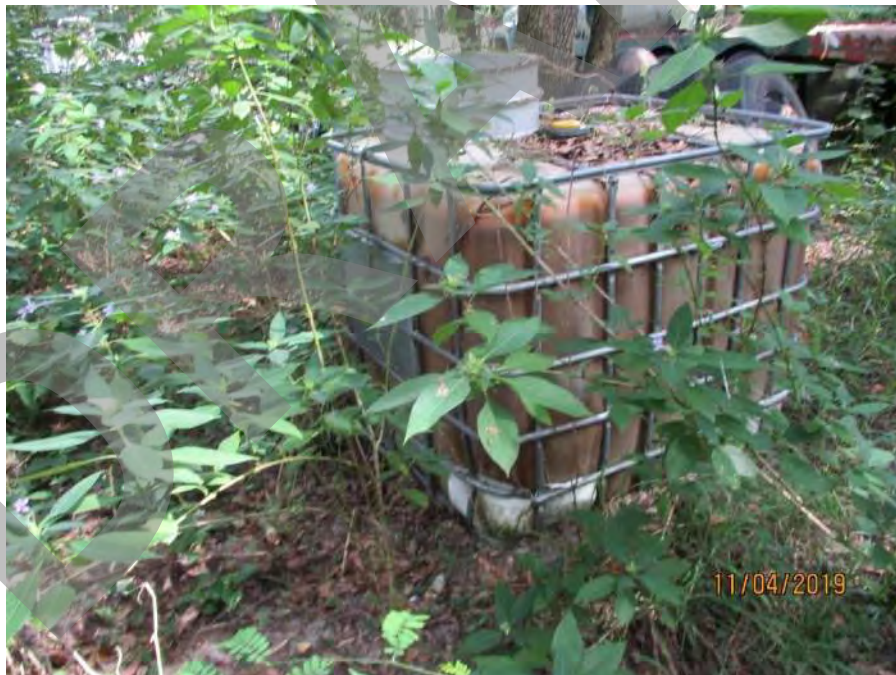
**Site 7 – Equipment Storage**  
**Waste oil tote located in southwest area of this site**

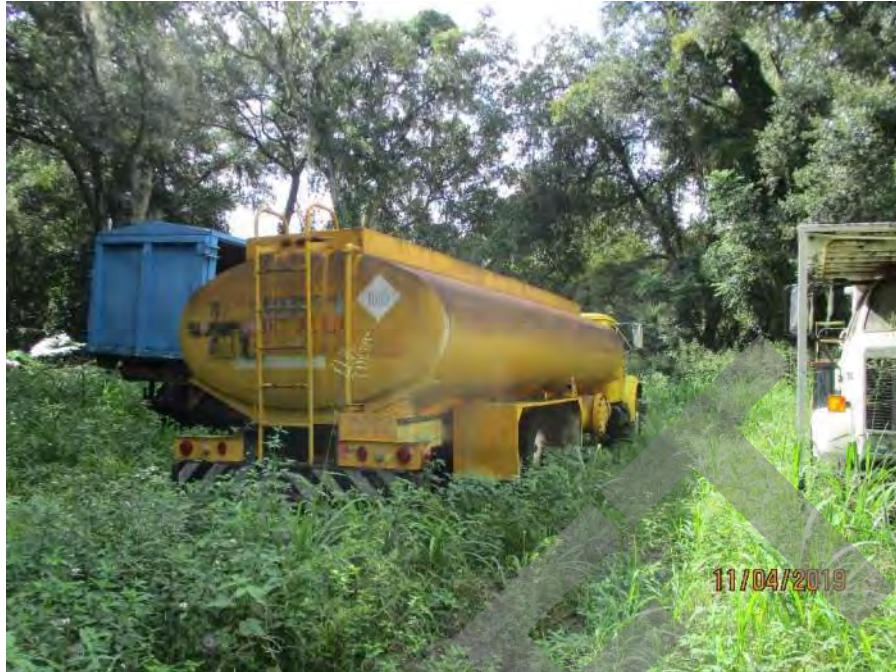
**Site 7 – Equipment Storage**  
**Tanker truck with “jet fuel” label located in southwest area of this site**

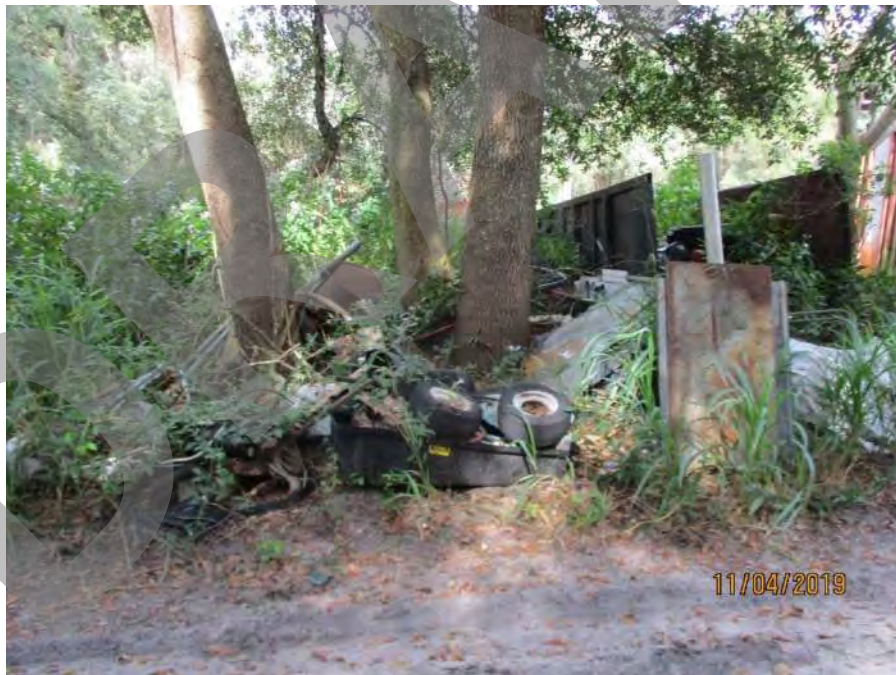
**Site 7 – Equipment Storage**  
**Metal, wood and tire debris located in southwest area of this site**

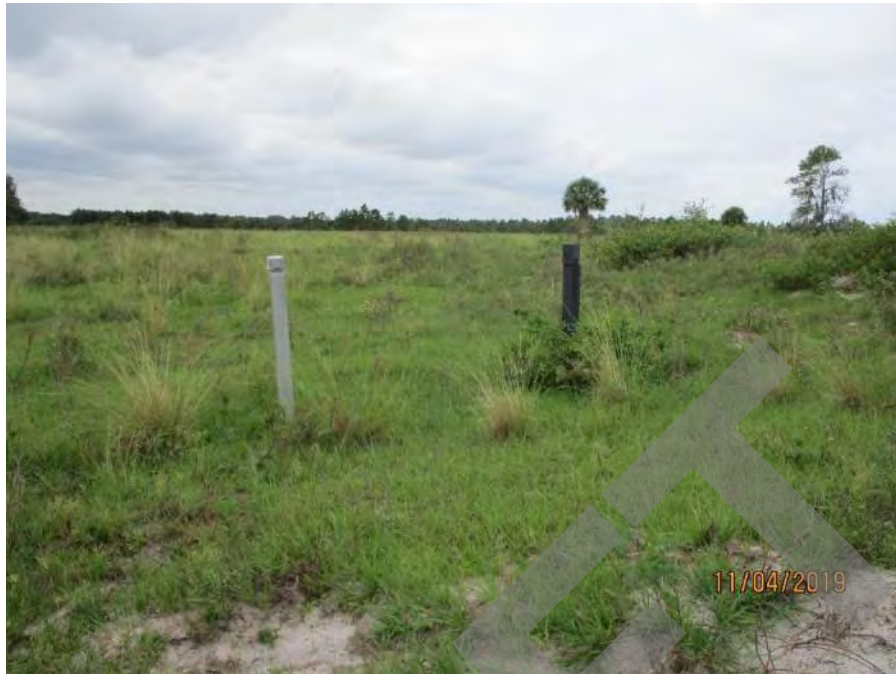
**Site 8 – Clear Springs Mine (Former IMC Agrico)**  
**Two piezometers in north-central area**

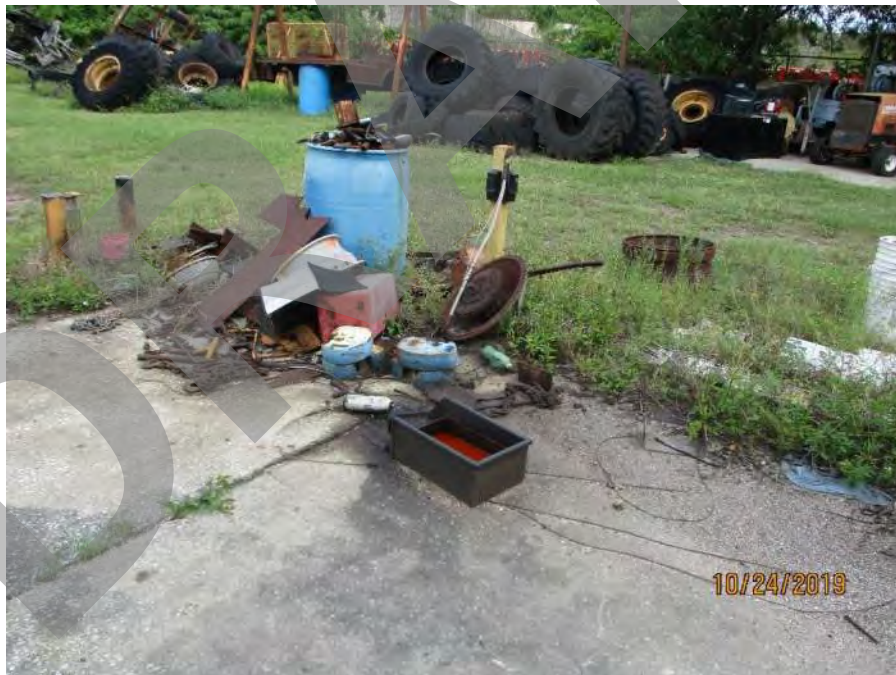
**Site 11 Tyre Equipment**  
**Northeast corner of shop looking northeast stained concrete and soil**

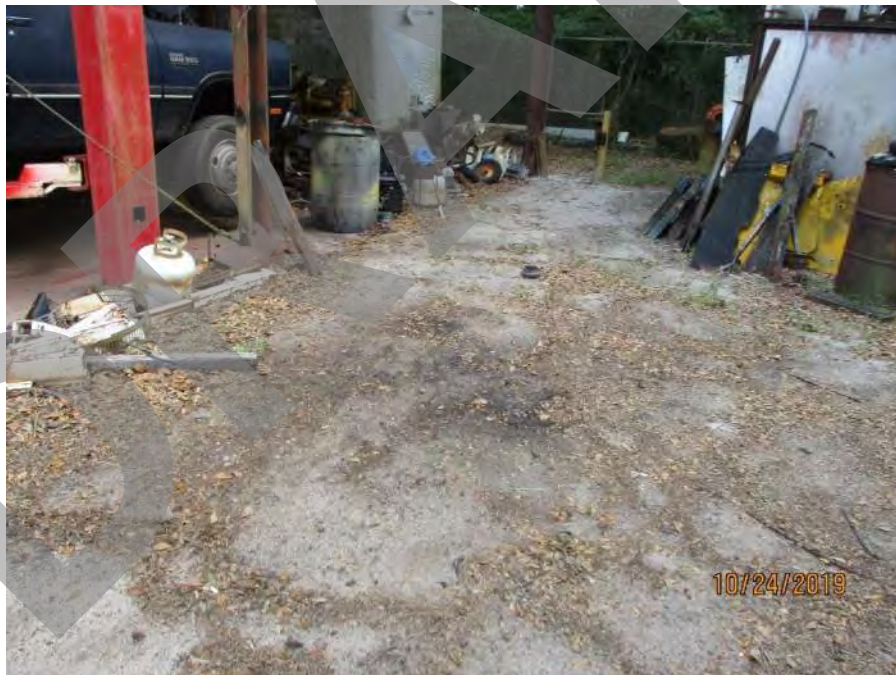
**Site 11 Tyre Equipment**  
**Stained soil southwest corner of shop**

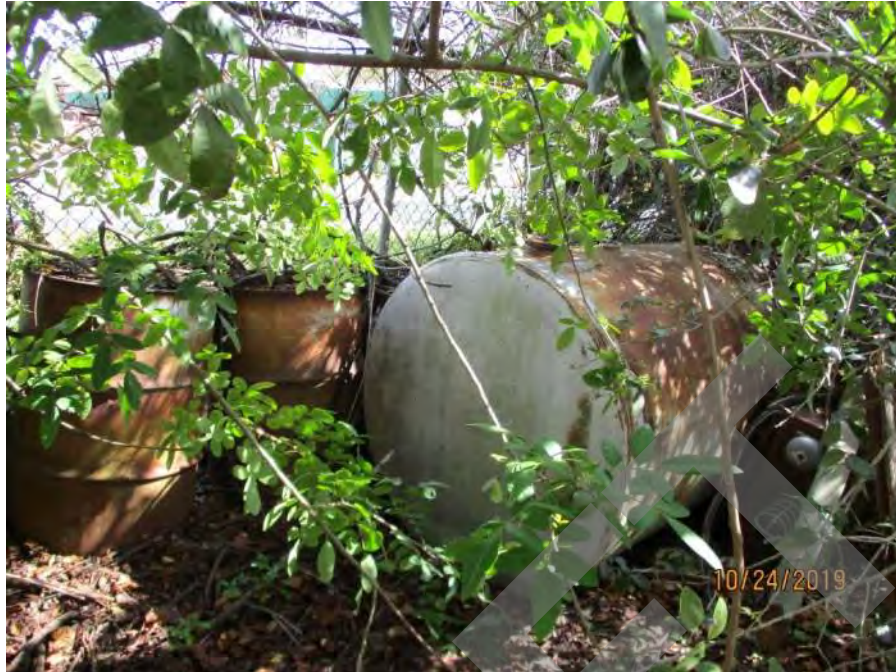
**Site 11 Tyre Equipment**  
**AST and rusted 55-gallon drums located along east-central boundary,**  
**just south of the petroleum storage shed**

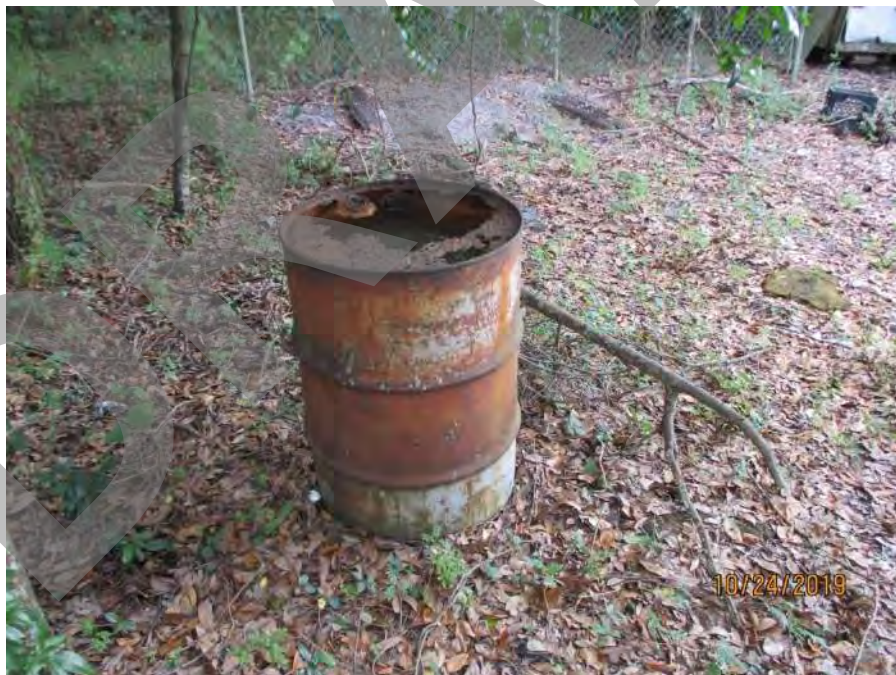
**Site 11 Tyre Equipment**  
**55-gallon drum southeast of shop looking northwest**
