POND SITING REPORT

CENTRAL POLK PARKWAY PD&E STUDY

**FROM US 17 (SR 35) TO SR 60
ROADWAY CONSTRUCTION PROJECT
FPID: 440897-4-22-01**

JANUARY 2021

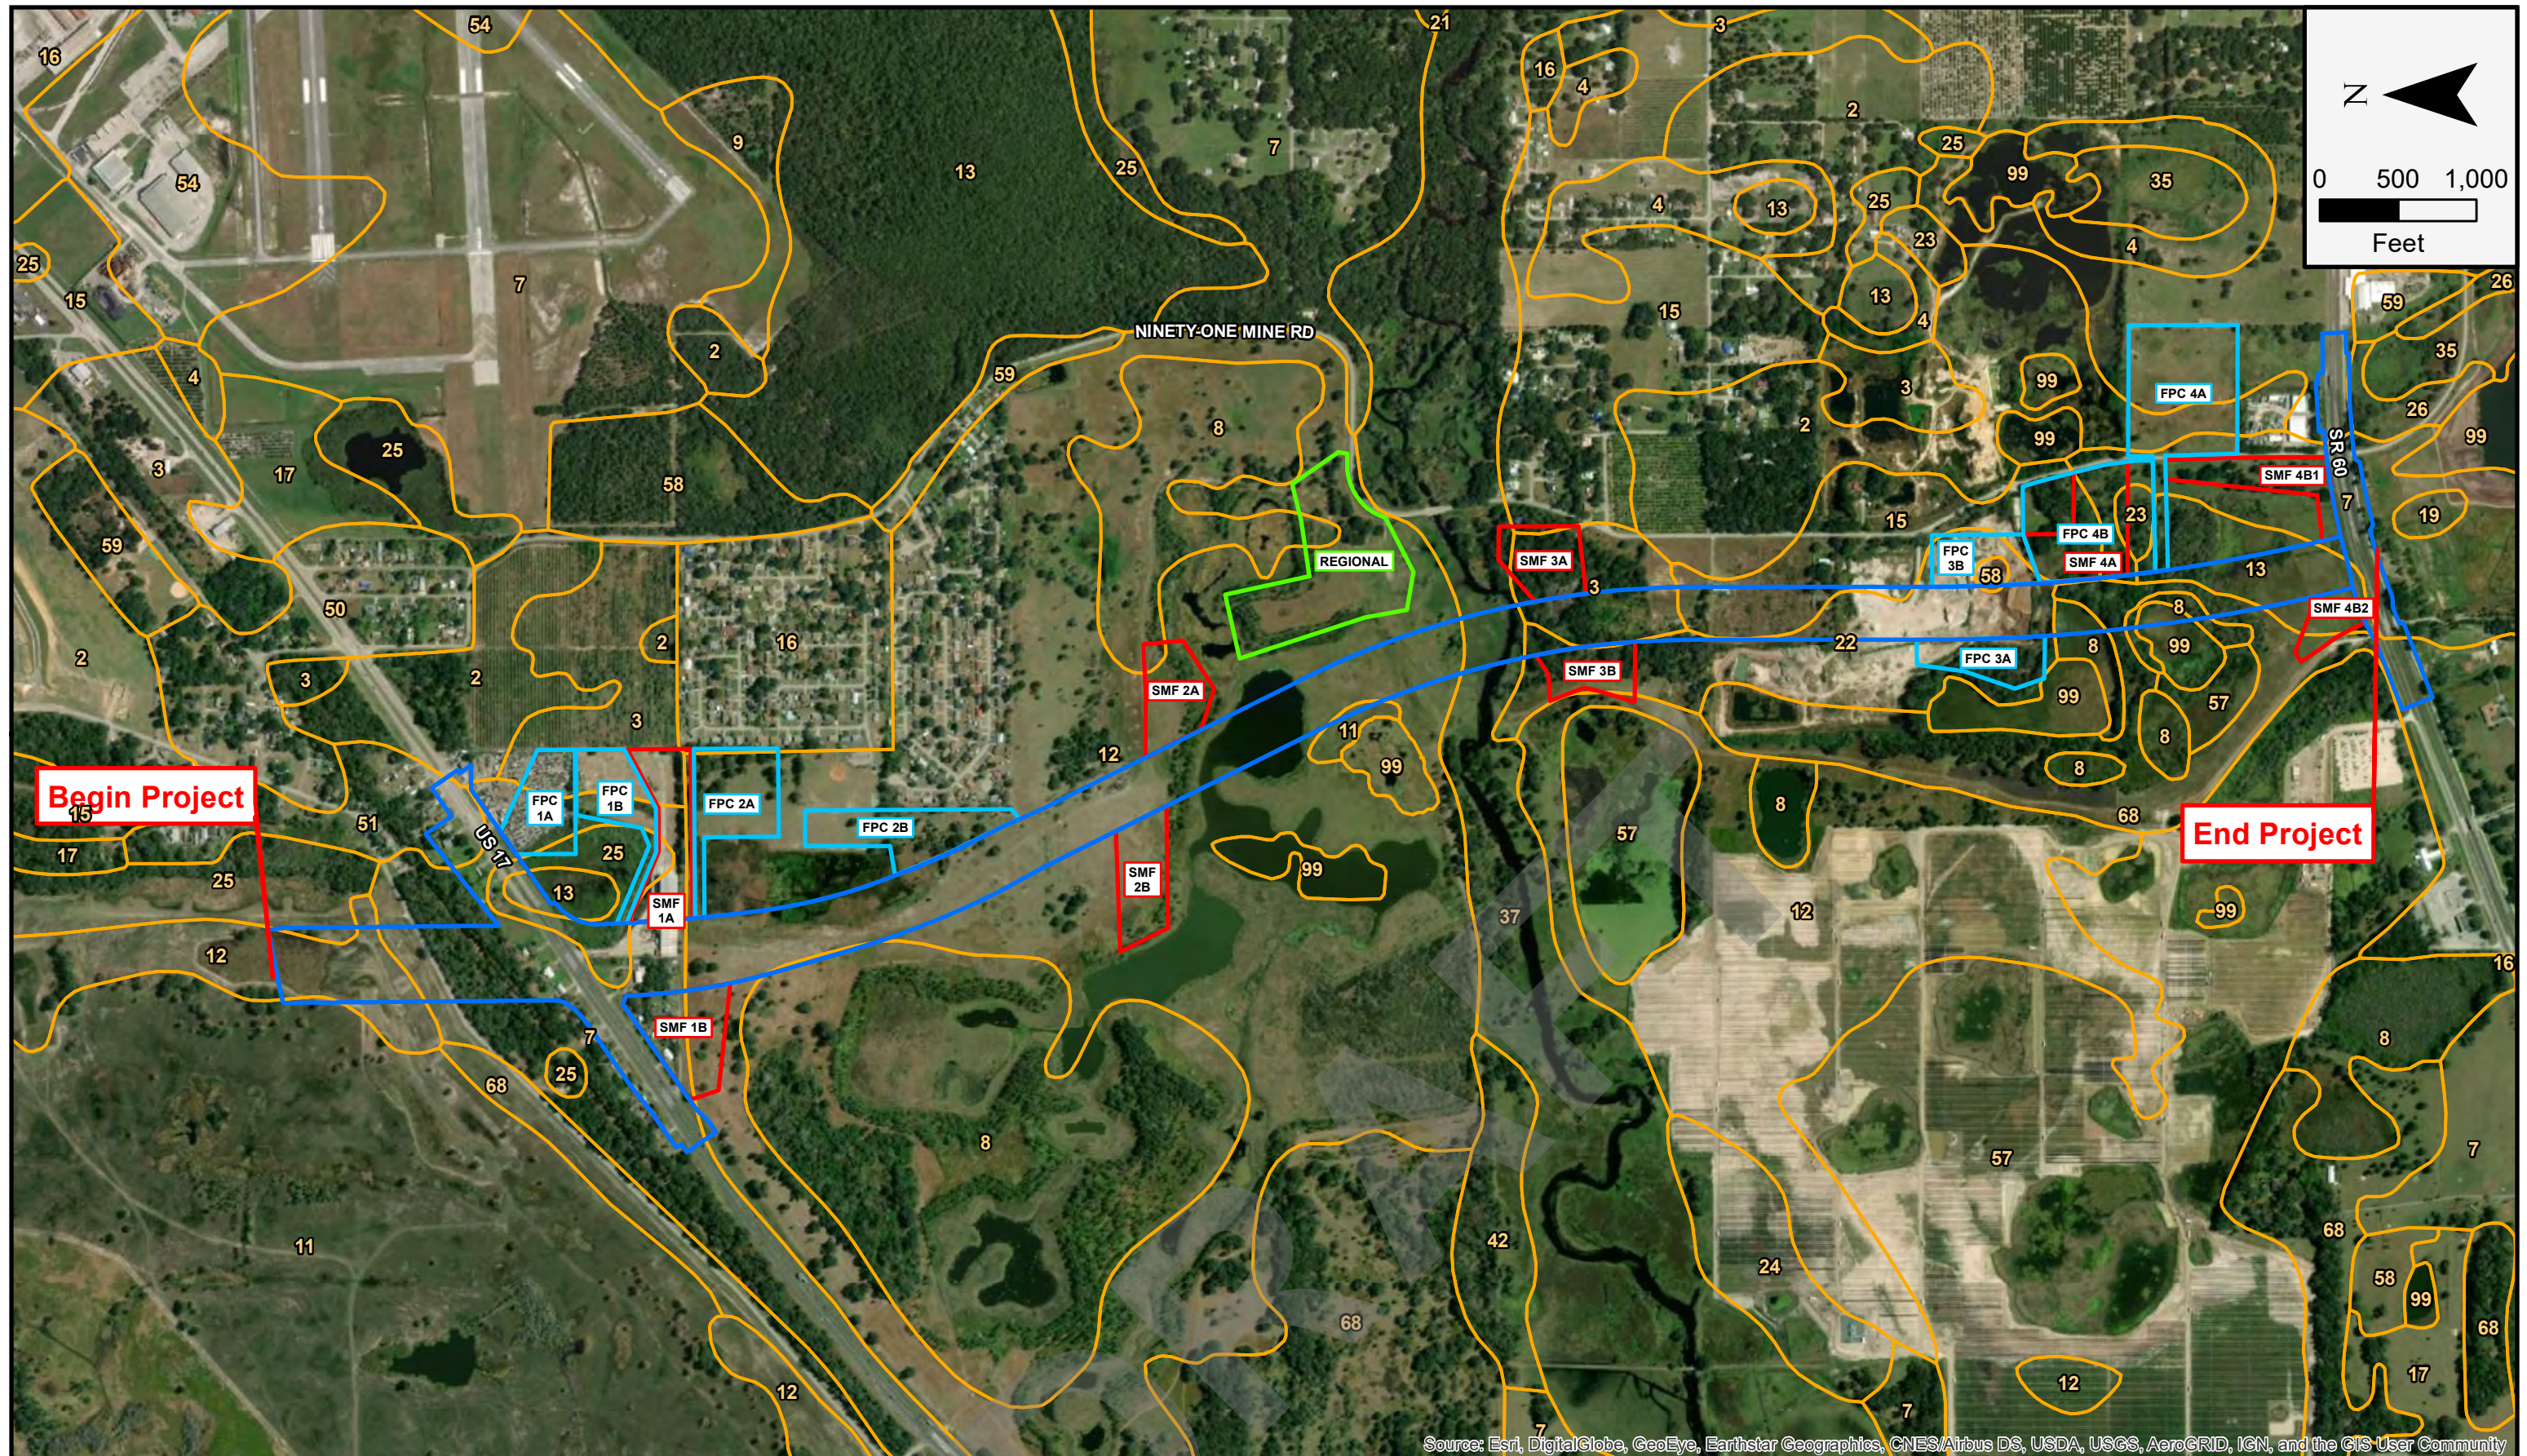
**Figure
3**

- Legend**
- Proposed ROW
 - FPC Site
 - Regional SMF
 - SMF Site
 - Soils

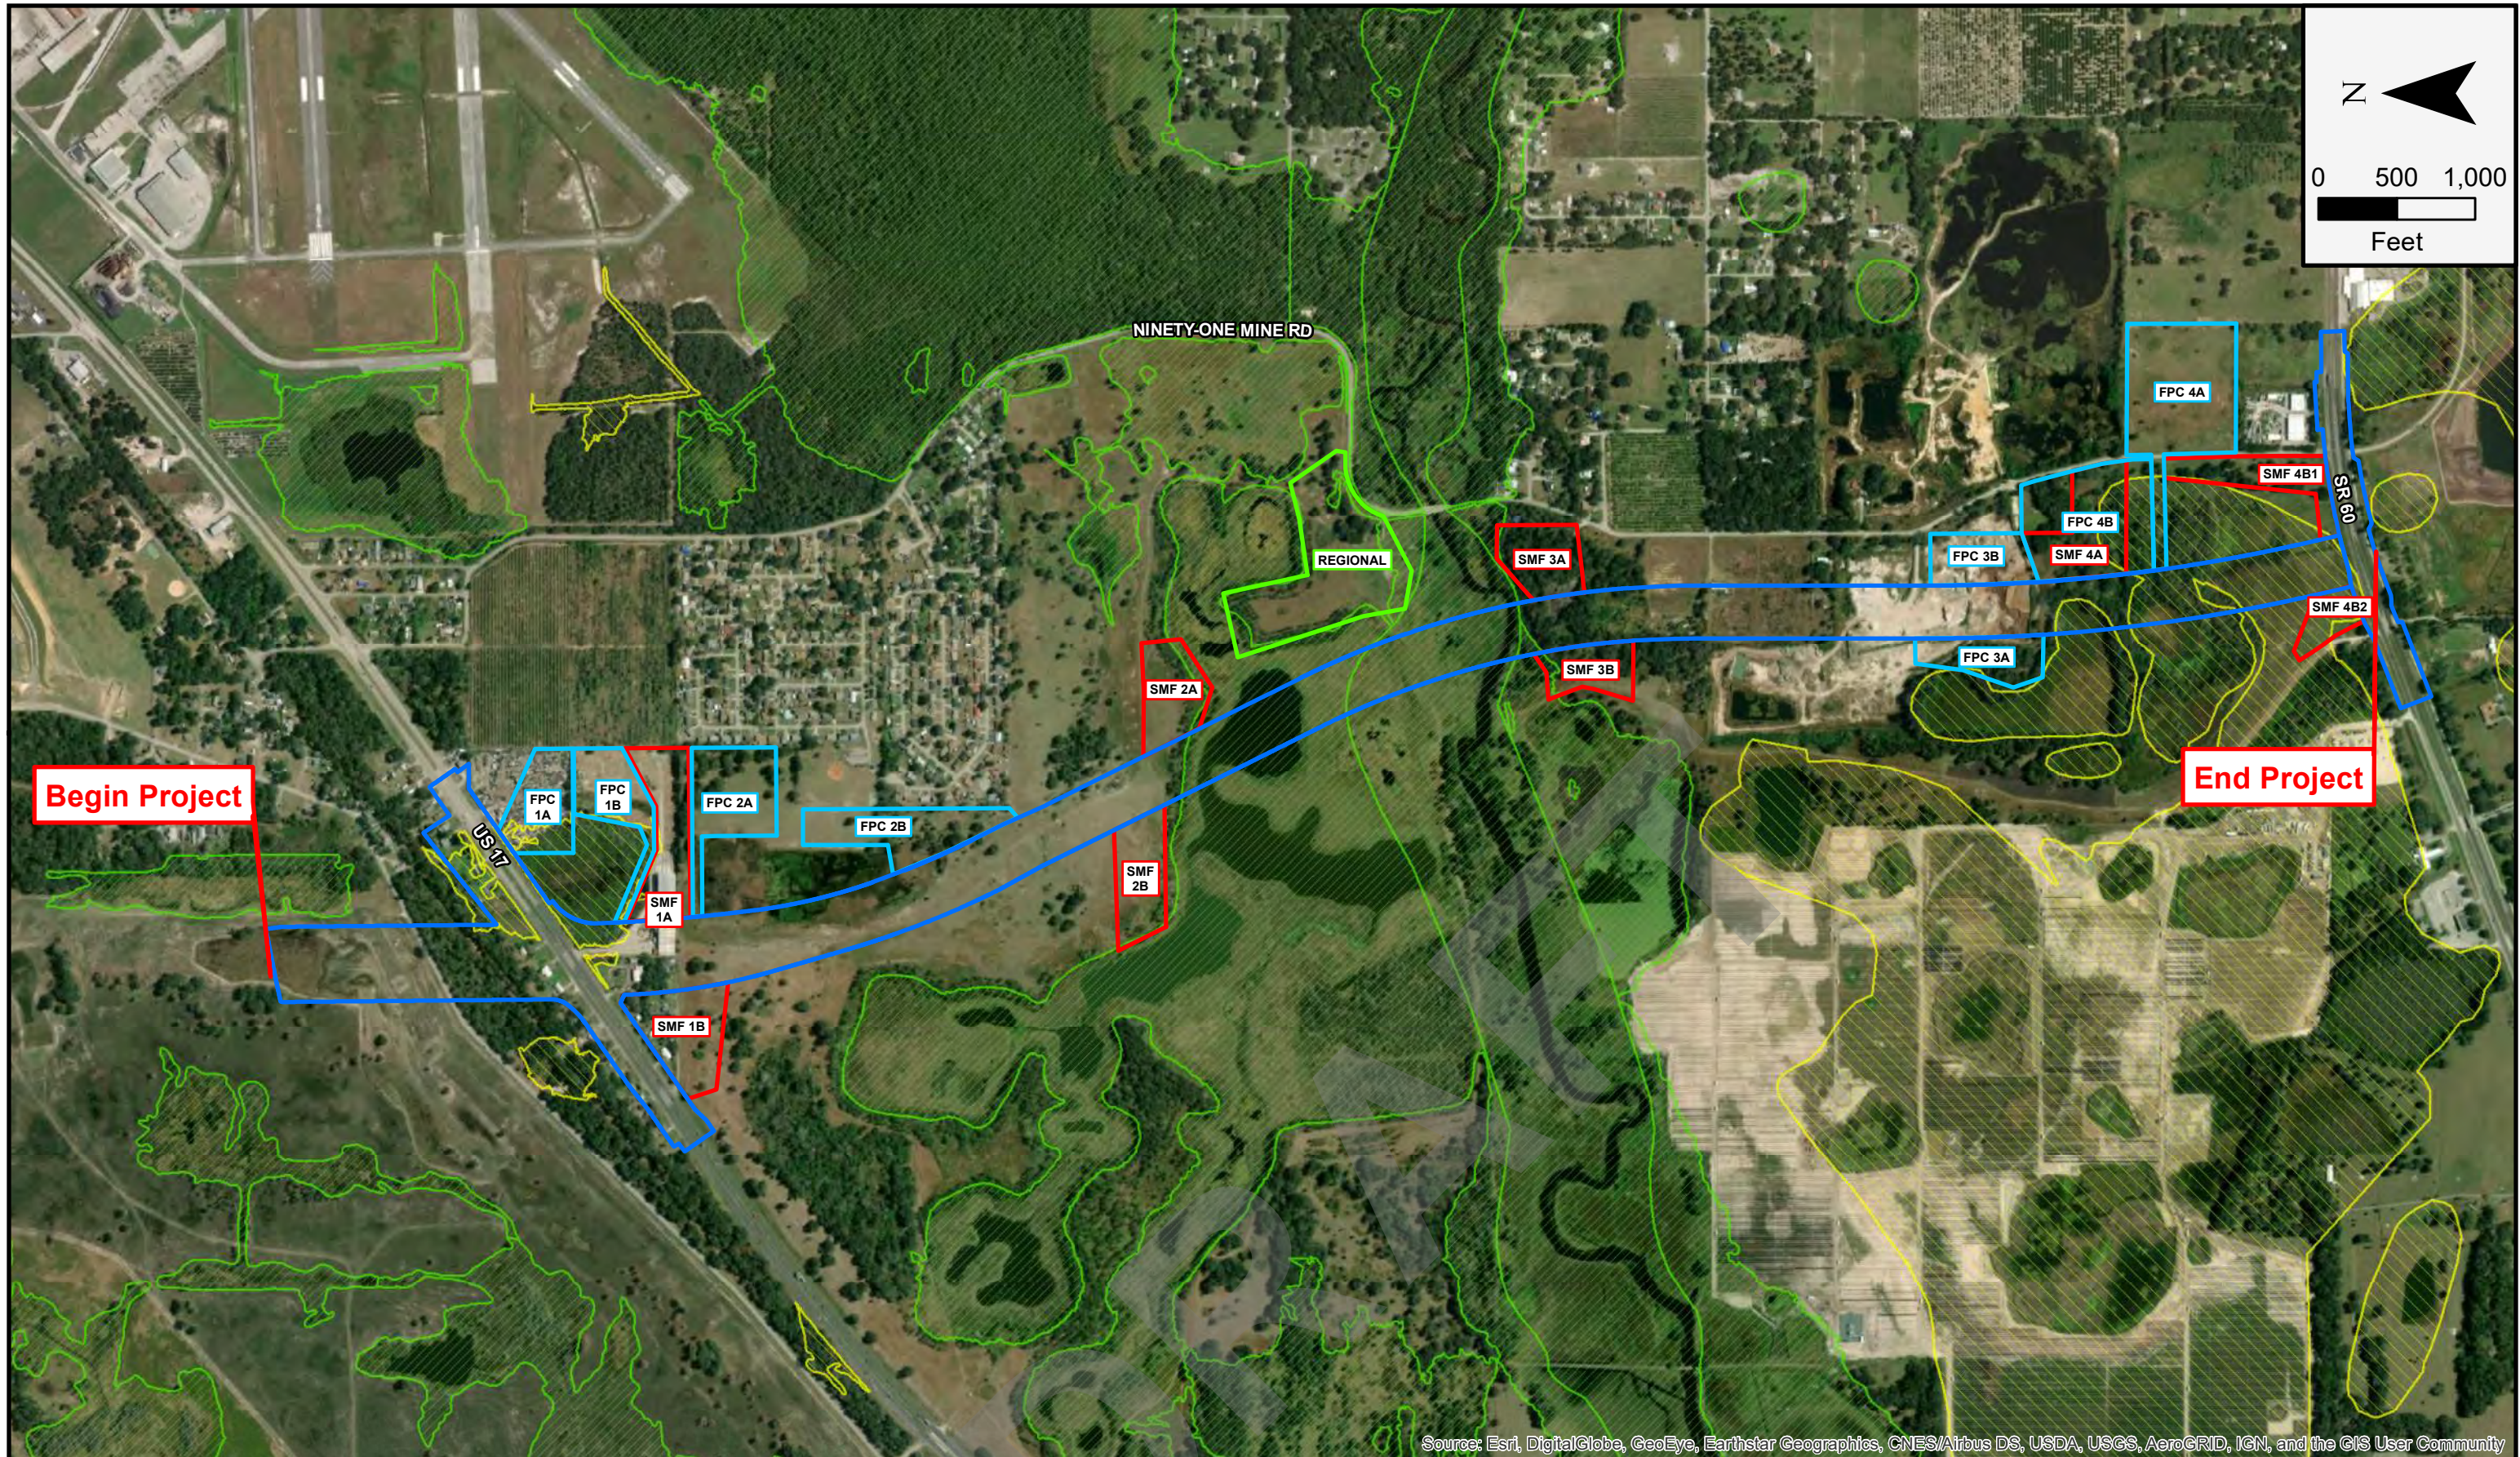
**Figure
4**

- Legend**
- Proposed ROW
 - FPC Site
 - Regional SMF
 - SMF Site
 - FEMA Zone A
 - FEMA Zone AE

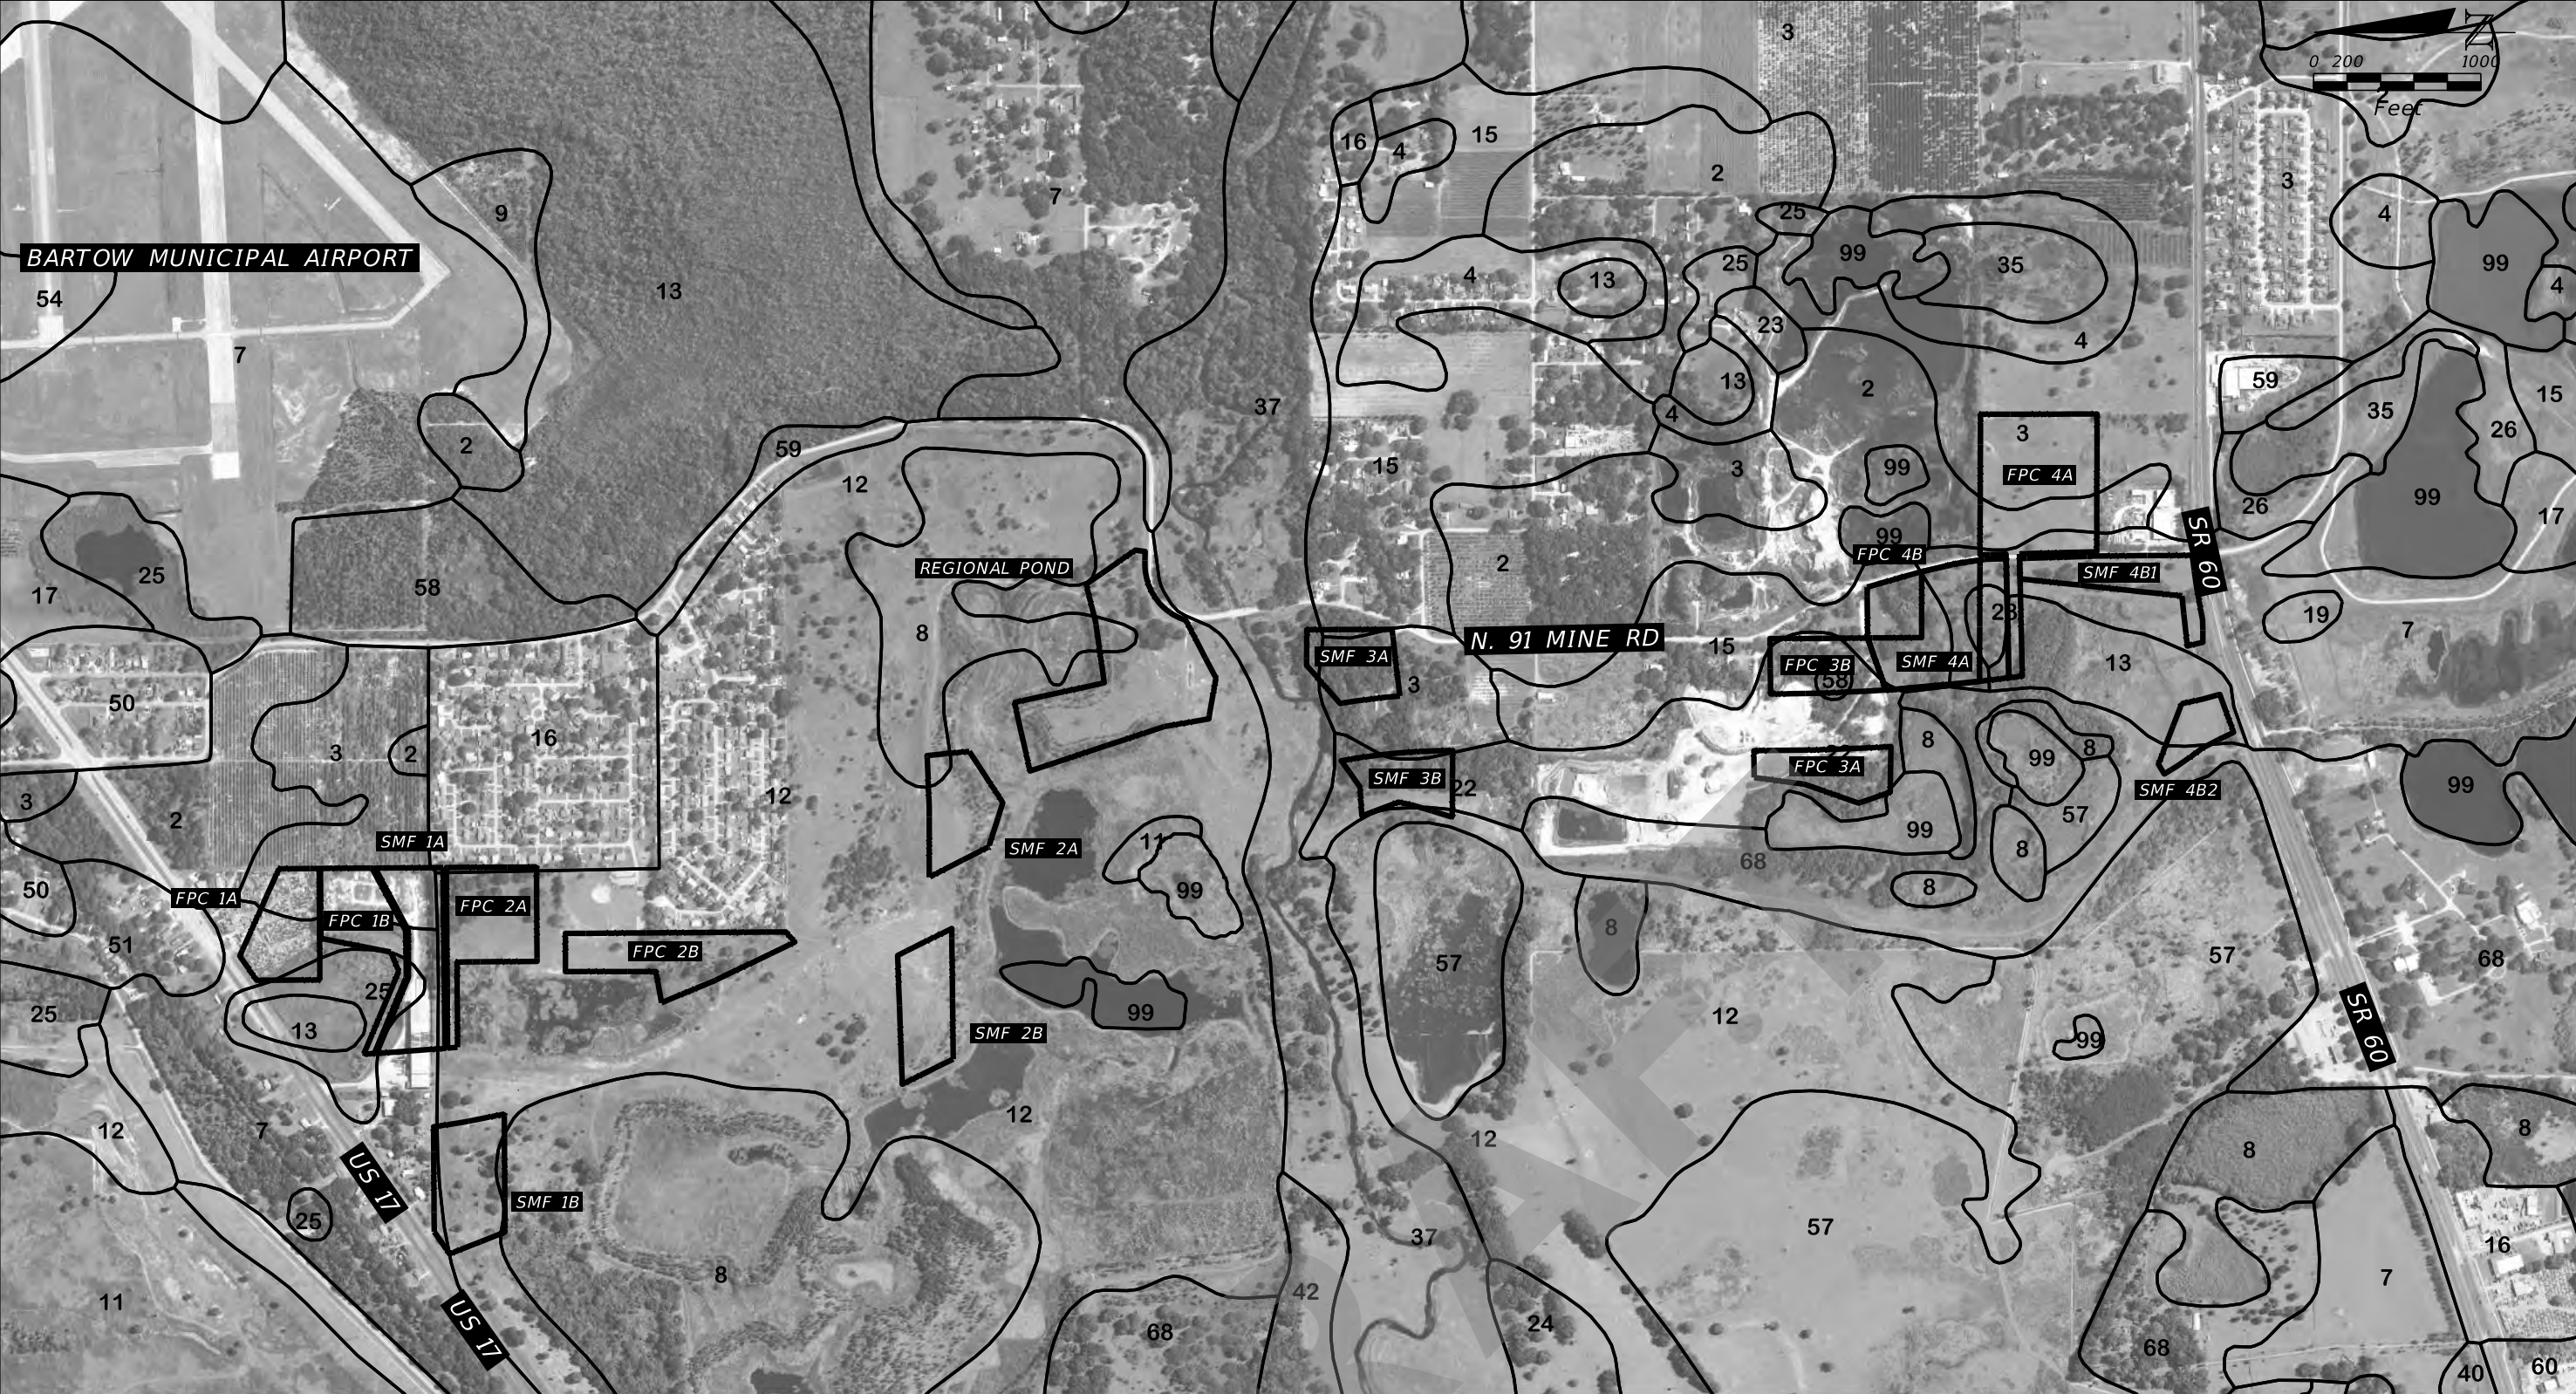
SOIL UNITS 8, 11, 57, 58, AND 99 REPRESENT RECLAIMED MINED SOIL AREAS WITH SLIMES OR OPEN WATER FEATURES (UNIT 99) ASSOCIATED WITH MINING ACTIVITY

SOIL UNITS 12 AND 68 REPRESENT RECLAIMED MINE SOIL AREAS
