## CONTAMINATION SCREENING EVALUATION REPORT

Florida's Turnpike (SR 91) and Interstate I-95 Direct Connection Interchange (MP 125)  
Along SR 91 and I-95  
Approximately 2 Miles North and South of SE Bridge Road (CR 708)  
Martin County, Florida

Financial Management Number: 446975-1

June 17, 2025

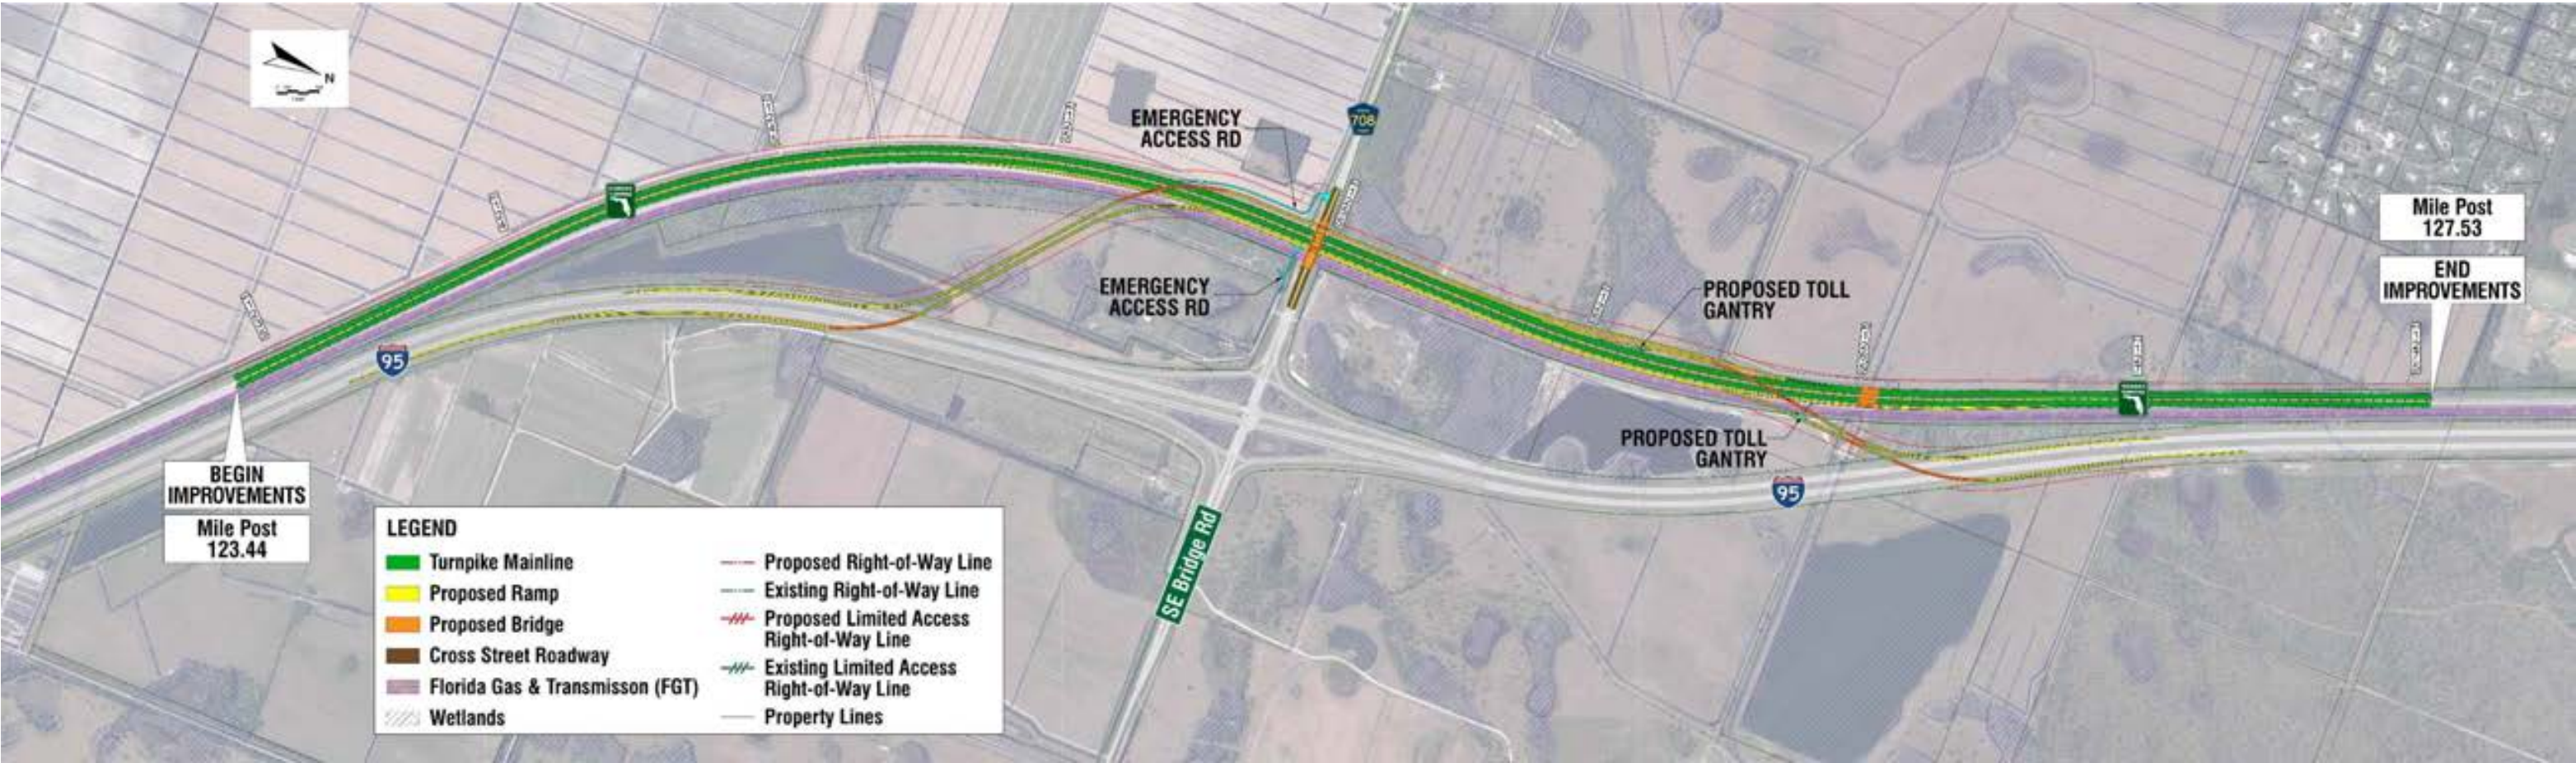
Figure 1-2: Proposed Turnpike at I-95 Direct Connection Interchange Alternative

The preferred alternative for the SR 91 and I-95 direct connection interchange study includes the construction of four system-to-system ramps to accommodate all directional movements between SR 91 and I-95 near SE Bridge Road in Martin County. South of SE Bridge Road, the ramps will serve northbound I-95 to northbound SR 91 and southbound SR 91 to southbound I-95 movements. North of SE Bridge Road, ramps will accommodate northbound SR 91 to northbound I-95 and southbound I-95 to southbound SR 91 movements. Additionally, SR 91 will be widened from four to eight lanes, with all widening occurring to the west side to avoid impacts to existing FGT infrastructure located along the east side of SR 91. A two-lane collector-distributor (CD) road is proposed between the northbound SR 91 to northbound I-95 and northbound I-95 to northbound SR 91 ramps to facilitate safe and efficient weaving operations. No geometric changes are proposed for I-95, as all ramp tie-ins will occur at the outer edges of the existing facility. While the SE Bridge Road typical section will remain unchanged, the existing bridge will be reconstructed to accommodate SR 91 widening and to span the southbound SR 91 to southbound I-95 ramp. Two tolling points are proposed—one on the ramp from the CD road to northbound I-95 and the other on the ramp from southbound I-95 to southbound SR 91. All ramps will be single-lane facilities, with a 15-foot-wide lane and a design speed of 50 miles per hour.

**Figure 1-2** shows the proposed interchange alternative.

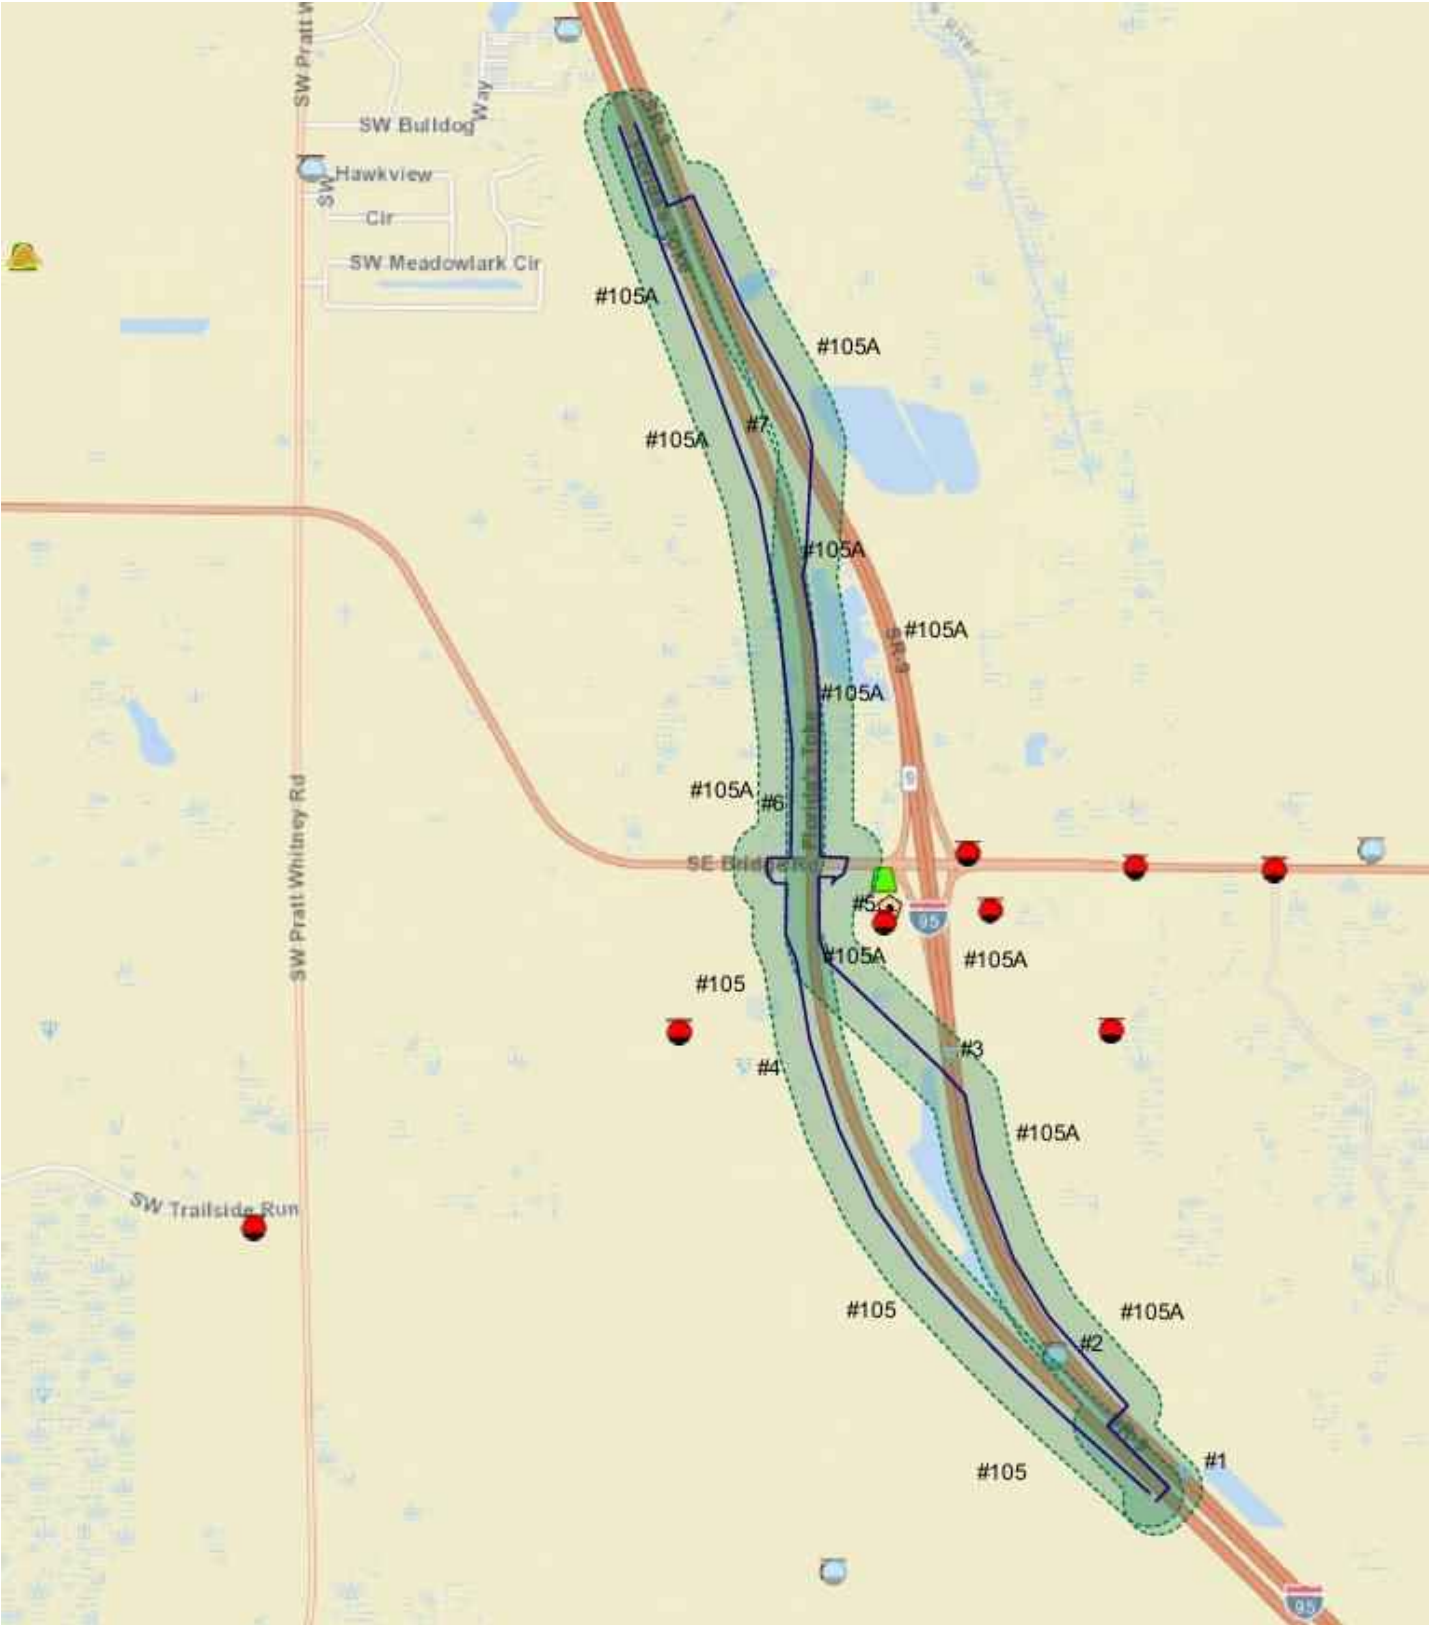
Figure 3-1: Potential Contamination Sites Diagram

Seven potential contamination sites (Site #1 to Site #7) were identified on regulatory databases within PD&E Chapter 20 search criteria. Groves/row crops adjoining west of SR 91 south of Bridge Road were designated potential contamination Site #105 in the 2021 CSER for FPID 423374-1. Site #4 identified during the regulatory database search is a portion of Site #105. Additional areas of former and existing groves, crops, and nurseries were identified during the desktop review and project reconnaissance at proposed R/W locations and designated Site #105A. The potential contamination site locations are shown on **Figure 3-1**. Risk rating evaluation is provided on **Table 3-1**.

Level II contamination impact to construction assessment may be warranted depending on final design to further evaluate areas of potential contamination rated medium risk, which include:

- Site #1 Bunnell Cypress Company, Inc. - 1994 vehicle crash diesel fuel spill at I-95 R/W. Potential petroleum contamination along I-95 R/W.
- Site #2 Casa Blanca Express of Palm Beach - 2004 vehicle crash diesel fuel and motor oil spill at I-95 R/W. Potential petroleum contamination along I-95 R/W.
- Site #105/#105A Grove, Crops, Nursery - includes Site #4 Hobe Grove DRI, Mr. Landscape Wholesale, and other areas where proposed new R/W intersects existing or fallow citrus groves, crop fields, or nurseries. Potential pesticide, herbicide, and metals contamination at portions of proposed R/W along west side of SR 91, north crossover, south crossover, emergency access roads east and west of SR 91, and east side of I-95.

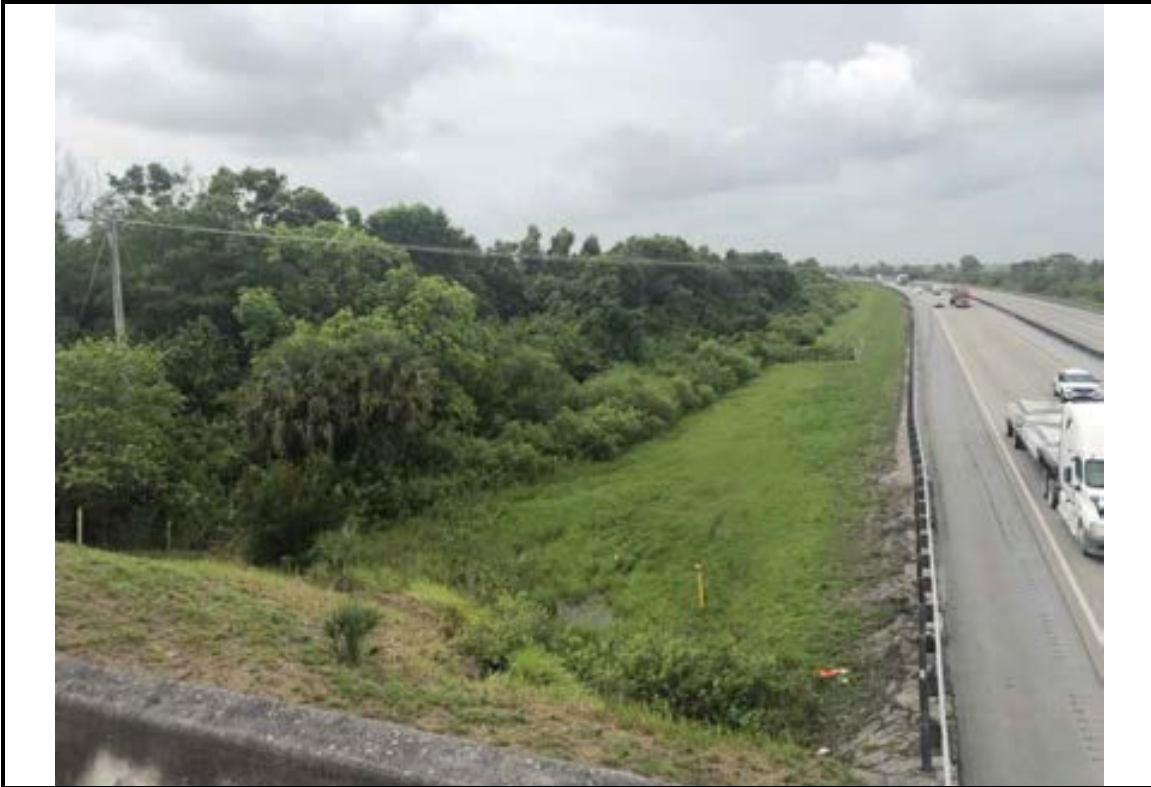
**Photo #1** Looking north of Bridge Rd at wooded proposed R/W along southbound side of SR91

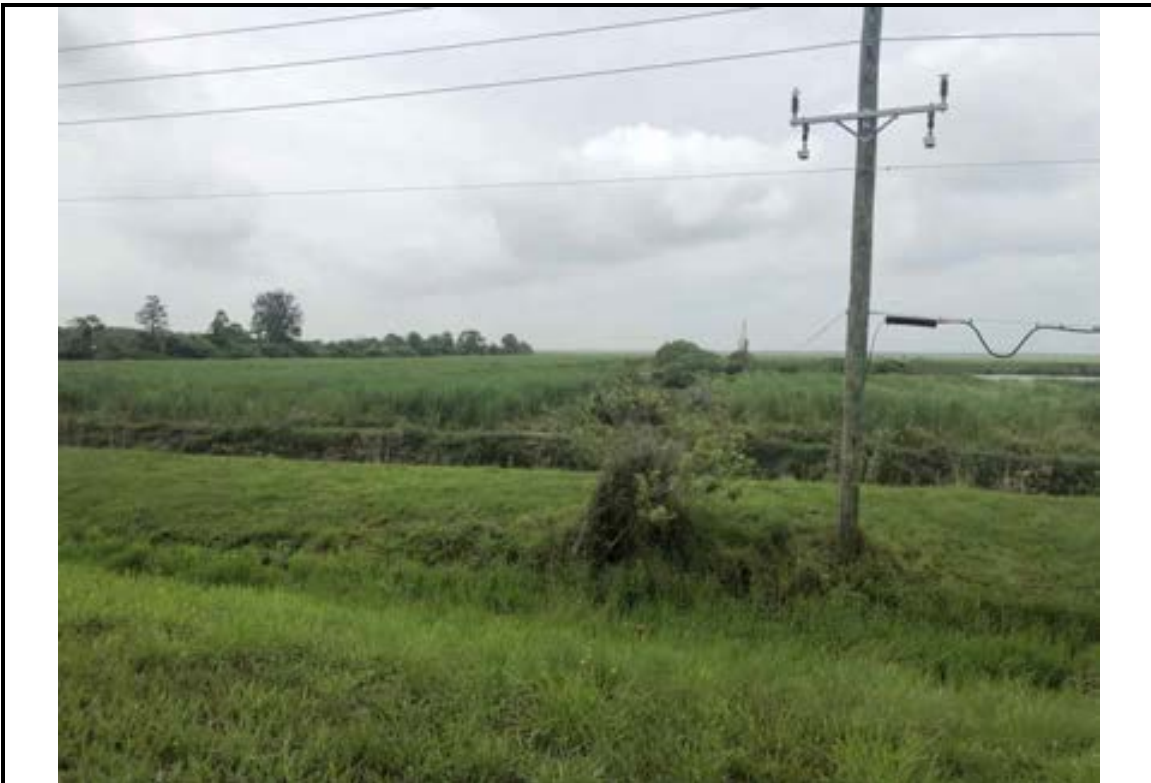
At the time of the field reconnaissance, proposed R/W west of SR 91 south of Bridge Road was a sugar cane field (Site #105). The proposed R/W west of SR 91 north of Bridge Road was wooded. Mr. Landscape Wholesale Nursery (portion of Site #105A), pasture, wooded area, and a portion of a stormwater pond were at the proposed crossover south of Bridge Road. Access to the proposed crossover south of Bridge Road was limited to SR 91 R/W and I-95 R/W. The proposed emergency access road at the east side of SR 91 was wooded and the landscape nursery (Site 105A). Pasture with grazing livestock apparently associated with Hobe Sound Farmers Market was at the proposed crossover north of Bridge Road.

**Photo #2** Looking south of Bridge Rd at sugar cane field at proposed R/W west of SB SR91

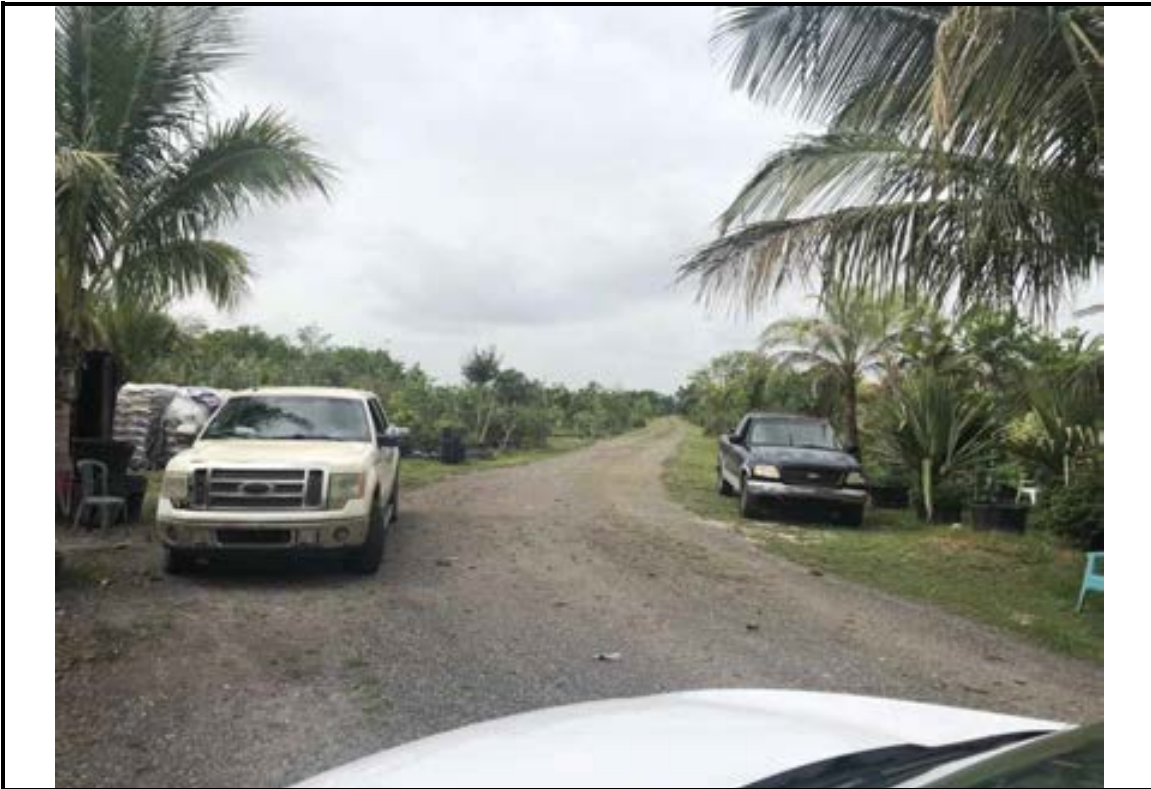
Attempts to contact the owner of Mr. Landscape Wholesale (adjacent east of SR 91 south of Bridge Road) for nursery access at the proposed crossover and nursery maintenance information were unsuccessful at the time of site reconnaissance and by telephone.

**Photo 3** Mr. Landscape Wholesale nursery adjacent east of SR91 south of Bridge Rd

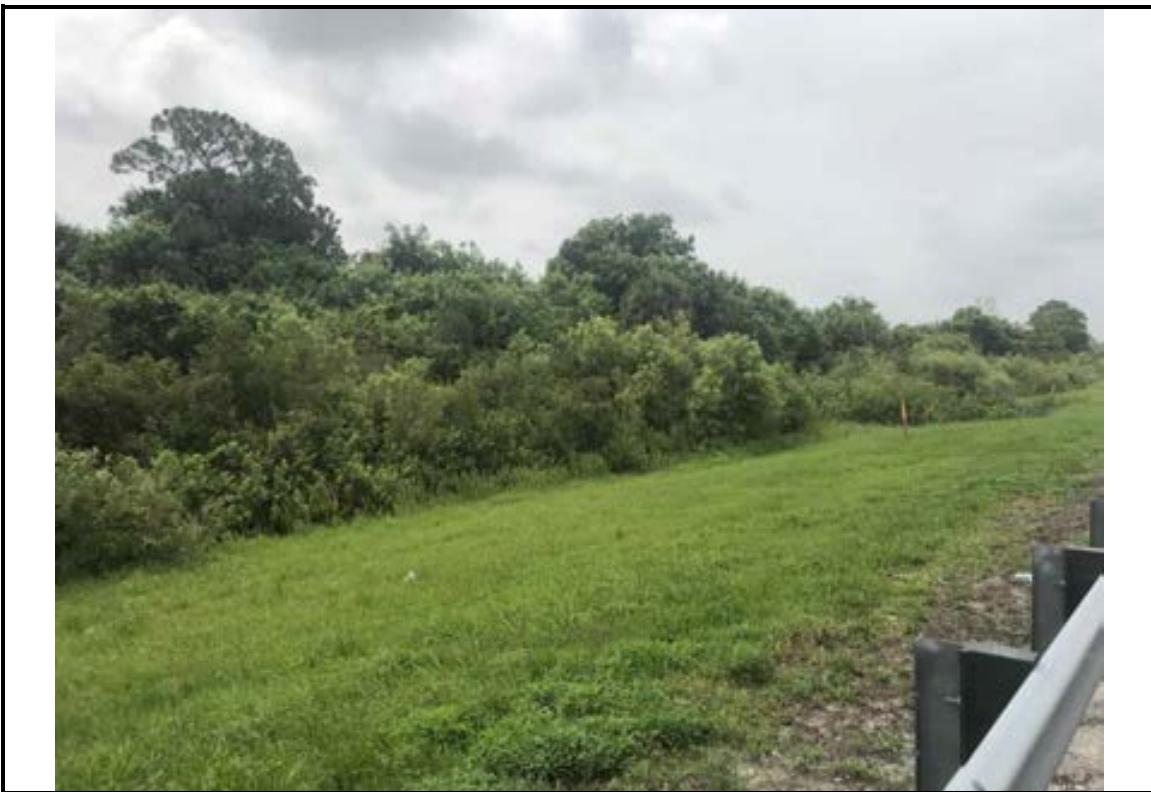
**Photo 4** Looking SE from SR91 at proposed crossover south of Bridge Rd

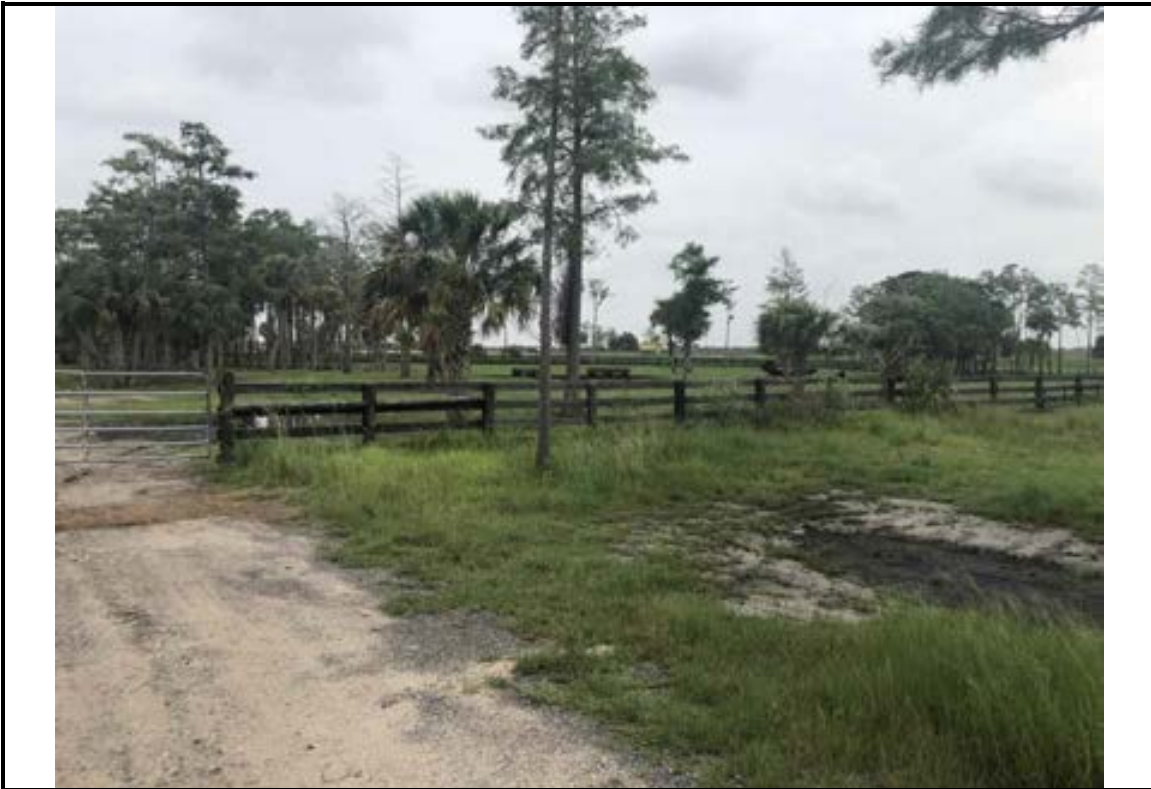
**Photo 7** Looking NE at pasture at proposed crossover north of Bridge Rd

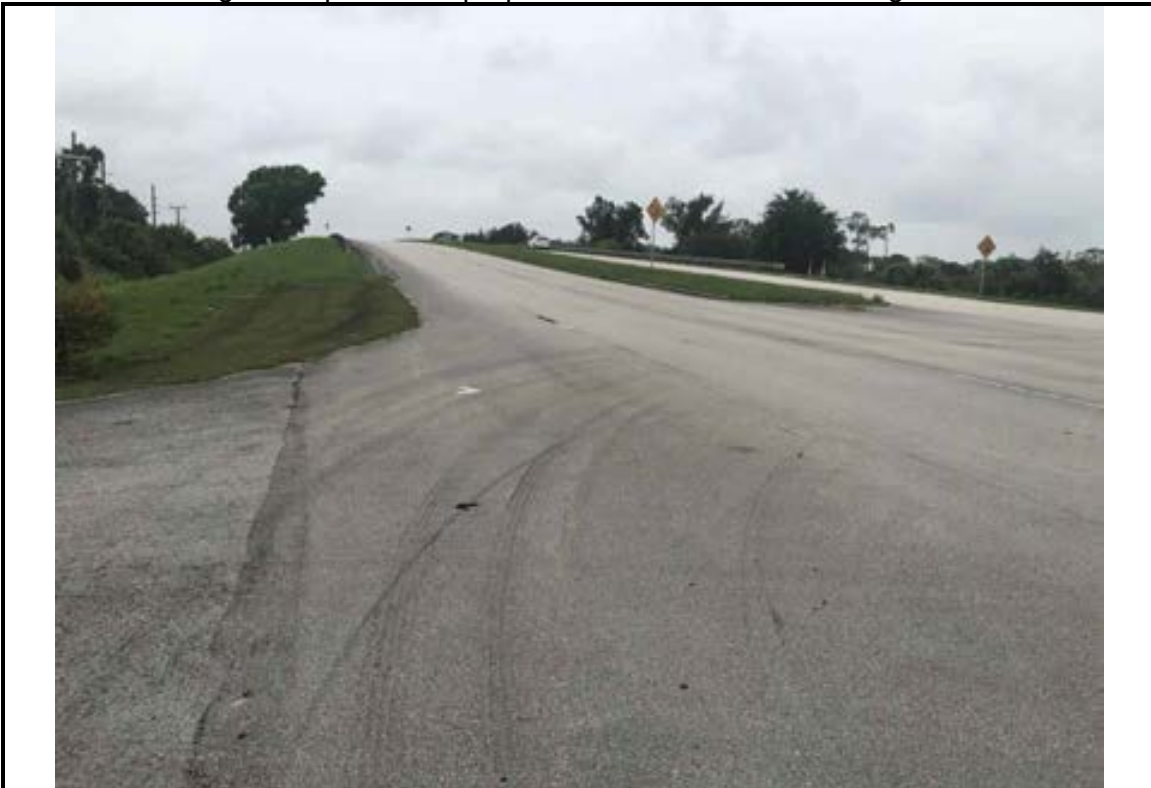
**Photo 8** Looking west at Bridge Road over SR91

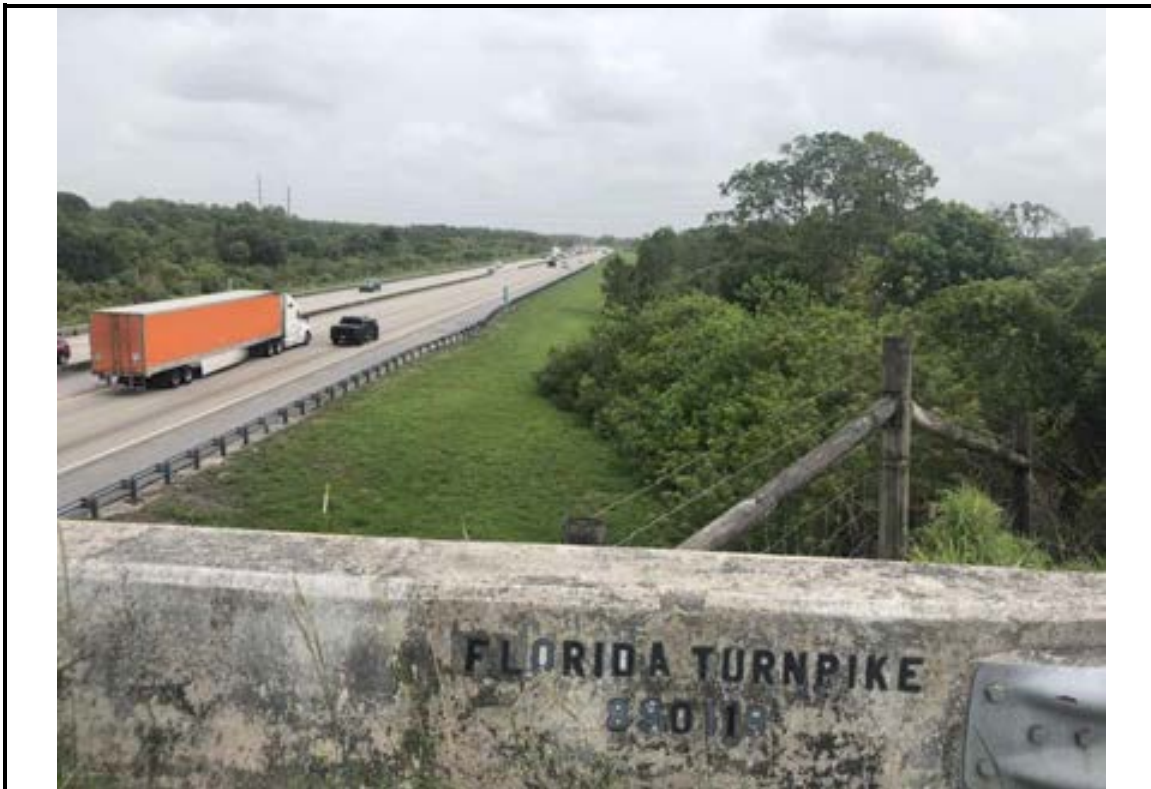
- Bridge 890119, Bridge Road (CR708) over SR 91. A November 2016 Asbestos Survey, Lead-Based Paint Survey, Limited TCLP Sampling, and Paint Screening Survey indicates Category II non-friable asbestos-containing white Class 5 finish was identified on the end bent, beam span, parapet wall, column, and intermediate cap. Metals at non-hazardous concentrations were measured in a paint chip sample.

Photo 9 Bridge 890119 over SR91, looking north

Category II non-friable asbestos-containing white Class 5 finish was identified in 2016 at Bridge 890119 (Bridge Road over SR 91). Asbestos abatement may be warranted depending on final design proposed renovations for widening.
