CONTAMINATION SCREENING EVALUATION REPORT

Florida Department of Transportation
Florida's Turnpike Enterprise
Central Polk Parkway East PD&E Study
From US 17/92 to Poinciana Connector (SR 538)
Polk County, Florida
Financial Management Number: 451419-1

April 2025

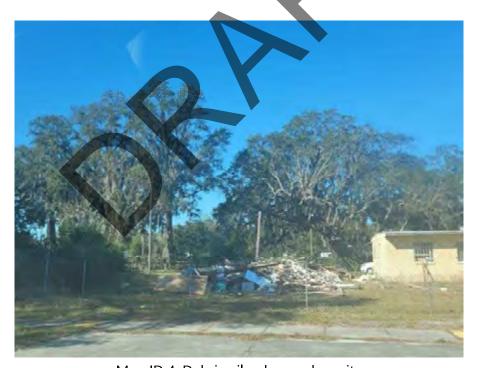
4	Apostolic Church of Jesus 811 North US 17/92 Davenport, Florida	TANKS: 9700313	Within proposed ROW	Petroleum	Medium	During the site reconnaissance, the facility was observed as a vacant building. A pile of debris, including wood and plaster, was noted on site. The current property owner is listed as Eglise De Diey Haitienne De Poinciana, Inc. The FDEP STCM database shows that the site formerly maintained one 550-gallon unleaded gas UST and one 1,000-gallon unleaded gas UST. The tanks operated from an unknown date until December 1996, No discharges are reported. However, since no tank closure reports or recent assessment records are available, contamination concerns cannot be determined based on the information provided. Although there are no reported discharges, due to insufficient records regarding closure testing and due to the close proximity to the project ROW (within proposed CPP East), Map ID 4 is assigned a risk rating of Medium. This site should be considered for Level II testing if proximal to subsurface excavations or dewatering during construction.

Map ID 4: Debris pile observed on site

o **Level II Testing** – the following eight Medium rated locations should be considered for Level II testing related to contamination conditions that may impact construction: Map ID 2, Map ID 4, Map ID 5, Map ID 11, Map ID 13, Map ID 21, Map ID 25, and Map ID 26. All sites are applicable to Alternative 1, while all sites except for Map ID 13 are applicable to Alternative 2. Additionally, one High rated location (Map ID 16) should be considered which is applicable to both alternatives. These are either petroleum-related sites, row crops, or a railroad corridor and should be tested to determine impacts to construction with soil borings, monitoring well installation, soil and groundwater sampling, laboratory testing, Organic Vapor Analyzer screening, and possibly Ground Penetrating Radar surveys. Analytical testing for soil and groundwater samples at the petroleum contaminated sites (Map ID 2, Map ID 4, Map ID 5, Map ID 11, Map ID 13, Map ID 16, and Map ID 21) may include TRPHs by the Florida PRO Method; benzene, toluene, ethylbenzene, xylenes, and methyl tertiary-butyl ether by EPA Method 8260; and polynuclear aromatic hydrocarbons by EPA Method 8270. Organic Vapor Analyzer screening is also recommended. Analytical testing for soil and groundwater samples at the row crops (Map ID 25) may include arsenic by EPA Method 6010, organochlorine pesticides by EPA Method 8081, organophosphorus pesticides by EPA Method 8141, and herbicides by EPA Method 8151. Analytical testing for the soil and groundwater samples at the railroad corridor (Map ID 26) may include arsenic by EPA Method 6010, polynuclear aromatic hydrocarbons by EPA Method 8270, organochlorine pesticides by EPA Method 8081, organophosphorus pesticides by EPA Method 8141, and herbicides by EPA Method 8151.

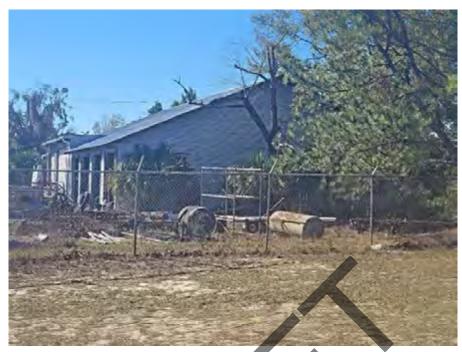
φ	Citrus Enterprises Inc HWY 547 & Palm Street North Davenport, Florida	TANKS: 8623362, 8735428	230 feet west of western Power Line Road limit	Petroleum	Low	During the site reconnaissance, the facility was observed as an industrial agricultural facility. Two small, rusted tanks were observed on the side of the property. No secondary containment was visible. The current property owner is listed as Citrus Enterprises, Inc. The FDEP STCM database shows that the site formerly maintained three vehicular diesel ASTs, ranging in size from 6,000 to 20,000 gallons. The tanks have been in operation since 1979. Two tanks were removed from the site on an unknown date, and one tank was removed in January 2008. No discharges are reported. A Storage Tank Facility Closure Site Inspection Report was submitted in February 2009, in which the facility received a minor violation for not notifying the FDEP prior to tank closure nor providing a tank closure manifest. Therefore, contamination concerns cannot be determined based on the information provided. Although there are insufficient records regarding closure testing, due to the distance of the tank from the project ROW (approximately 230 feet), Map ID 6 is assigned a risk rating of Low.

Map ID 6: Tanks observed on site, no secondary containment visible

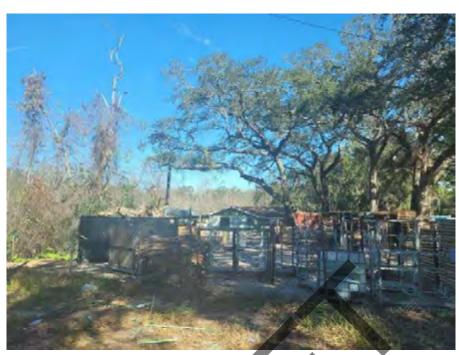
Map ID 7: IBC tanks, dumpster observed on site

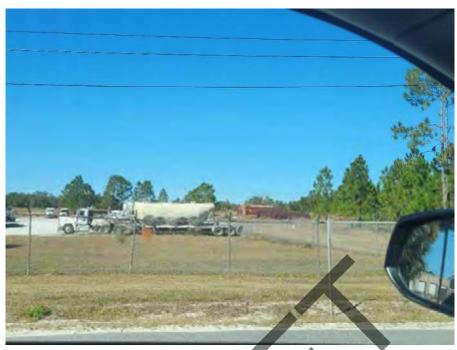
Site Number/ EDM Number	Site Name & Address	Databases/ Facility ID/ Other Sources	Distance from ROW	Contaminants of Concern	Risk Rating	Comments
O	Cemex – Davenport 100 Lem Carnes Road Davenport, Florida	LUST/TANKS: 8628348 Hazardous waste: SQG_85006	Within proposed ROW	Petroleum	wat .	During the site reconnaissance, the facility was observed as Cemex Florida Sand. Large, rusted tanks were noted along the northern poperty of the property. The current property wower is listed as Rinker Materials Corporation, Although this site functions as a serement plant, the major contamination concerns associated with the site and the adjoining prond are related to the presence of tanks. The adjoining pond in major contamination concerns associated with the site and the adjoining pond are related to the presence of tanks. The adjoining pond is not mentioned in OCULUS files. Based on aerial photographs, the pond is first depicted in 2004 and filled with water in 2005. A small slope, likely for runoff drainage, is apparent in the northwestern corner of the pond. The gene coloration is likely due to eutrophication, as the site's raw material storage includes both gypsum and fly ash, which contain nutrients that promote algae growth. The FDEP STCM database shows that the site formedy maintained seven USTs and five ASTs, ranging in size from 550 to 12,000 gallons, and three were noted in June 1991, two were closed in place in April 2002, and three were noted as out of service since March 2017. The site currently maintains three ASTs, ranging in size from 550 to 12,000 gallons, which have been in operation since 1990. The contents include waste oil. kenosene, and vehicular diesel. The most recent Site Inspection Report dated July 2020 states that four ASTs were proceed in June 1991, two were stated to be Out-of-Service and are listed as such on the FDEP STCM database. The active 12,000 gallon ASTs were mortioned during the inspection; however, the two 550-gallon ASTs were not discussed. Two discharges were reported for this site one in June 1999 and another in June 2004. The Yung 1999 discharge was reported when contamination was found during closure assessment activities for dispensers. In the October 2001 Supplemental Site Assessment Report and No Further Action Proposal, it was stated that no soil impacts w

Map ID 9: Rusted tanks along northern portion of the site

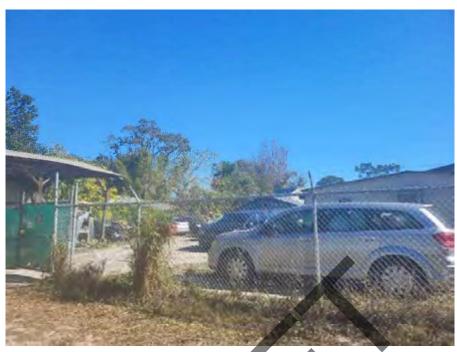
50	RJR Contractor LLC 4 Page Road Davenport, Florida	SLDWST_NLF: 106224	630 feet southwest	Waste tires	Low	During the site reconnaissance, the facility was observed as Tint My Ride Pro Inc. – a window tinting service. Vehicles were observed on site. The current property owner is listed as Yoamarie Logistics Inc. The EDM Report states the facility currently operates as an active waste tire collector. According to the EDM Report, the facility applied for a Waste Tire Collector Registration in July 2019 and most recently renewed their application in March 2024. No other site activities were identified that may be potential contamination concerns. Based on the lack of contamination concerns noted and the distance from the project ROW (approximately 630 feet), Map ID 20 is assigned a risk rating of Low.

Map ID 20: Vehicles observed on site
