<p>FLORIDA'S TURNPIKE ENTERPRISE (FTE) Construction Engineer: Pete Nissen, P.E. Assistant Construction Engineer: Bill Sears, P.E. FDOT Design Project Manager: William Sloup, P.E. GEC Design Project Manager: Terry Miller, P.E. Construction Project Manager: Ken Hudson</p> <p>CCEI NEW MILLENNIUM ENGINEERING, INC. (NME) Sr. Project Engineer: Gus Quesada, P.E. Project Administrator: Sergio Ambros</p> <p>CONTRACTOR COMMUNITY ASPHALT CORPORATION (CAC) Project Manager: Vernon Walker Project Manager: Aryail M. Gomez</p> <p>ENGINEER OF RECORD MOFFATT & NICHOL (M&N) EOR: Richard Rocktoff, P.E. Project Manager: Jeff Messenger, P.E.</p>	<p>PERFORMANCE MEASURES:</p> <p>Notice to Proceed Date: 06/06/13 Construction Start Date: 07/08/13 Completion Date: 05/19/14 Original Contract Time: 270 days <u>Approved Time Extensions:</u> Weather/Holidays: 46 days Supplemental Agreements: 0 days Final Contract Time: 316 days % Overrun Orig. Contract Time: 0%</p> <p>Original Contract Amount: \$6,589,153.50 Final Contract Amount: \$6,665,935.50 % Overrun Contract Amount 1.17%</p> <p>Final CPPR: 91</p>

<p>PROJECT DESCRIPTION: The Improvements under this Contract consist of milling and resurfacing with design cr

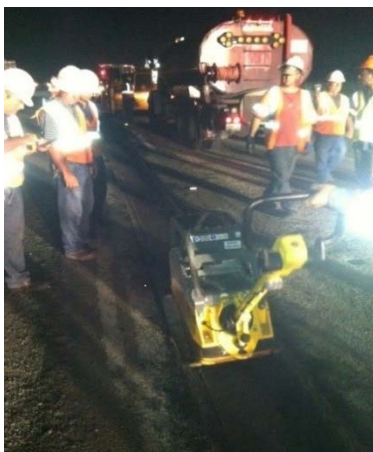
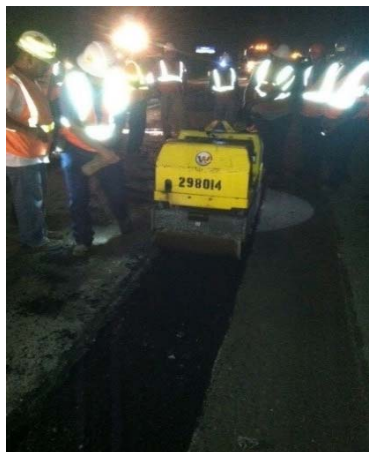
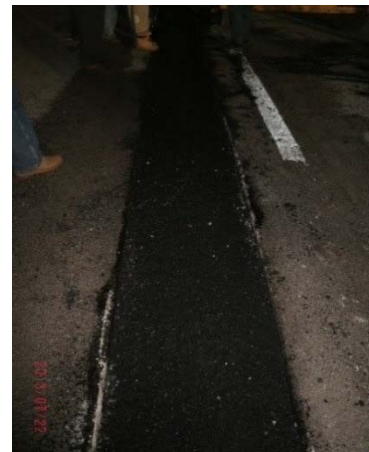
Pay Item: 334-1-4 SP Trench Repair – The trench repair detail called for a 2' wide trench; however, to achieve density requirements and based on the contractor's available equipment, the trench width was too small. It was determined to increase the trench width to 27+/-" to allow the contractor's equipment to access the trench and properly achieve density.

Summary and Recommendation: Although CAC performed this work at no additional cost to FTE, we feel this may have been a potential claim because another contractor may have tried to achieve density with a smaller piece of equipment which would not have yielded the favorable results CAC achieved. The industry has compactors that are exactly 24" in width, but they are not readily available and need to be ordered, the typical ones are 26". Density could have also been achieved by using smaller lift thickness, but the operation would have taken longer, which is a greater impact to the motorist. This repair procedure proved successful and we highly recommend its use in other areas; to avoid potential claims, we recommend increasing the trench width to 27".
