EXTINGUISH THE TORCH MEETING SESSION ONE

Project: Turnpike Mainline Shoulder Evacuation NB (MP 210-249)

LESSONS LEARNED

SUMMARY REPORT

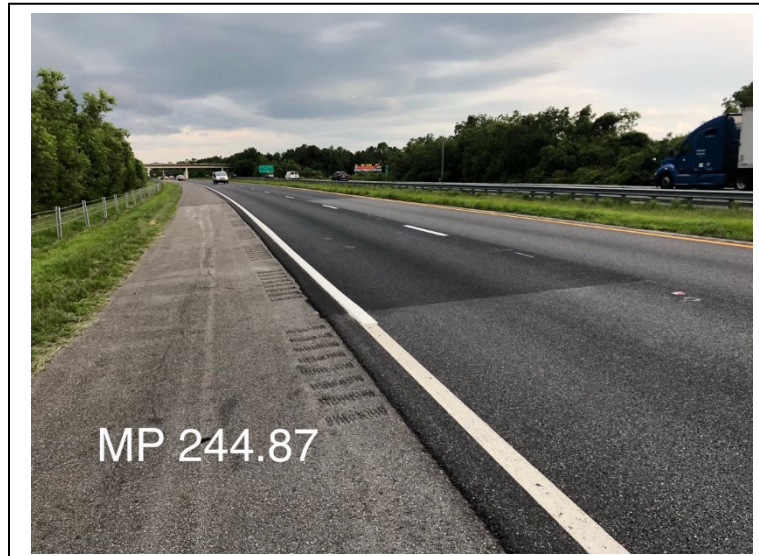
2) Transition approach distance for milling and resurfacing limits

MOT plans did not account for transition approach distance of 100' to be included with milling and resurfacing.

Extended the milling limits 100' at MP 229.37, MP 241.94, MP 243.56 and MP 244.87 to remove the strips outside MOT plan limits. This required additional 756 SY of 3/4" mill and 31.2 tons of additional FC-5 (over-runs).

Milling and resurfacing limits should include transition approach distance as per Standard Plans.

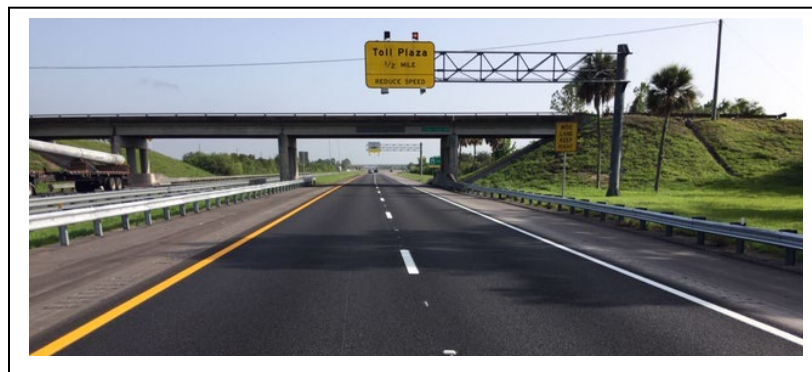
3) Milling and resurfacing of existing travel lanes

The traffic control plan called for milling the existing friction course on the outside travel lane in phase III. Then mill and resurface the inside travel lane (structure course) in Phase IV. Phase V called for placement of friction course on both travel lanes. Milling the friction course in the outside lane would have left a milled surface until Phase V. Even though Special Provision Section 327 allowed traffic on the milled surface for up to 3 calendar days, FTE and the CEI were concerned that weather would likely impact the work on the inside lane (which had to be milled and resurfaced with structure course and friction course), resulting in traffic being kept on the milled surface for more than 3 days.

During construction, the contractor did not mill the friction course in the outside lane (Phase III) until after the inside travel lanes were resurfaced with structure and friction. This allowed the traffic to shift to final configuration as the FC-5 was placed and traffic was never placed onto a milled surface.

The EOR should avoid leaving milled surface and should call out placement of friction course same night of milling.
