Summary Report

Polk Parkway (SR 570) Resurfacing from MP 8.1 to MP 21.7
FPN's 423199-1-52-01 and 423199-3-52-01
Contract E8L90

Project Scope of Work

Polk Parkway (SR 570) Resurfacing and Improvements from MP 8.1 to MP 21.7

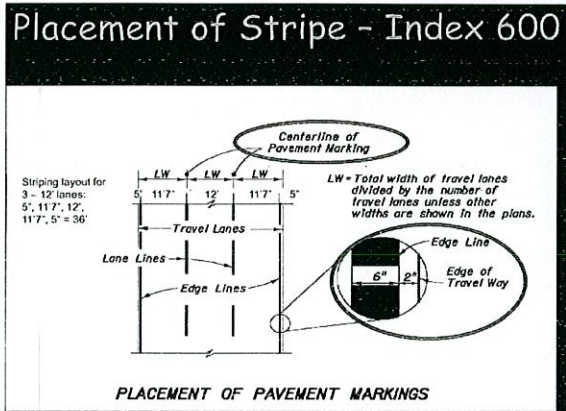
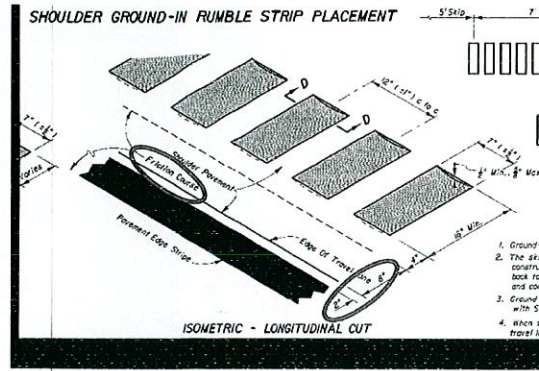
Placement of Stripe – Index 518

Following the initial placement of Friction Course, multiple instances of incorrect striping were noted by the inspection staff. Striping deficiencies included placing the outside solid stripe too close to the edge of the FC-5 mat, and the failure to install all RPM's, skip lines, and chevron striping as indicated in the Plans. In some areas, the stripe had been laid out correctly, but the striping crew had failed to follow the lay-out.

During the Pre-Activity meeting for Striping Operations, the Contractor had been given clear direction as to the proper location of the stripes relative to the outside edge of the travel lane.

Slides from a presentation handed out at the Striping Pre-Activity meeting

In is recommended that the CEI ensure that the Prime Contractor has a person experienced in the proper layout and placement of pavement markings assigned to oversee the operations of their striping subcontractor. During the initial striping operations, the CEI should closely monitor the layout and placement of pavement markings to verify that the Contractor is exhibiting proper Quality Control over the operations. - WATERBLASTING CORRECTIONS

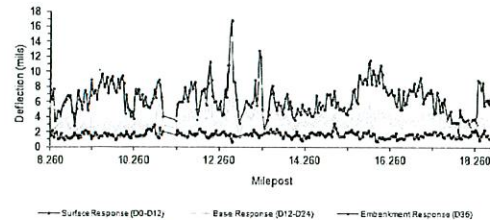
Figure 5. Response profile of westbound inside lane

During the design phase, the EOR used the Falling Weight Deflectometer (FWD) test as one of the methods to analyze the condition of the pavement and base. During the course of the construction, the State Materials Office again had the FWD testing performed on the Polk Parkway. The SMO testing was done at more frequent intervals than had been done during the design phase. Once the milling and resurfacing operations were complete, we were able to review the project as a whole to compare those areas predicted to have weak base by the FWD testing with those areas where failure of the existing base actually occurred.

During the course of the project, we discovered that distresses in the surface of the pavement (cracking, rutting, raveling, etc.) proved to be a much better indicator of weak base than the FWD testing. However, the ultimate test of the base occurred when the fully loaded asphalt trucks were backed up onto it during the resurfacing operations. Any area where the base did not yield under the weight of the trucks has successfully held up under normal traffic

It is recommended that the EOR does not rely solely upon the FWD test results as an indicator of the areas where base remediation is required. It should be used along with detailed surveys of pavement distress patterns, measurement of the in-situ moisture content of the base, and (if possible) proof rolling of the base.
