Florida's Turnpike Enterprise

Annual Inspection Report

for the Fiscal Year ending June 30, 2022

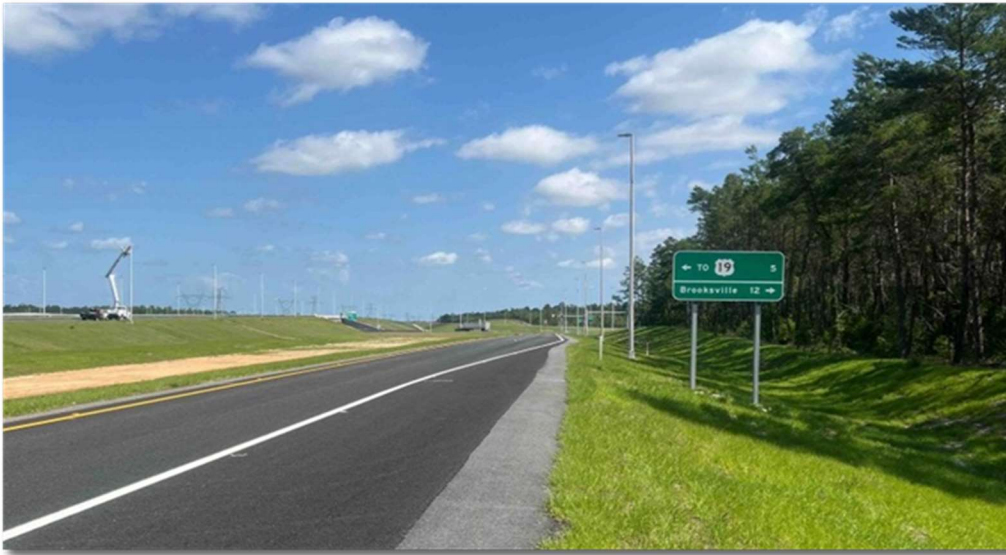
Figure 9: Typical Paved and Soil Shoulder Section

The determination of an RRP rating for roadside characteristics is generally based upon the consideration of all fencing, shoulder, slopes, and other characteristics located outside of the paved travel way (Figure 1). The overall RRP rating for Roadside for this FY is 94.83 with no major below standard characteristics of more than 1.84 percent noted for the five characteristics of this element on FY 2022. Figure 9 shows a typical paved and soil shoulder section on FTE's system.

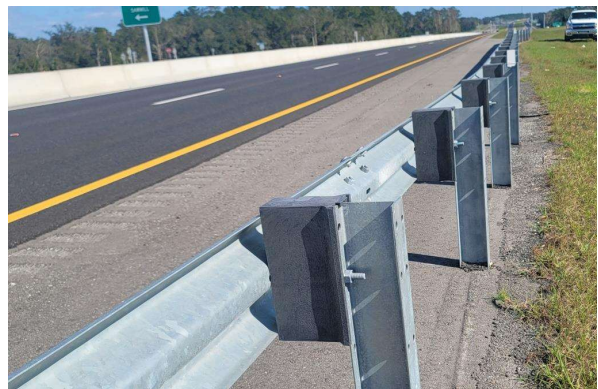
Figure 10: Typical Guardrail

The Traffic Services element rating is based on the condition of all characteristics that guide, protect, and assist the customer while traveling FTE's roadways, interchanges, and service areas. The overall RRP rating for Traffic Services is 93.51 for FY 2022. with no major below standard characteristics of more than 1.93 percent noted for the 11 characteristics of this element on FY 2022. Zone one has the characteristic of Guardrail with 5.92 percent and Zone one has the characteristic of Object Markers with 4.09 percent. Typical Guardrail example on the FTE system is shown in Figure 10.

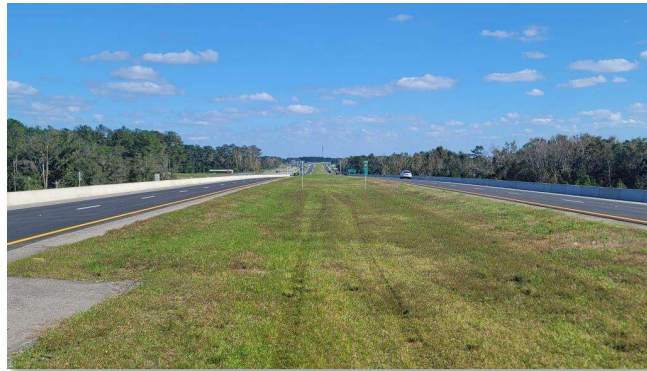
Figure 11: Typical Median Ditch

The rating for this element is based on the overall condition of all structures that collect, treat and convey stormwater run-off. The RRP rating for drainage is 98.96 for FY 2022. Overall, no below standard ratings of more than 0.17 percent were noted for the eight characteristics of this element in FY 2022. **Error! Reference source not found.** shows a typical median ditch on the FTE system.

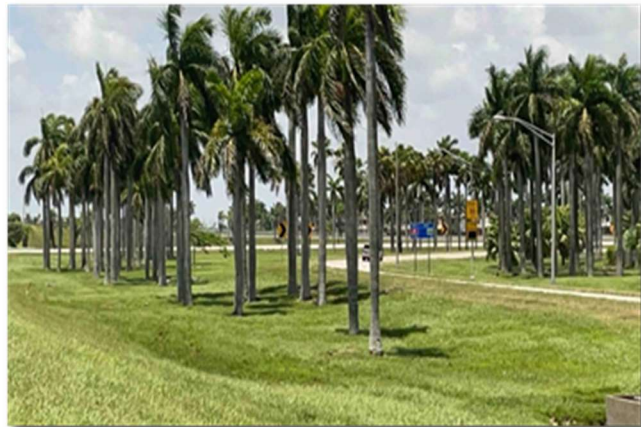
Figure 12: Typical Landscape

According to its comprehensive Turf Management Plan, FTE continually monitors the condition of vegetation and the need for mowing, trimming, re-landscaping, and litter removal. The overall RRP rating for Vegetation and Aesthetics is 95.05 for FY 2022. Overall, no below standard ratings of more than 1.86 percent were noted for the six characteristics of this element in FY 2022. Figure 12 shows an example of landscape in FTE's system.

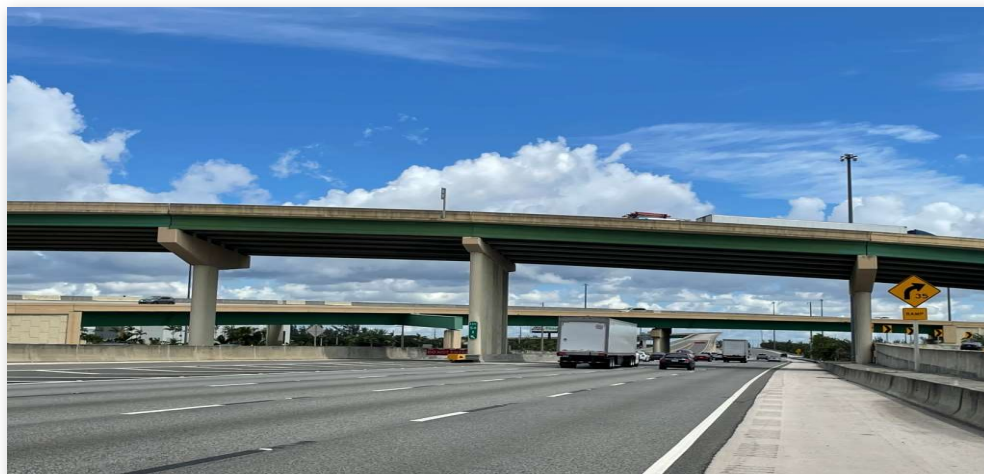
Figure 13: Bridge over Florida's Turnpike

The State Maintenance Office Bridge Inventory 2022 – Annual Report, which uses the NBI guidelines, reported four bridges in fair condition. FTE Maintenance directed a portion of its Periodic and Routine Maintenance funding in FY 2022 to rehabilitation and repair projects. Figure 13 shows an example of a bridge on the FTE system.

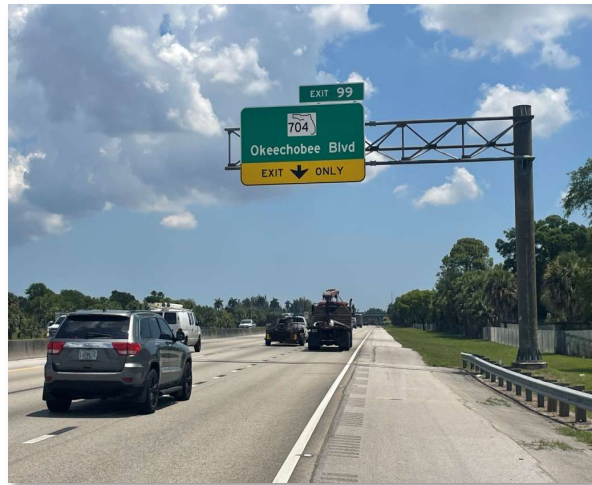
Figure 14: Typical Overhead Sign Structure

Overhead sign structures are inspected separately from those signs in the traffic services element due to being suspended above the travel way by large support structures, but the sign panel condition (retro-reflectivity, peeling, etc.) is documented in the RRP inspection. These signs provide critical directional information, guiding the customer throughout the FTE system. The overhead sign structures inspection reported no structures in poor condition. Figure 14 shows an example of a span sign in the FTE system.

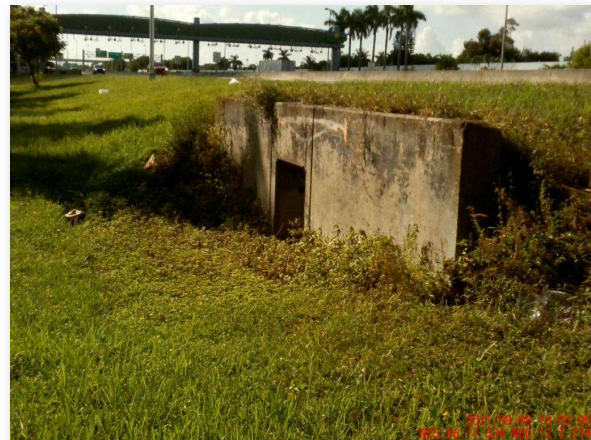
Figure 15: Typical Culvert

LNQCs are inspected once every six years. Each cycle is a two-year period with 1/3 of the total LNQCs inspected during the cycle. It takes three cycles for the entire LNQC inventory to be inspected. The LNQCs are in good condition with minor repairs ongoing as part of the routine maintenance contracts. The LNQCs inspection noted no structures in poor condition for the 2022 inspection period. Figure 15 shows an example of a culvert in the FTE system.

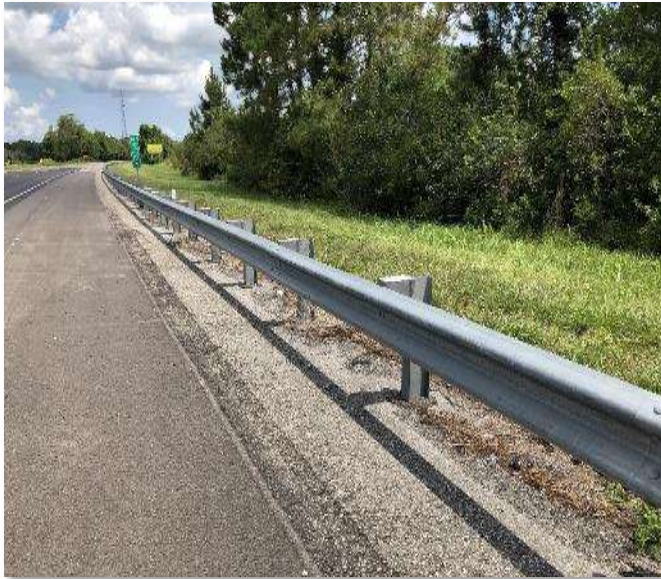
Desired Guardrail Asphalt Condition

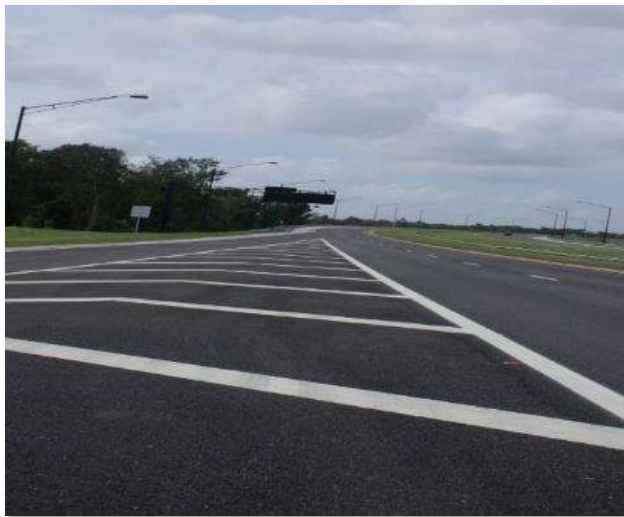
Desired Travel Lane / Ramp Condition

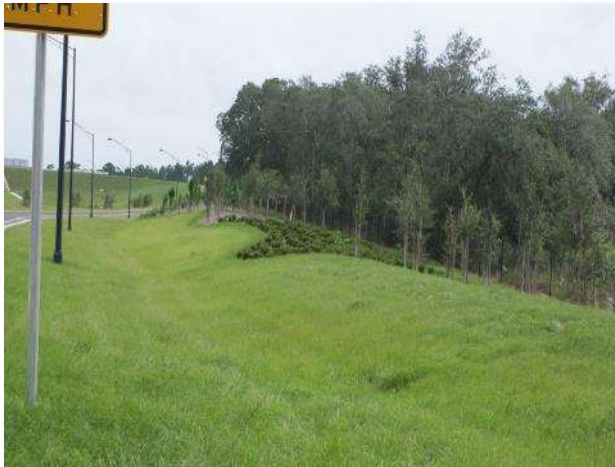
Desired Soil, Shoulder and Front Slope Condition
