EXTINGUISH THE TORCH MEETING SESSION ONE

FIN: 442901-7-52-01 Contract No.: E8R57

Project: Turnpike Mainline Shoulder Excavation NB (MP 140-210)

LESSONS LEARNED

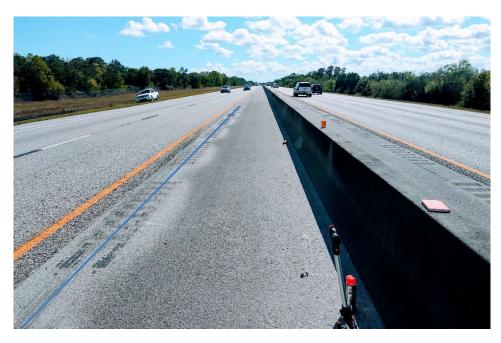
Issue: Picture of layout of widening per Plans.

The EOR agreed with the CEI recommendation to relocate the control point to 1" outside of the existing rumble strips and widen the roadway from that point to the interface of the existing roadway, increasing the width of the widening strip by an average of 8.5". Resulting in an overrun of Pay Item 285-714 Optional Base Group 14 (50 SY), 285-7-15 Optional Base Group 15 (53 SY), & 334-1-14 Superpave Asphaltic Concrete (35 tons).

The EOR/Department should not rely on old as-built information for the development of plans. The reference line provided in the plans was the face of the bottom of the Barrier Wall which is a variable distance from the Rumble Strips which put the edge of widening in the middle of the rumble strips instead of the outside edge. Survey should be performed to locate the Rumble Strips.

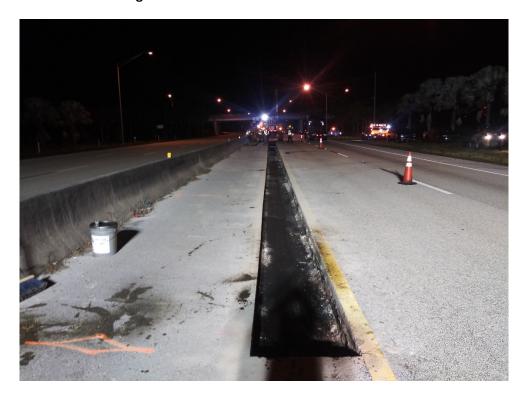
Resolution: Picture of widening with increased width

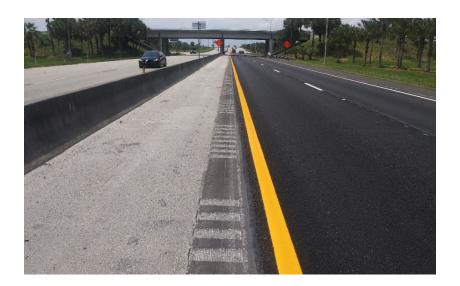
According to Typical Section for inside widening (MP 150.390 & MP 152.89), the FC-5 was supposed to be flush with the structure and no overlap (0" overlap); so the yellow stripes falls 2" from the edge of FC-5. But the existing FC-5 had an 8" overlap (see issue picture under item 1). We had to transition from 8" overlap to 0" overlap. In addition, the pavement marking plans did not address the 2 to 3 feet transition from existing pavement to newly widened roadway.

The plans show the FC-5 and the rumble strip move away from the lane the entire 2 to 3 feet at the beginning of the widening strip; however, the yellow strip transitions over a few hundred feet. This would have resulted in either the rumble strip being too far from the yellow stripes through the transition area or the rumble strip would have to be cut through the FC-5 to keep it at the correct location relative to the yellow strip. To fix this, we transitioned the edge of FC-5 to match the transition of the yellow stripe; keeping the edge of FC-5 2" outside where the yellow strip was to be placed (except, we started the FC-5 with an 8" overlap and quickly transitioned the overlap to 0" overlap).

The CEI team coordinated with the FTE and EOR and made an adjustment to edge of friction course (transitioning from 8" overhang to 0") to avoid placement of rumble strips on FC-5 in the transition area.
